## **Current Conditions Inventory Report**

### **Dry Creek: Warm Springs Dam to Russian River**

**Sonoma County, CA**

**December 2, 2010**

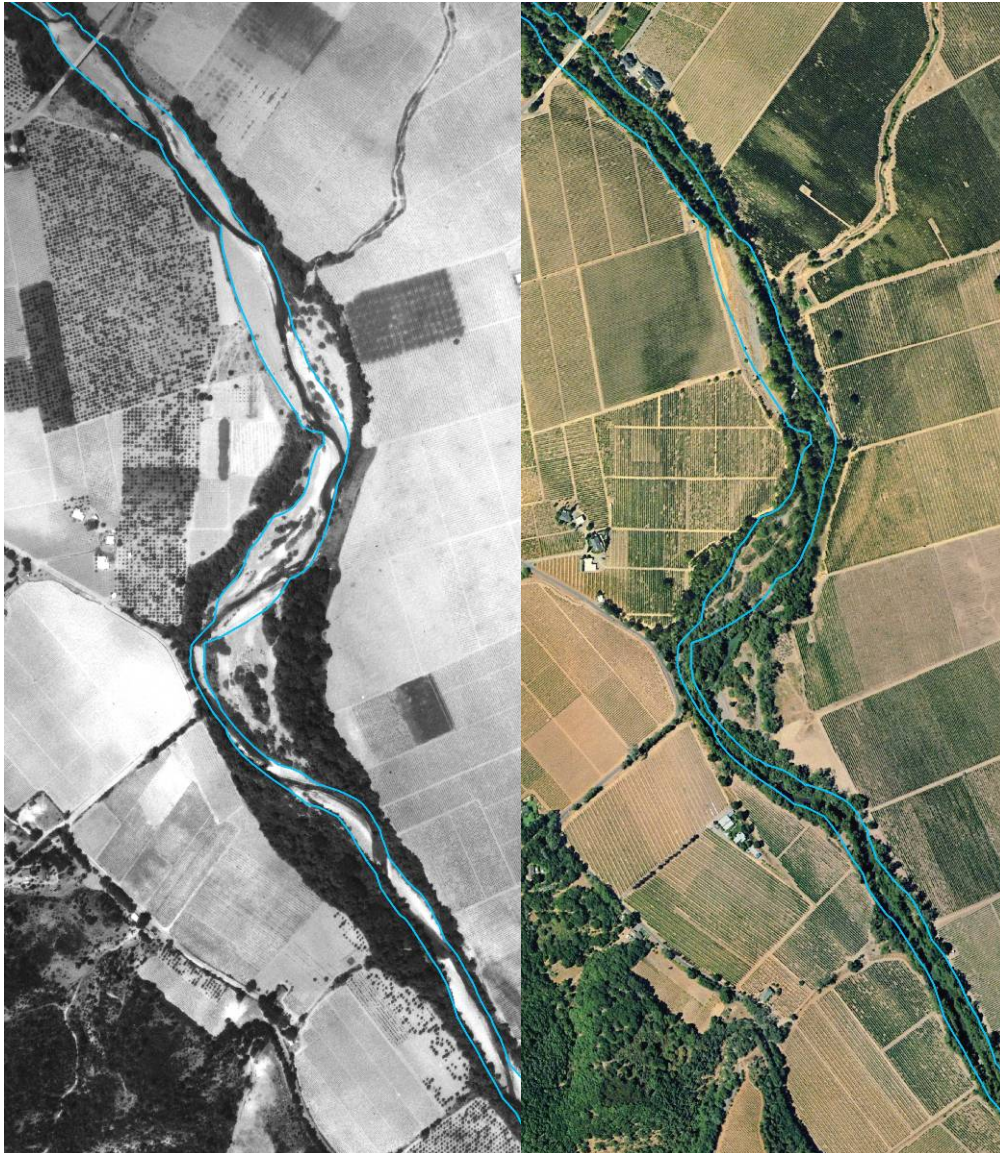
Figure 15: Example of vegetative encroachment near Yoakim Bridge. Yoakim Bridge (RM 10.7) is seen at upper left of each frame. Dry Creek flow is from top to bottom of each frame. Left frame is from 1976, right frame is from 2004. Light blue line is estimated limit of active fluvial features in 1976.

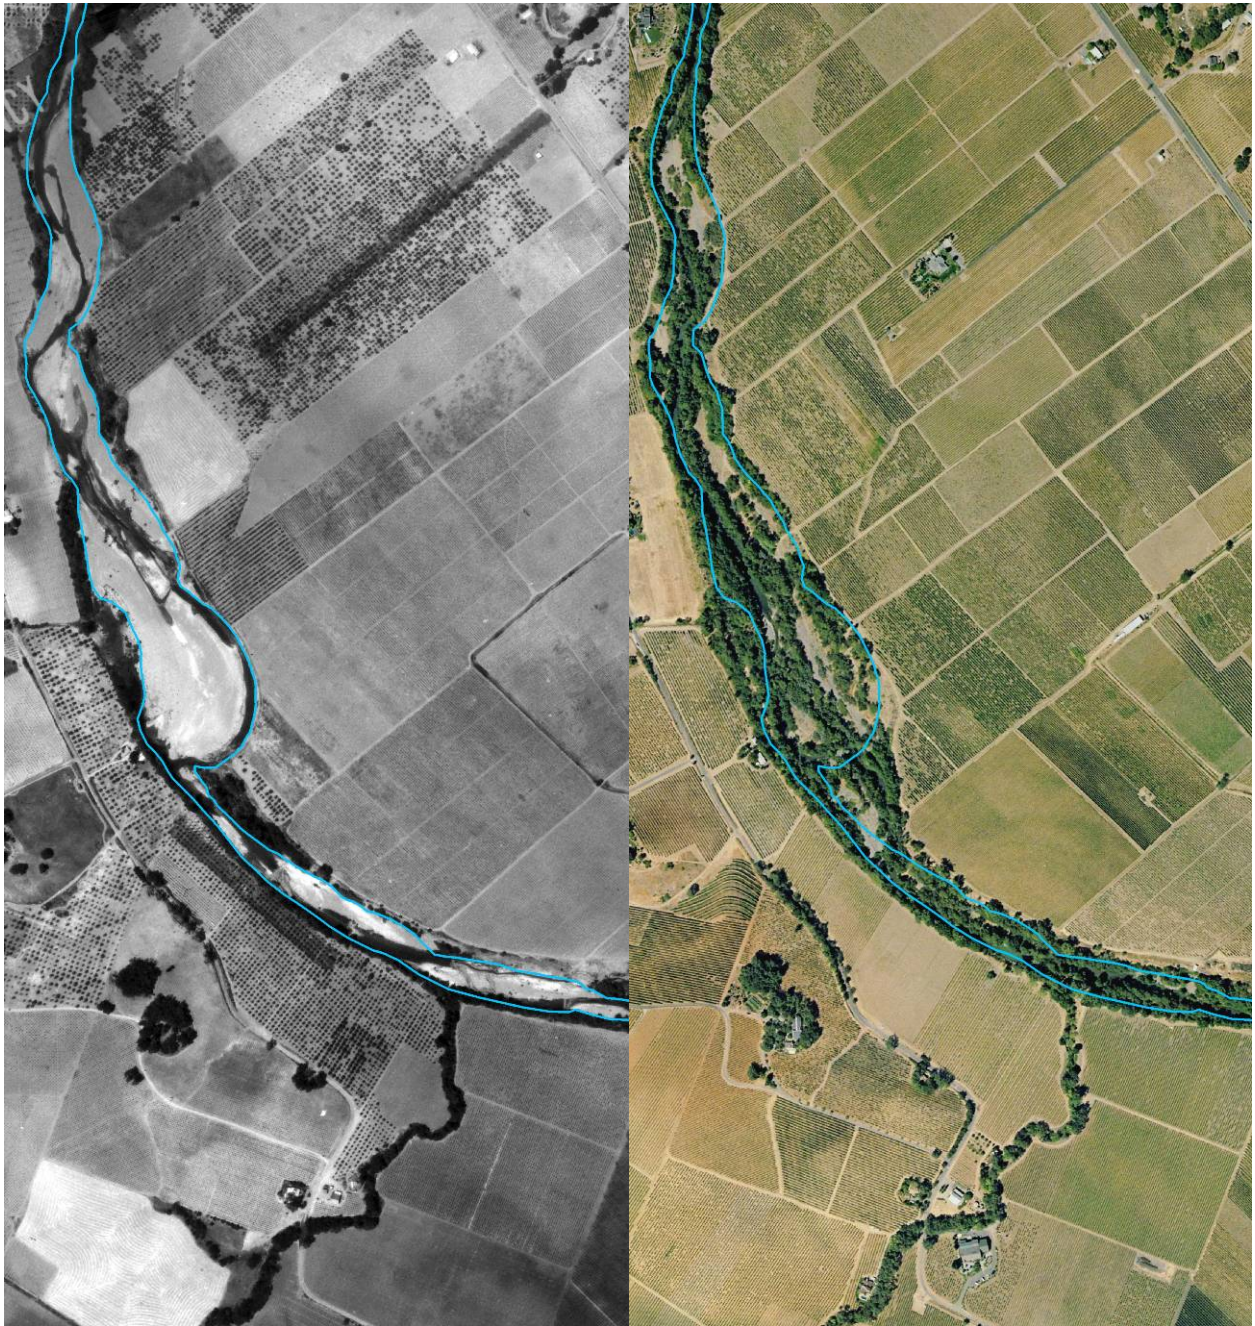
Figure 16: Example of historic bank erosion leading to relatively wider area of channel corridor near confluence of Grape Creek (RM 7.3). Grape Creek is seen at bottom center of each frame. Dry Creek flow is from top to bottom. Left frame is from 1976, right frame is from 2004. Light blue line is estimated limit of active fluvial features in 1976.

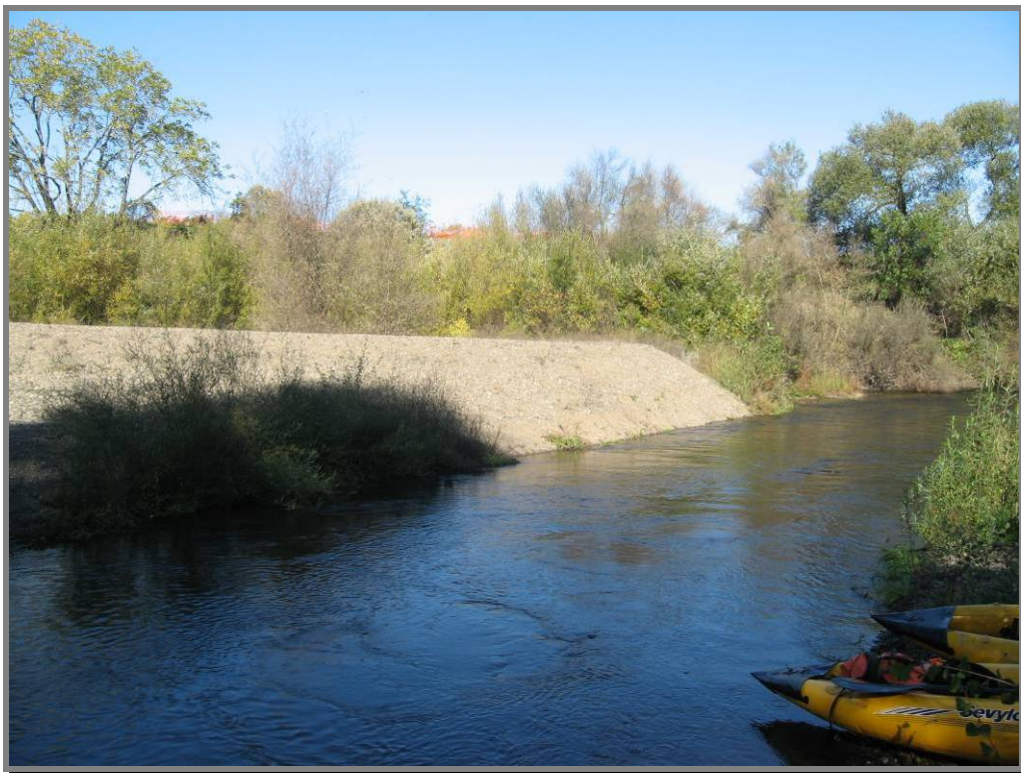
Photograph 10: Deposit of gravel across from Mill Creek confluence (RM 0.6), reflecting backwater influence of Russian River.

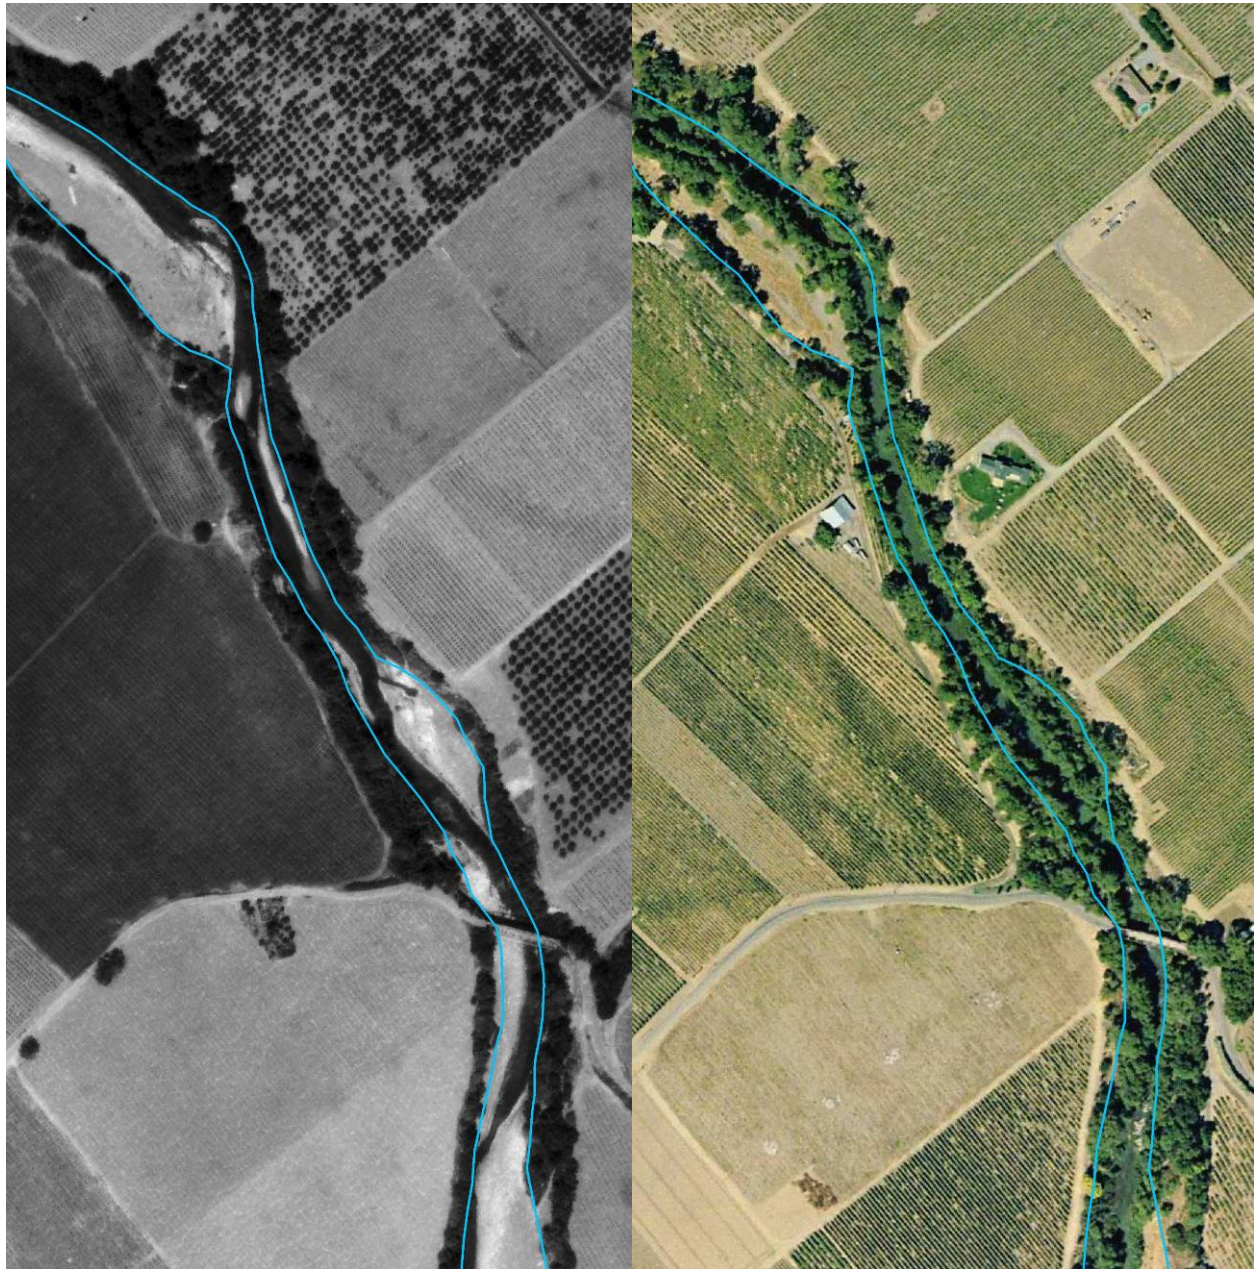
Figure 17: Example of vegetative narrowing of channel corridor near Lambert Bridge (RM 6.6). Lambert Bridge is seen at lower right of each frame. Dry Creek flow is from top to bottom. Left frame is from 1976, right frame is from 2004. Light blue line is estimated limit of active fluvial features in 1976.

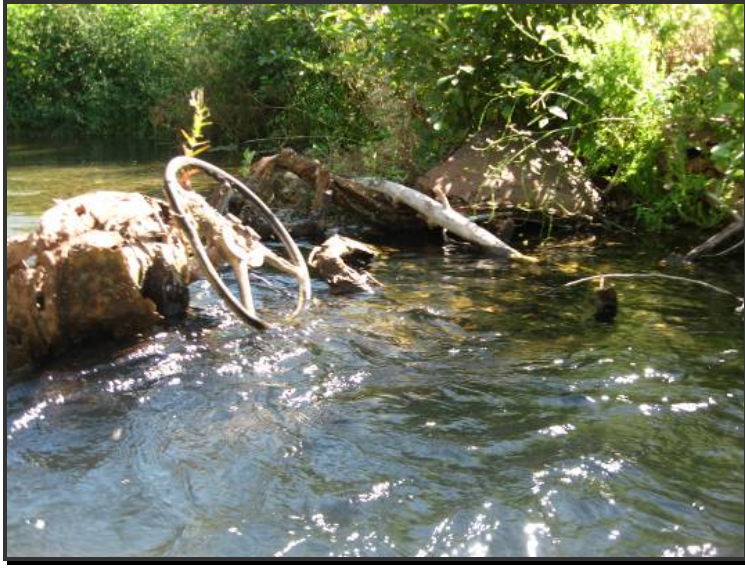
Although we did not specifically measure lengths of bank erosion, eroding banks were observed in Reach 1 and in Reach 7. We did record bank stabilization efforts and other man-made features in the creek where visible (Photograph 16). These were added to the existing feature GIS layer, and are described in the Reach Summaries (Appendix A) in greater detail. Overall, there were a high number of bank stabilization efforts using riprap, cars, creosote-preserved wood fences, steel I-beams, and chain-link fence.

Photograph 16: Man-made features in Dry Creek.

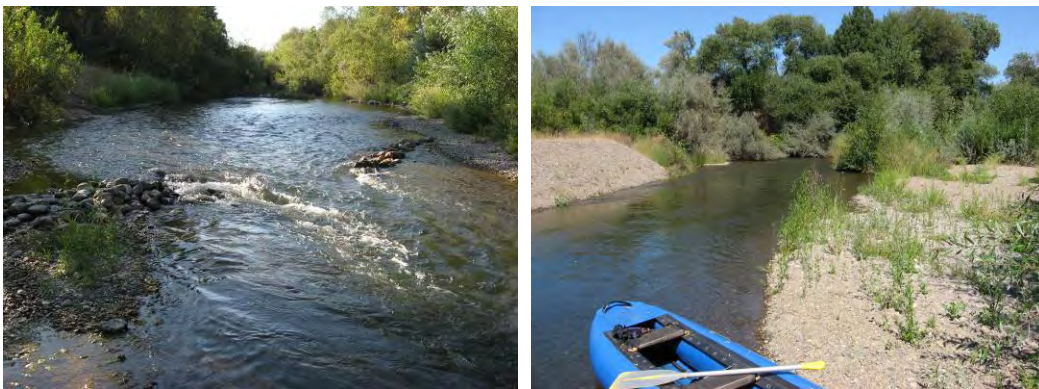
Figure 2: (left) A hand-built cobble dam across Dry Creek, (right) Unvegetated streambanks at the Mill Creek confluence.

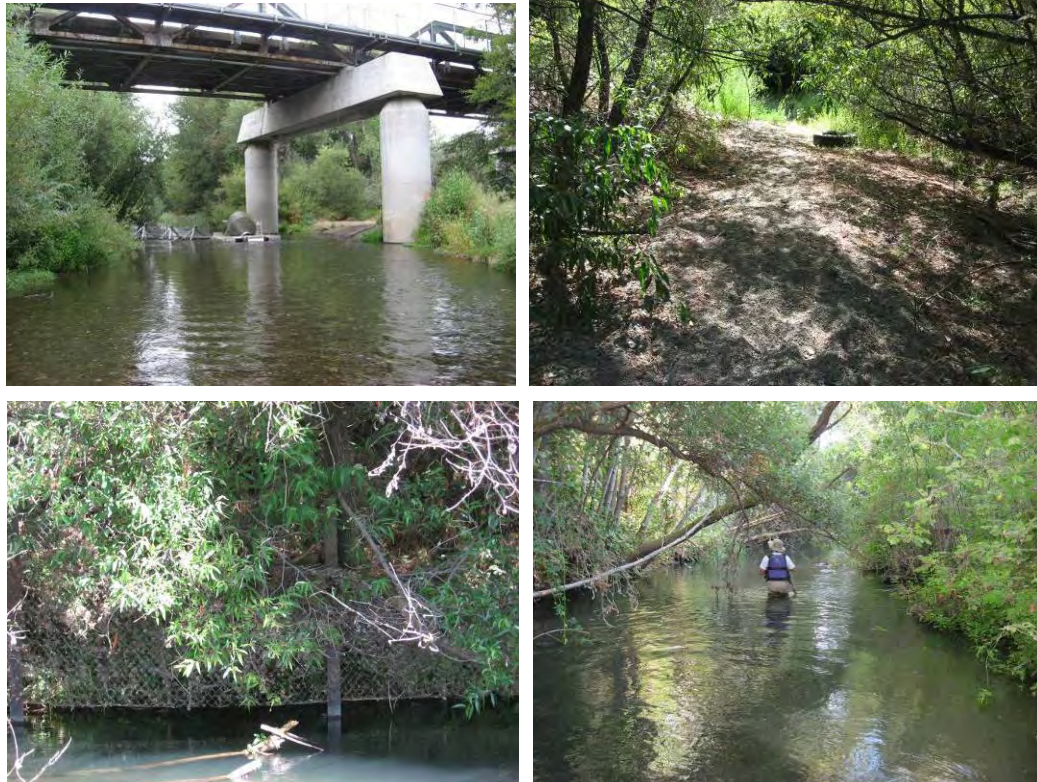
Figure 12: (upper left) Westside Road bridge and screw trap, (upper right) mouth of intermittent stream, (lower left) failed I-beam and chainlink bank armor, and (lower right) side channel pool.

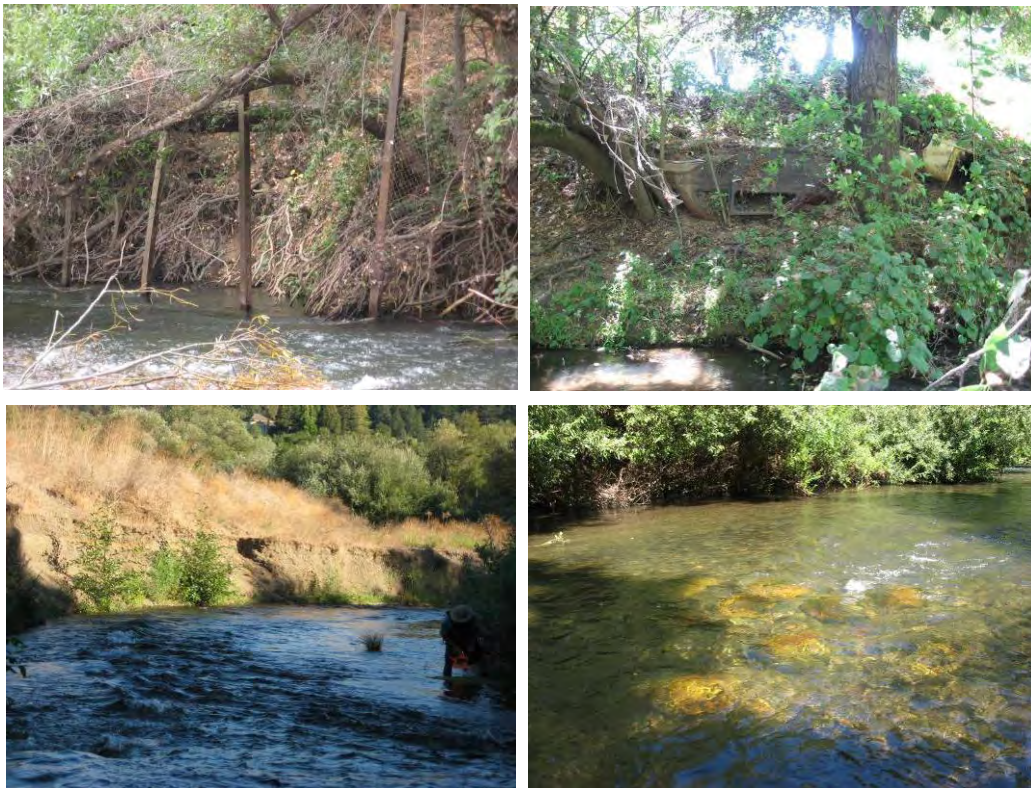
Figure 34: (upper left) Failed I-beam and chainlink fence stabilization efforts, (upper right) car bodies in the banks, (lower left) erosion along an outside bend, (lower right) a triangular boulder cluster in Dry Creek.

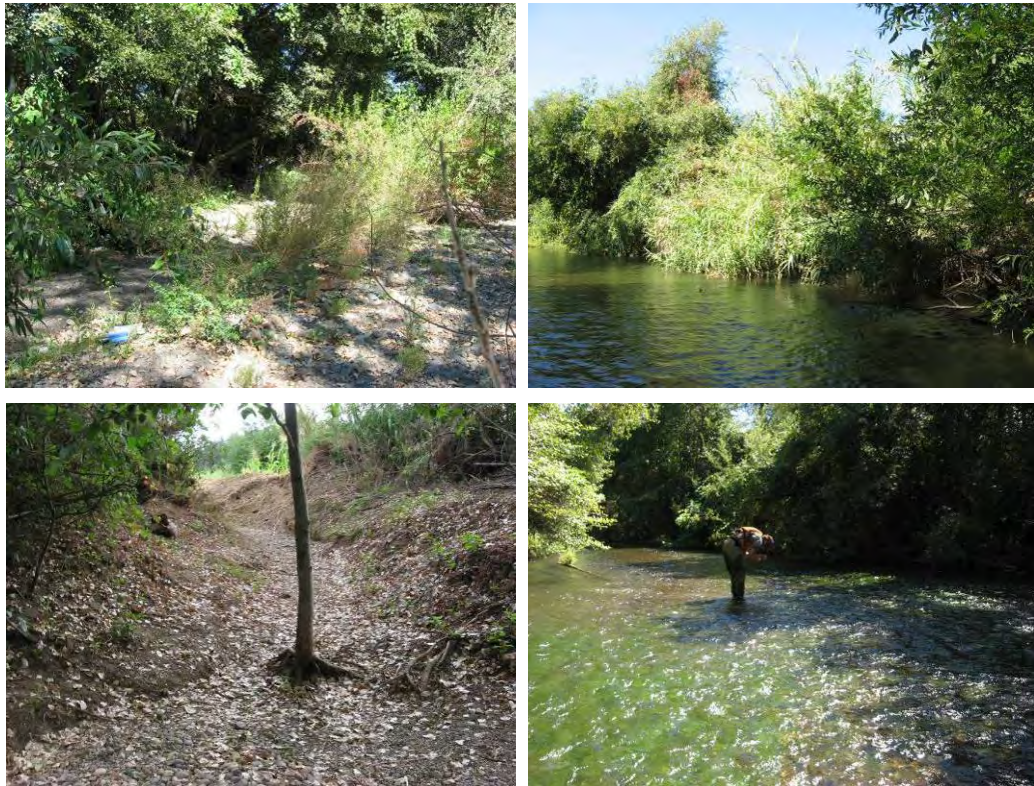
Figure 54: (upper left) A large gravel bar in Pena Creek 100 feet upstream from its confluence with Dry Creek, (upper right) an invasive grass (*Arundo donax*) grows on the right bank just downstream from Pena Creek, (lower left) small, intermittent stream with cleared banks, (lower right) Pebble count being conducted in a riffle in Reach 11.

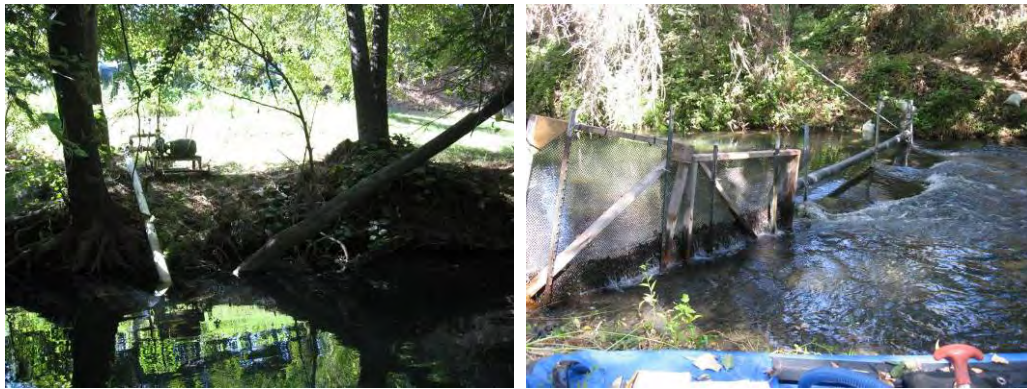
Figure 65: (left) Pump in Dry Creek, (right) Pit-tag antennae spans Dry Creek.

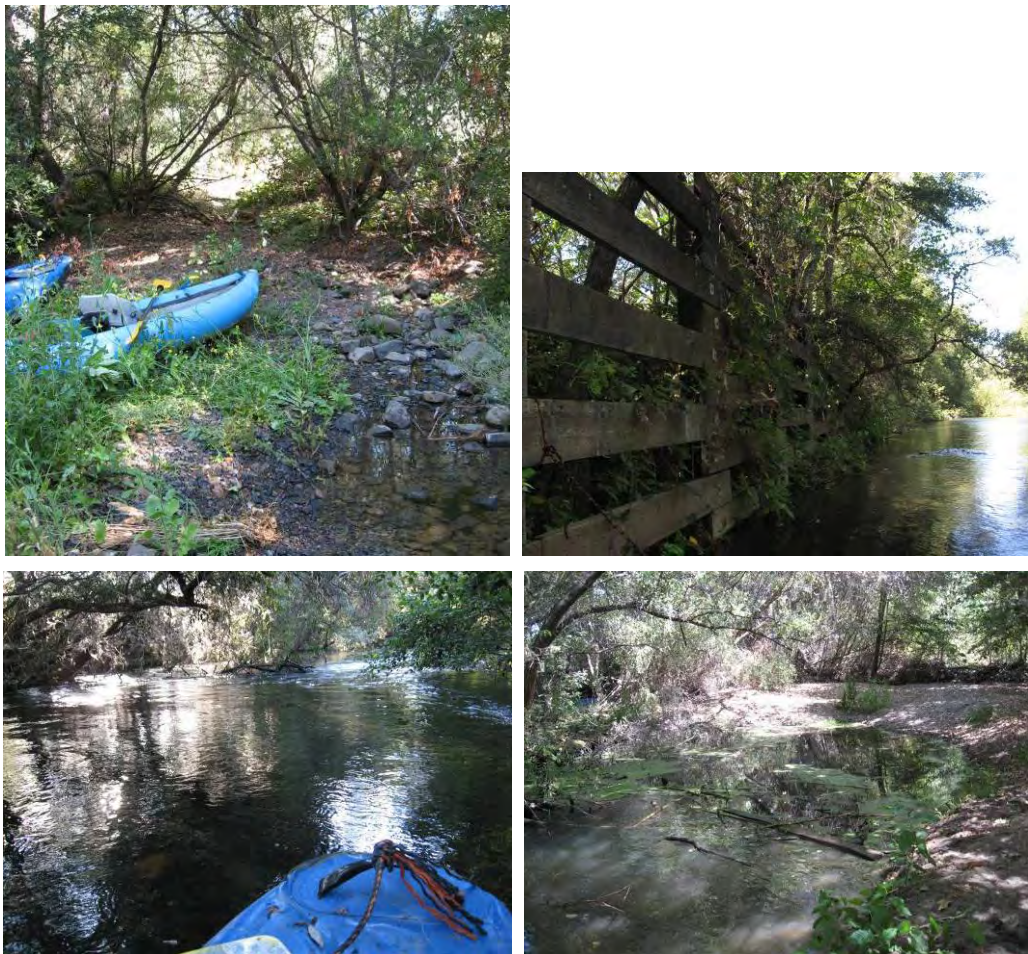
Figure 70: (upper left) mouth of Schoolhouse Creek, (upper right) board fence along the right bank, (lower left) deep pools with interacting live tree cover, (lower right) alcove habitat with aquatic vegetation.
