DEPARTMENT OF TRANSPORTATION
Structure Maintenance & Investigations

Bridge Number : 25C0117
Facility Carried: CLAY ST
Location : 150 FEET NORTH OF MAIN S
City : PLACERVILLE
Inspection Date : 07/26/2016

Bridge Inspection Report

STRUCTURE NAME: HANGTOWN CREEK

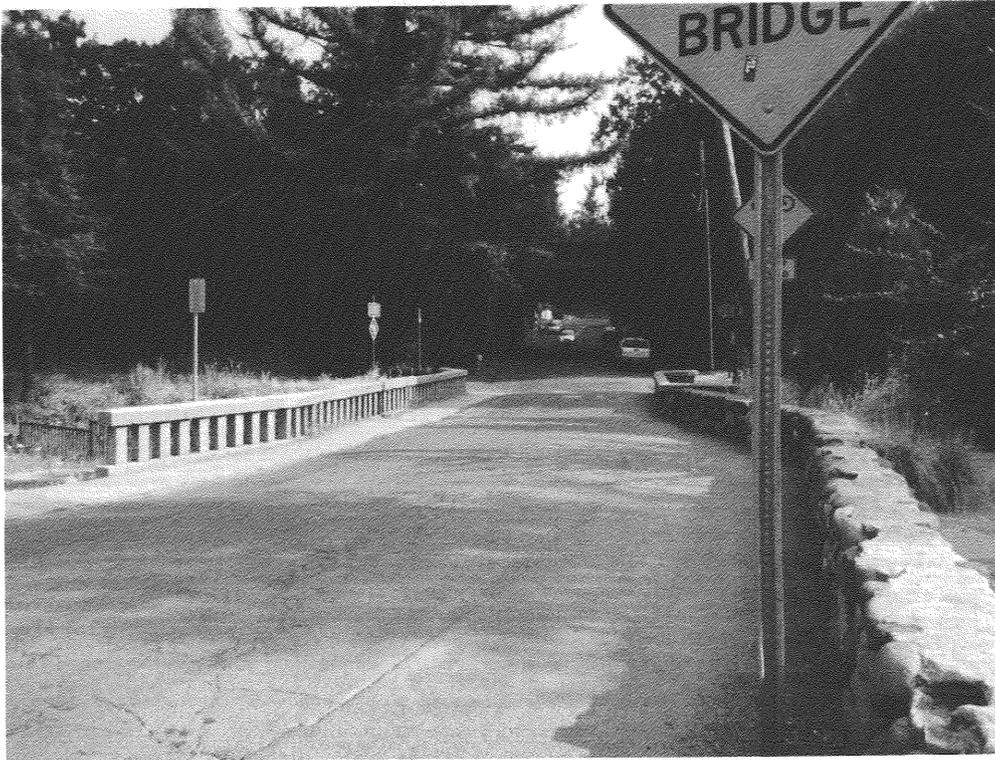
Photo No. 1

Routine roadway looking north

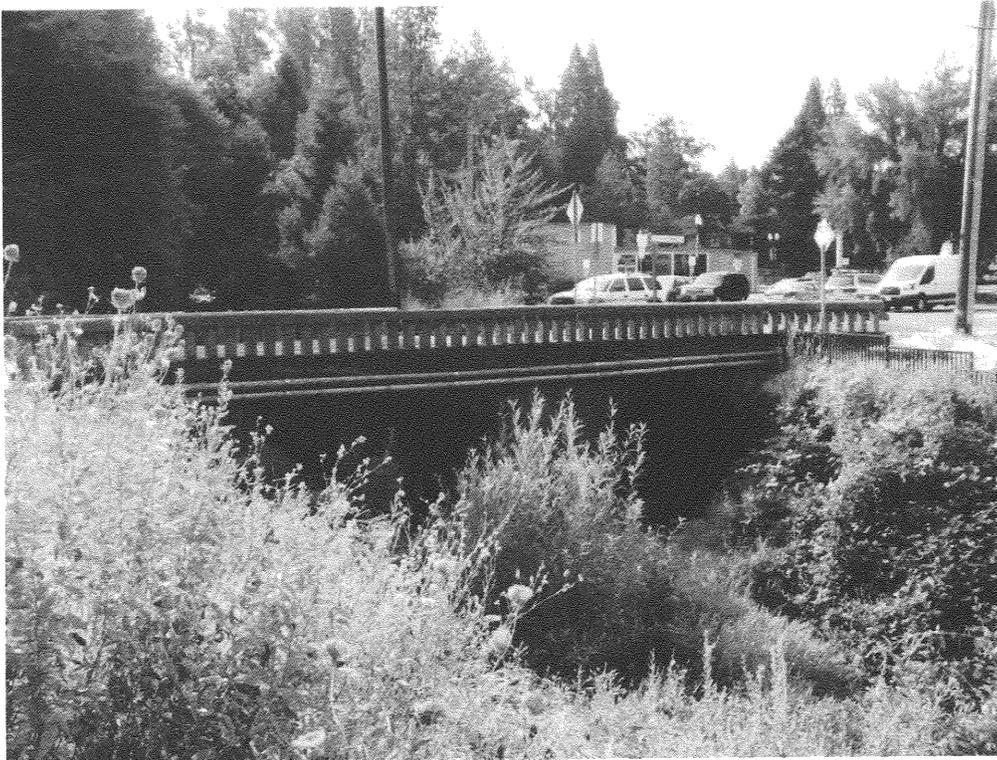
Photo No. 2

Routine elevation view (left side)

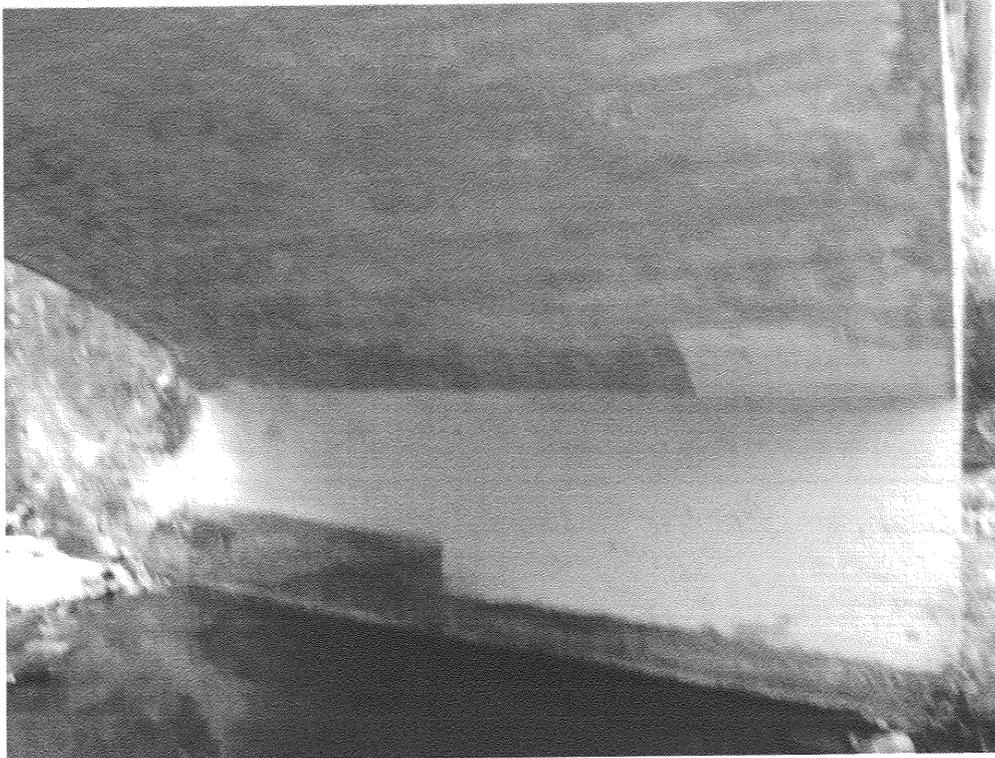
Photo No. 3
Routine underside (Span 2)

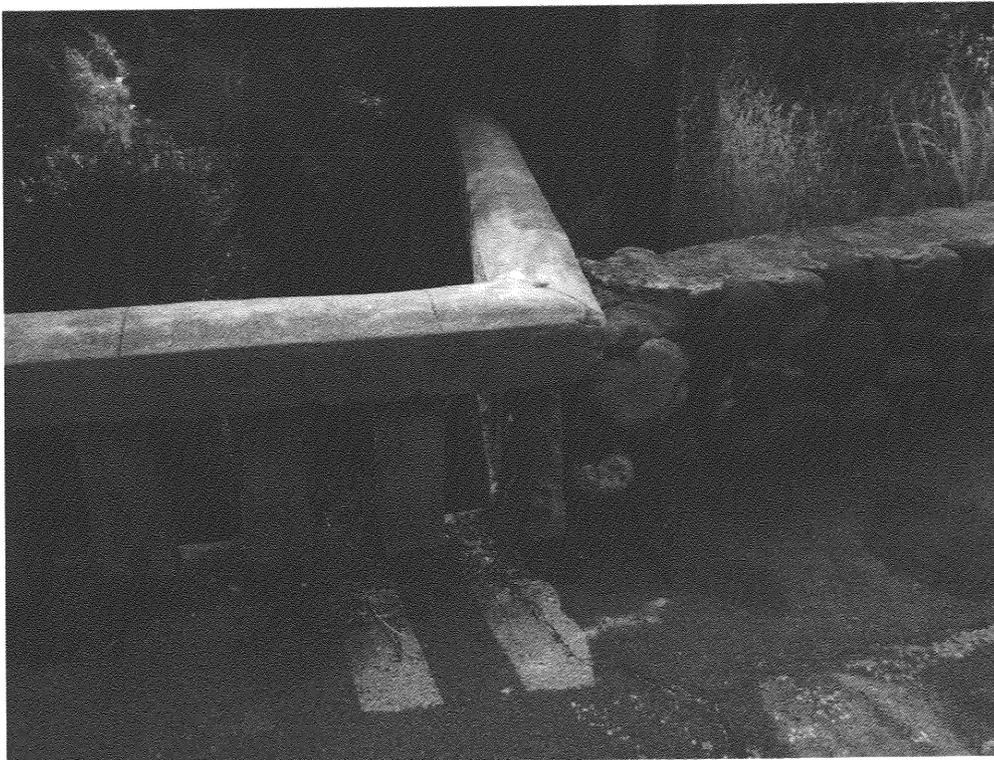
Photo No. 4
Spalled right rail post (at Abutment 1).

RecDate: 01/13/2011 EstCost: Remove unsound concrete from the bridge
Action : Railing-Repair StrTarget: 2 YEARS rails, clean rebar, and patch the spalls.
Work By: LOCAL AGENCY DistTarget:
Status : PROPOSED EA:

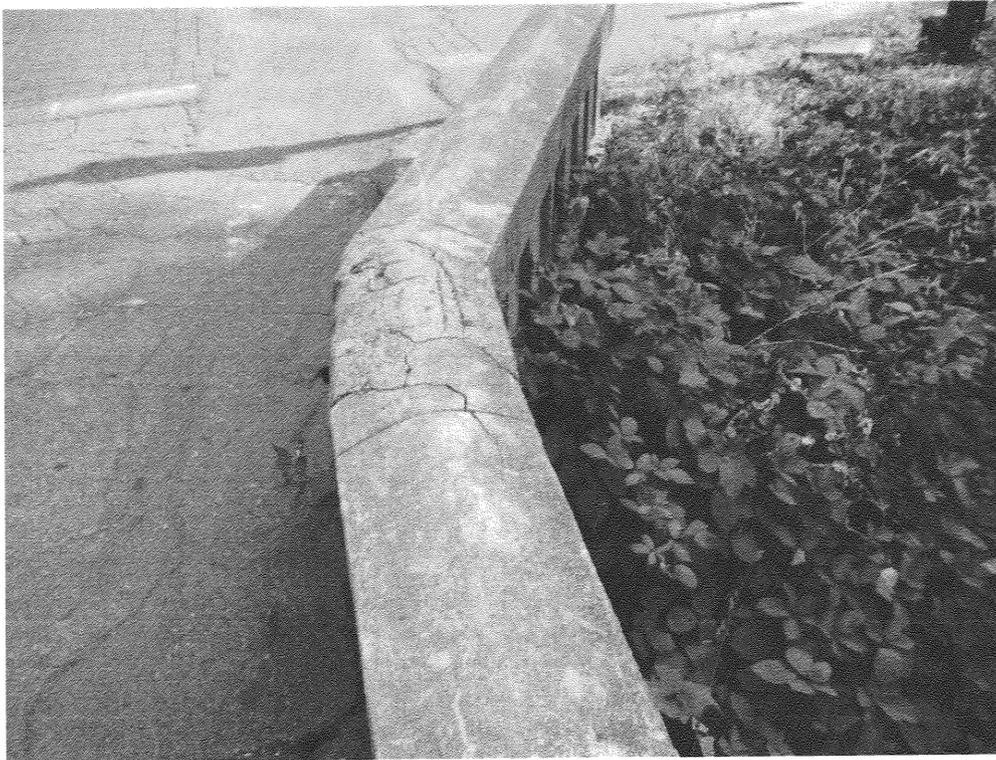
Photo No. 5

(210)			There were no significant defects noted.								
215			Abutment-RC	2	24	m	24	0	0	0	0
(215)			The monolithic wingwall quantity has been included in the total abutment quantity. No significant defects were noted.								
256			Slope Protection	2	1	ea.	0	0	1	0	0
	6000		Scour	2	1		0	0	1	0	0
(256-6000)			The slope protection at the left side of Abutment 3 is undermined for 12 inches high, 1.5 feet inward. Based on a field comparison to the 01/2011 bridge inspection photos, this condition has not changed.								
331			Railing-RC	2	20	m	15	0	5	0	0
	1080		Delamination/Spall/Patched Area	2	5		0	0	5	0	0
(331-1080)			The right rail post near Abutment 1 has a full height spall with exposed rebar (see photo 4). There is a 24 inch long delamination on the top of the right rail at Abutment 3 (see photo 5). The top of the left concrete rail has spalled along 25% of the length (see photo 6).

Delamination on right rail (near Abutment 3)

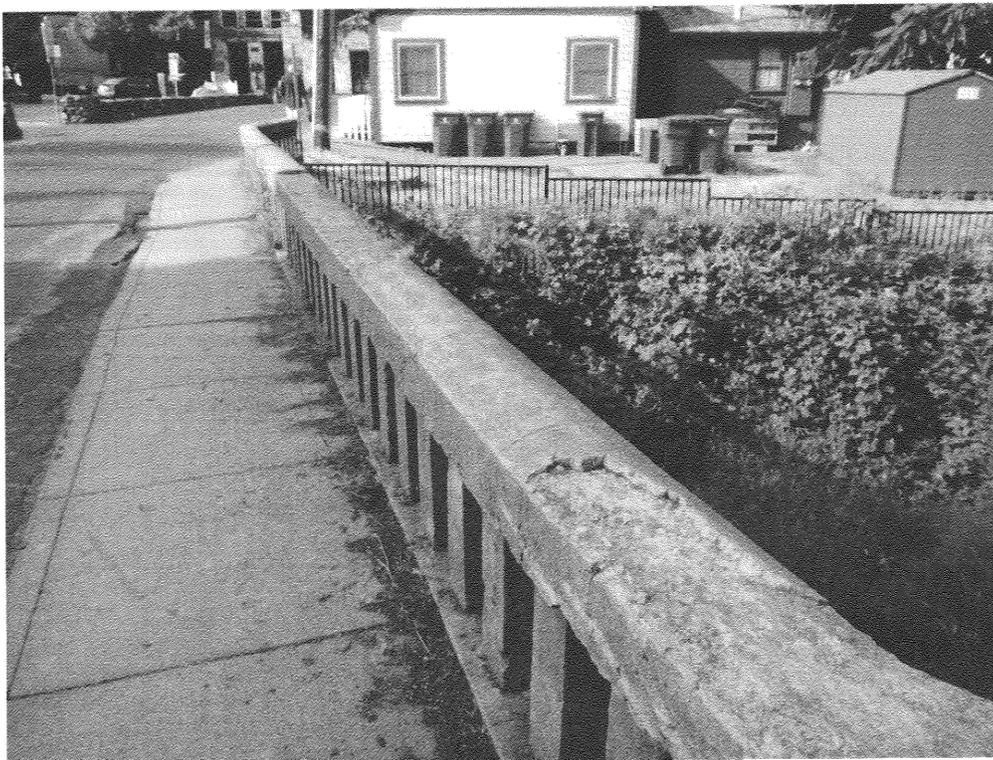
Photo No. 6

Spalling at top of left rail (near Abutment 3)
