City of Dover, Delaware

Old Dover Public Library, Building Assessment Report

Date: July 2017

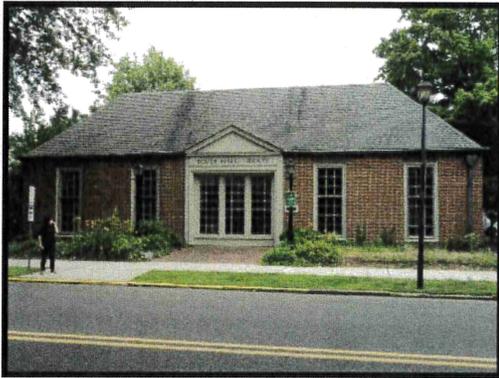
C-1
Exterior
West Elevation, Original Construction

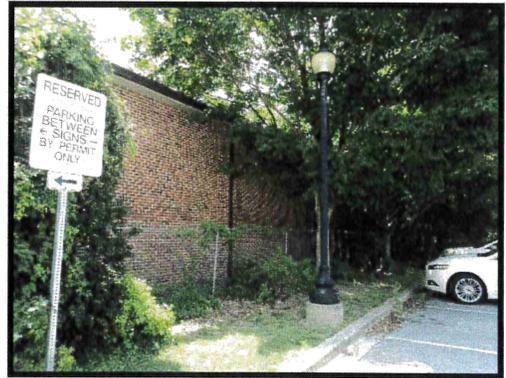
C-2
Exterior
North Elevation, Trees & Vegetation

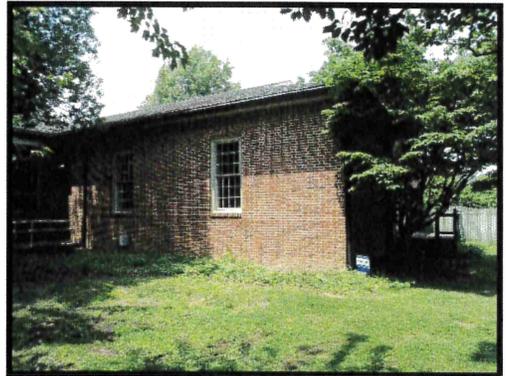
C-4
Exterior
South Elevation at Addition

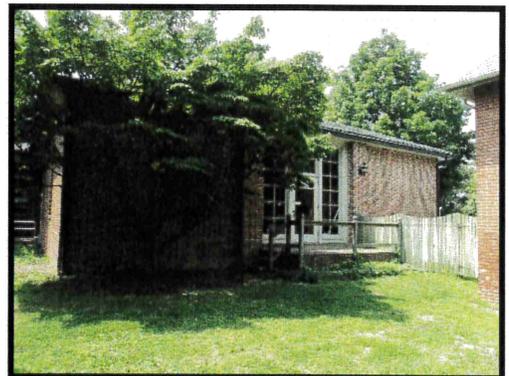
C-6
Exterior
East Elevation at Addition

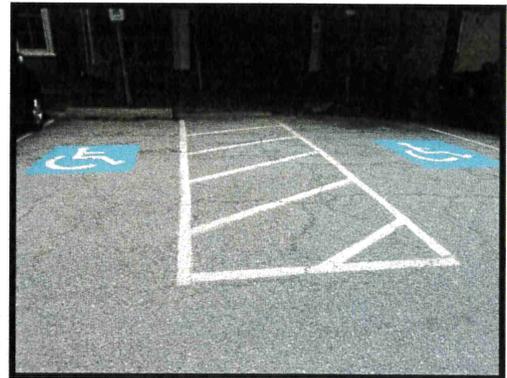
C-8
Exterior
Accessible Entrance, Pavement

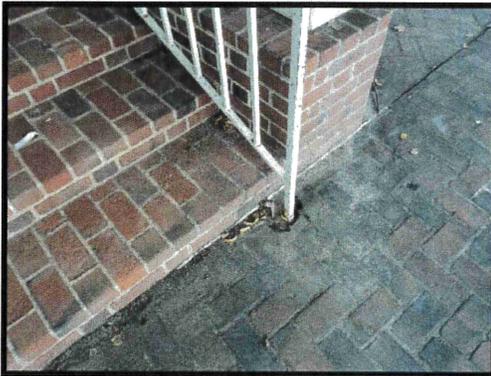
C-9
Exterior
Main Entrance Stair Railing Damage

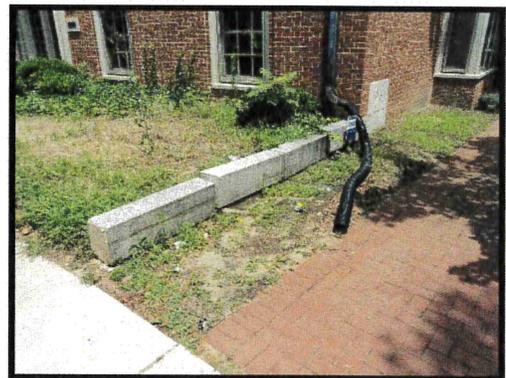
- The cupola above the main entrance (Section 2) seems to be in good shape but should be prepped and painted.
- Planters and retaining walls on the southwest side of the building are in poor condition and should be repaired.

C-10
Exterior
West Side, Stone Curb Retaining Wall

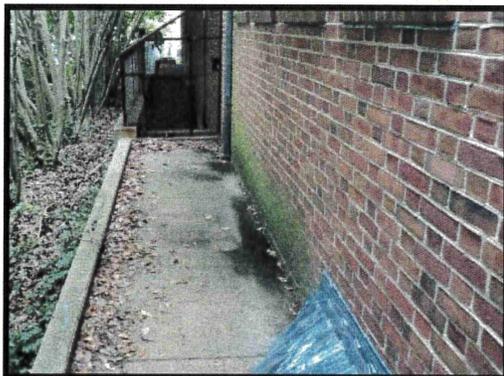
- Concrete sidewalk on the north side of the building slopes toward the building, which forces water to run along the face of the building.
- Sidewalk on the north side of the building is too narrow to accommodate the drop-down fire escape and pedestrian traffic from the basement exit at the same time.
- Trees on the north side of the building are in contact with the roof and walls.
- Tree roots on the south side of the building are pushing up the brick sidewalk.

C-11
Exterior
North Walkway and Standing Water

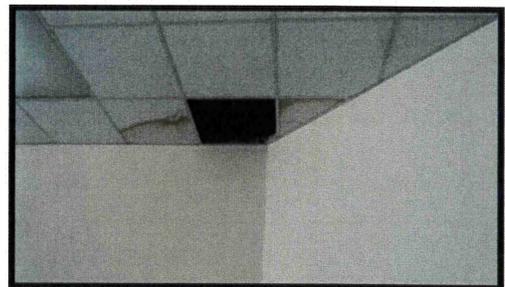
E-12
First Floor
Water Stained Ceiling in Addition

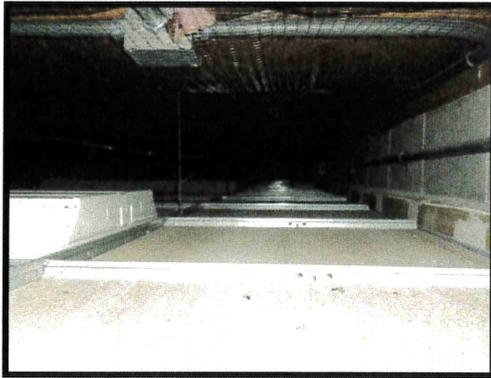
- Timber roof trusses span the east addition. Limited access only allows inspection of the bottom chords of the trusses. However, no sagging of the bottom chords or the roof from above was noted.

E-13
First Floor
Truss Space Above Addition

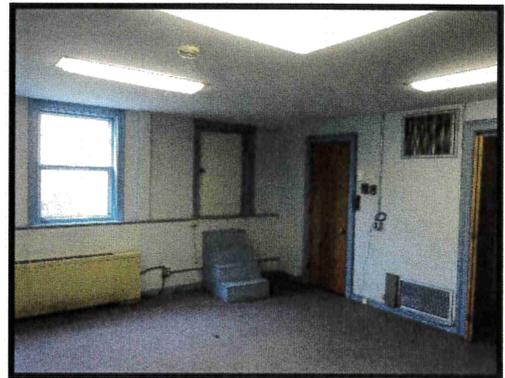
- The storefront doors (main entrance) are in good condition. However, the two doors on the northwest side of the building are in fair condition, and the fire escape exterior door on the second floor is in poor condition. The wood/glass door on the northeast side of Section 2 is in fair condition and needs to be prepped and painted.

E-14
Second Floor
Fire Escape Door and Access Stairs

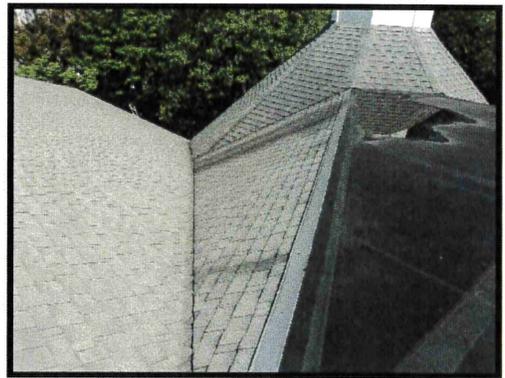
E-16
Roof East Addition Transition to Original
Construction

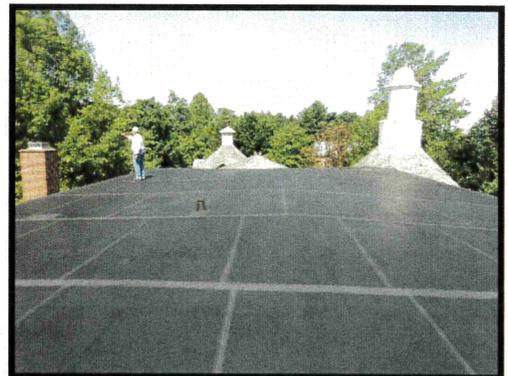
E-18
Roof
Original Construction Main Roof

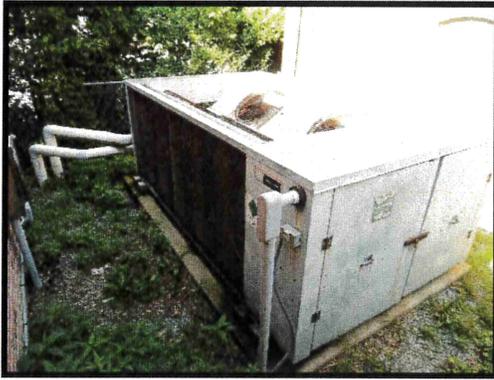
Chilled water is provided by an air-cooled chiller located outside with one pump located in the boiler room. The chiller is showing wear and weather damage. Repairs have been made to keep the system operating. The chiller is past its average life expectancy of 20 years. The chilled water pump appears in poor condition and is past its average life expectancy of 25 years. Gauge on the pump piping is broken. Chilled water pipe is run underground and the wall penetrations are in poor condition and resealed with a can of spray foam.

F-1
Chiller.

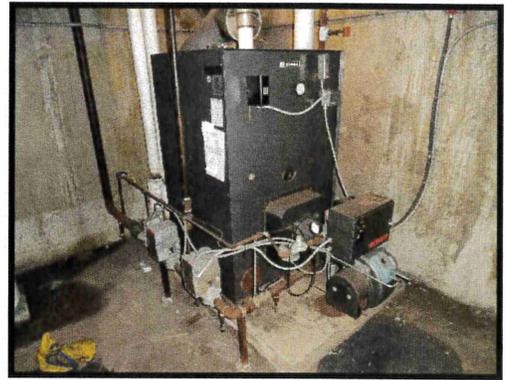
Heating hot water is provided by a gas-fired cast-iron boiler with two pumps located in the boiler room. The boiler appears to be in fair condition. The boiler has reach its average life expectancy of 35 years. The hot water pumps appear in poor condition and are past their average life expectancy of 25 years. Gauges on the pump piping are broken. Combustion air louver is dirty, shows signs of water infiltration and is in poor condition.

F-2
Boiler.

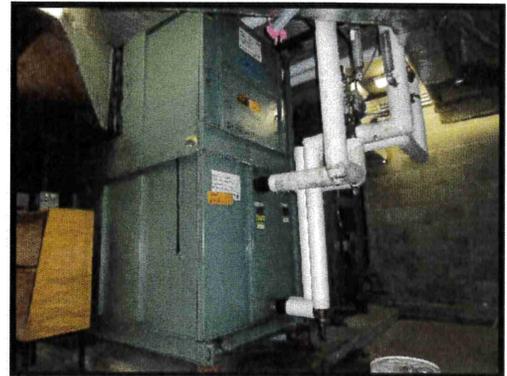
floor and second floor has chilled water, and hot water coils. HC-2 has condensation on the surface of the unit and is in poor condition.

F-8
Air-Handling Unit (HC-2).

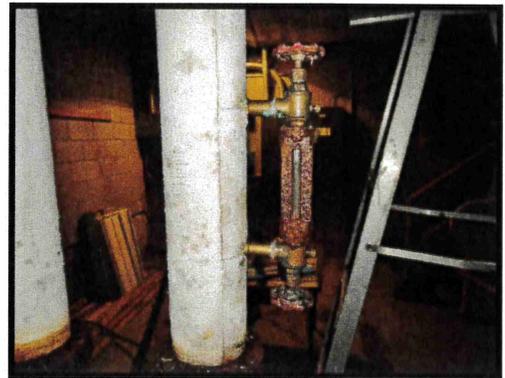
F-14
Broken Gauge.

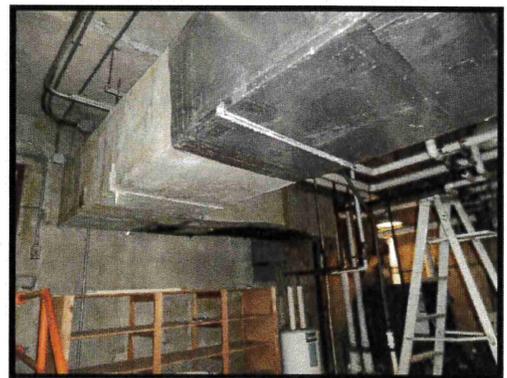
The majority of the HC-2 supply ductwork is the original construction ductwork. The ductwork is in poor condition and is past its average life expectancy of 30 years.

F-16
Ductwork.

- The supply, return, and outside air ductwork and insulation needs to be removed and replaced.
- Natural gas is available on site from Chesapeake Utilities. New equipment could utilize natural-gas.
- The existing cooling equipment uses R-22 refrigerant. R-22 (an HCFC) had been the refrigerant of choice for residential heat pump and air-conditioning systems for more than four decades, however the material contains “Chlorodifluoromethane,” known as an ozone destroying chlorine. The Montreal Protocol requires the U.S. to reduce its consumption of HCFCs and it cannot be utilized with new equipment. R-22 can only be used to service existing equipment until further phasing eliminates that use per the 2013/2015 deadlines.

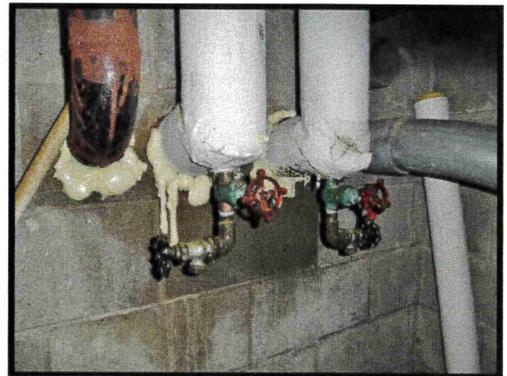
F-22
Pipe Wall Penetrations.

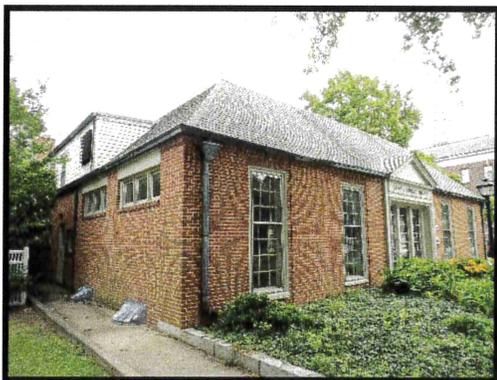
- Gutters and downspouts are copper and in need of repair. Dissimilar metal connections on the downspout system are deteriorating and causing leaking back into the building along with uncoupled connections.

G-1
Gutter and Downspout.

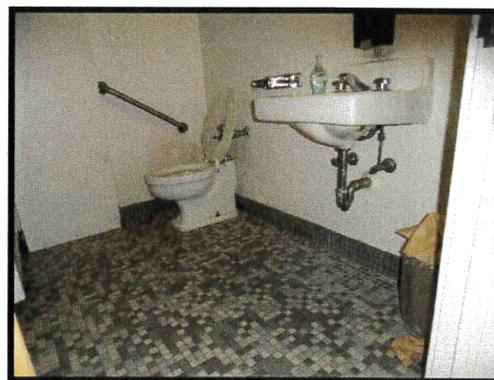
- The plumbing fixtures are generally in poor condition.
- There is no insulation for the cold and hot water piping.
- There are floor drains in the boiler room in poor condition.

G-2
Toilet and Lavatory.

- Water saving trim for the existing lavatory sinks, toilets, urinals and other fixtures should be added to replace the existing fixtures and trim.
- Additional fixtures and toilet room modifications are required to meet code for proposed future building utilization.

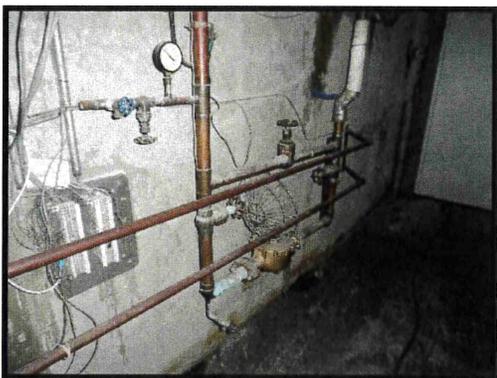
- The 2-1/2" water service line runs above the ceiling to the boiler room passage on the north side of the building. The water meter and pipe in the passage look in fair to good condition.

G-3
Water Meter.

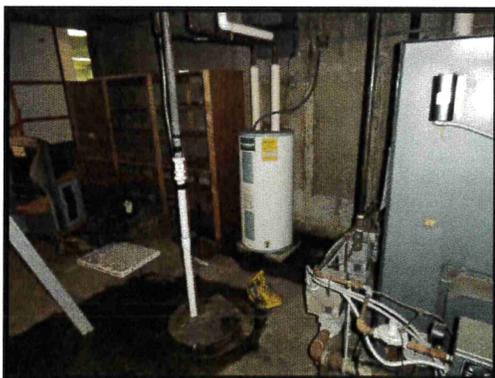
G-5
Water Heater and Sump Pump.

- The existing potable domestic water system should be tested for water quality if it is to be re-used.
- The electric water heater will need to be replaced.

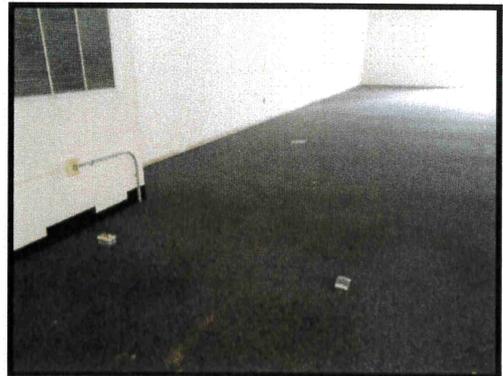
H-20 - First Floor
Exposed EMT, Telecom Outlet, and Floor Mounted Telecom Outlet and Receptacles.

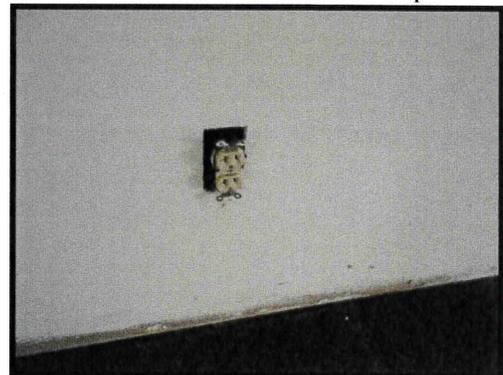
H-22
First Floor - Missing Cover Plate for
Receptacle.

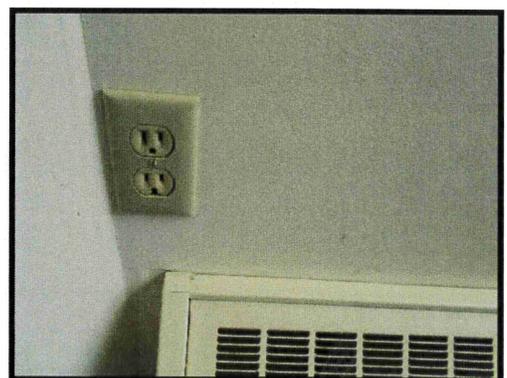
H-24
First Floor - Non-Compliant and Broken
Receptacle.

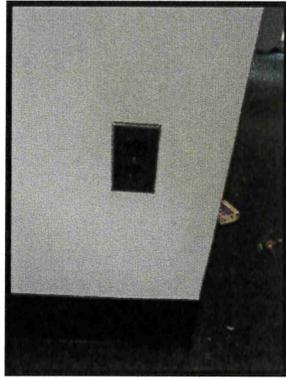
H-25
First Floor - Mix Used of Receptacle Color and Plate.

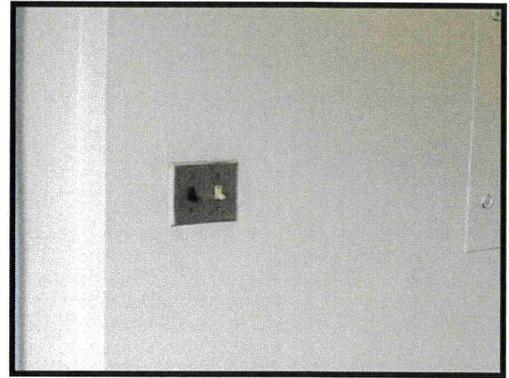
H-32
Second Floor - Rusted and Mixed Color Light
Switches.

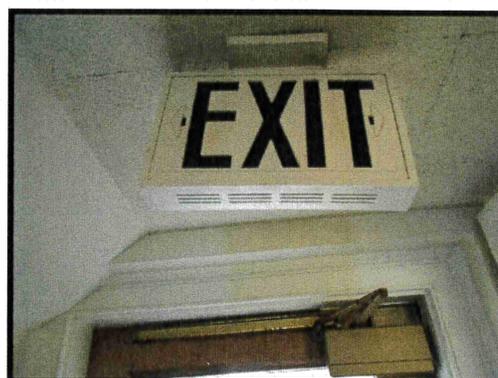
The emergency lighting consists of wall mounted emergency lighting units with backup batteries. Egress paths do not have adequate illumination due to quantity installed and spacing. Outdoor egress paths at exit doors are not illuminated by emergency lighting. Some units were installed original with the building and some were replaced with newer type but are old and obsolete. Exit signs are no longer work. Some are non-illuminated type.

H-38
First Floor - Non-Functional Exit Sign.

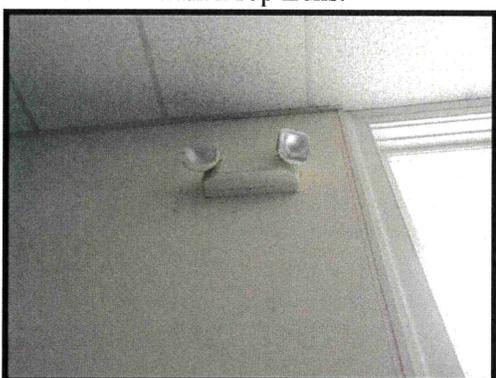
H-39
First Floor - Tungsten Emergency Lighting
Unit.

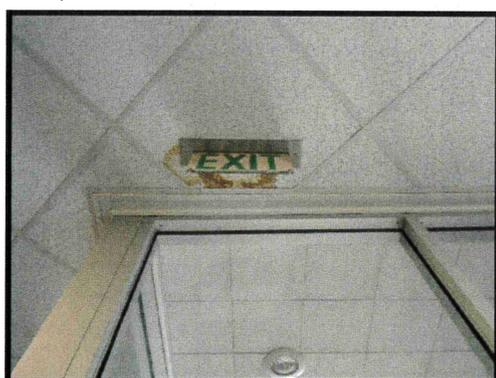
H-41
First Floor - Edge-Lit Exit Sign No Longer
Illuminated.

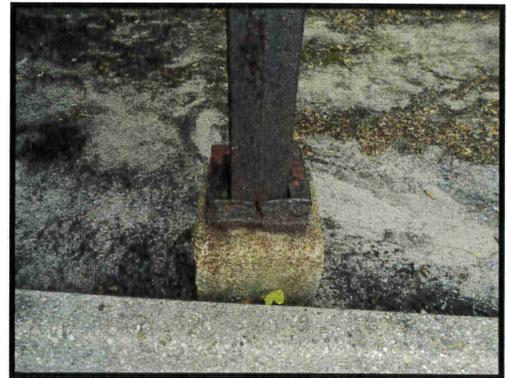
Two pole mounted dual flood fixtures in the parking lot are high intensity discharge (HID) type. Fixtures, poles, bases and foundations are not in good condition. They appear as old as the building. Wall mounted fixtures out entry/exit doors are decorative lantern style that have been fitted with compact fluorescent bulbs. Downlighting fixtures installed in main entrance canopy use incandescent bulb. Exterior lighting fixtures do not meet Dark-Sky requirements.

H-44
Damage Pole Base and Aged Foundation.

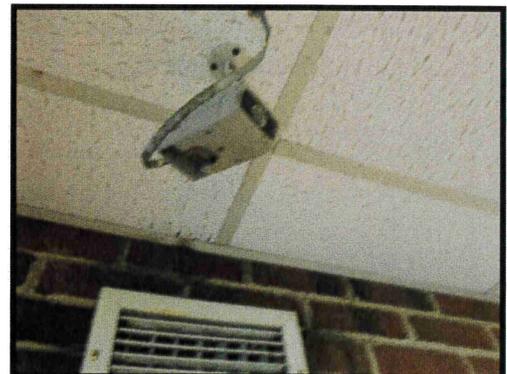
H-58
Basement - Old and Obsolete CCTV Camera.
