## **LIMITED PRE-RENOVATION ASBESTOS BUILDING SURVEY**

**Former Gander Mountain Bldg.  
Town of New Hartford  
8635 Clinton Street  
New Hartford, NY 13413**

**July 9, 2018**

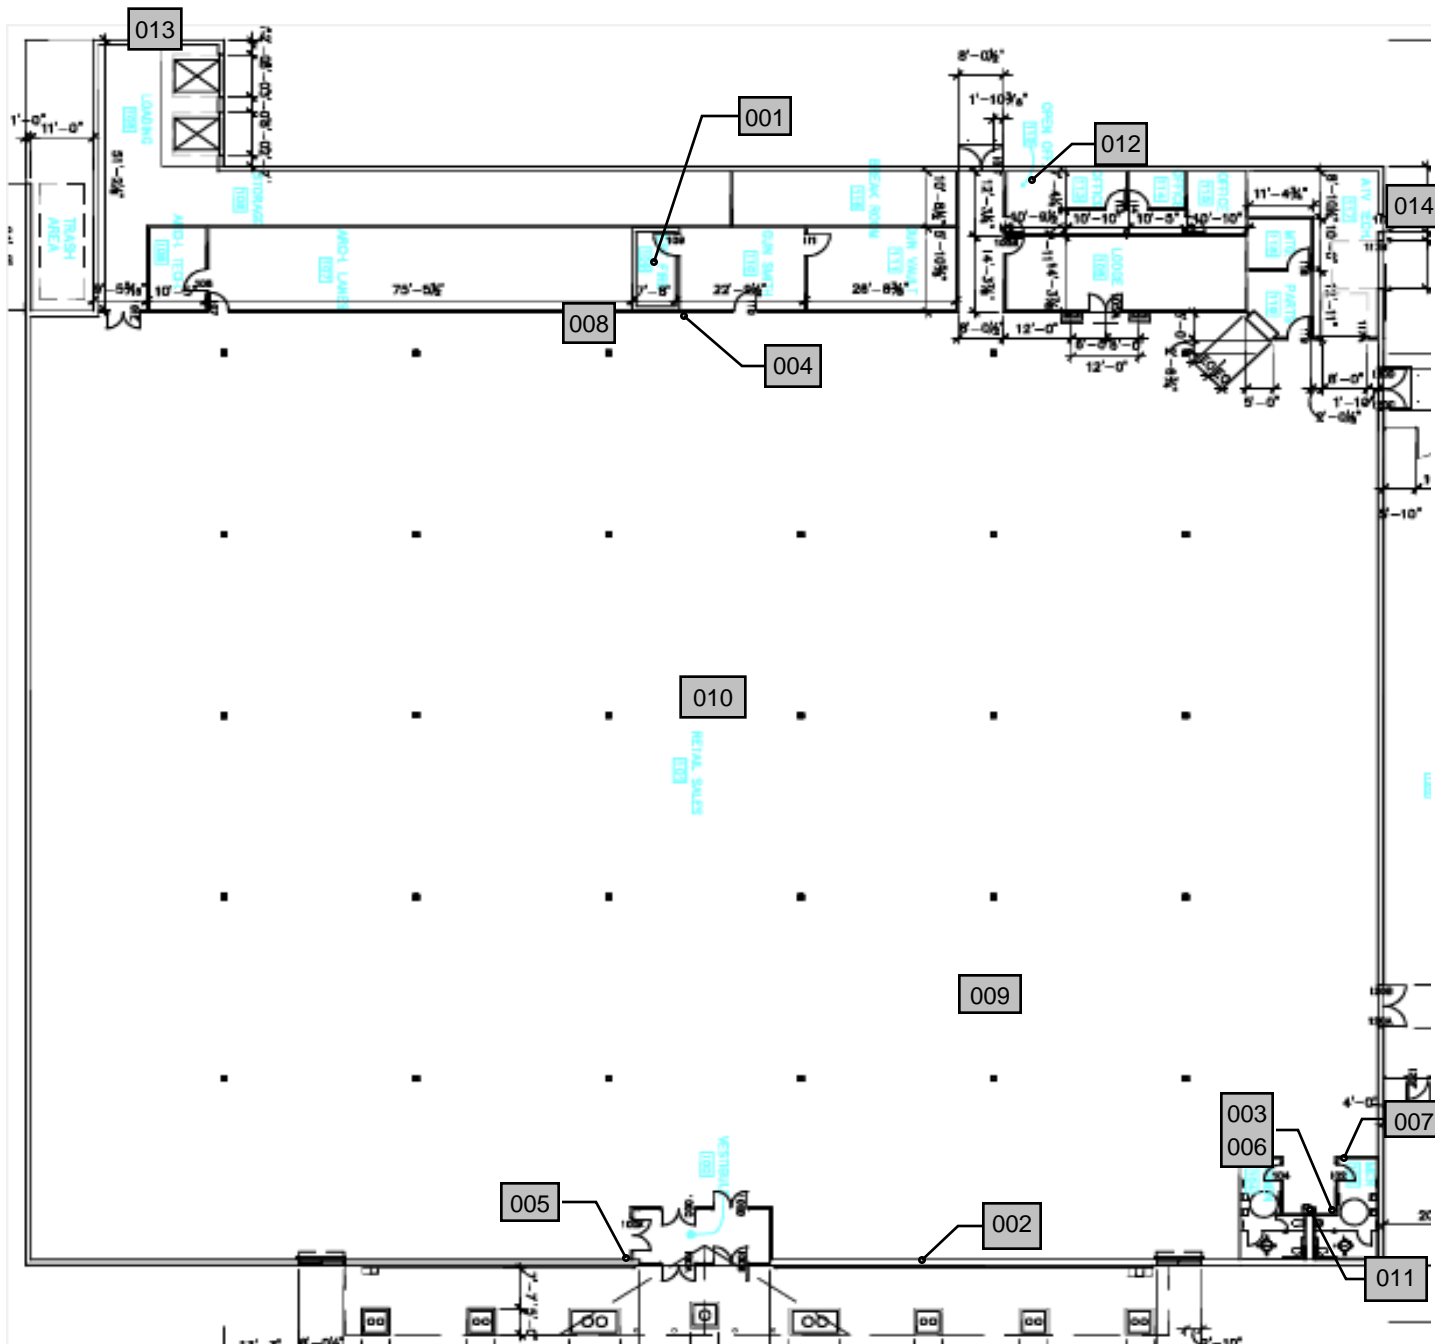
18-124-1

Bulk Sample Locations
