Herber Farm House

Building Review

July 27th, 2016

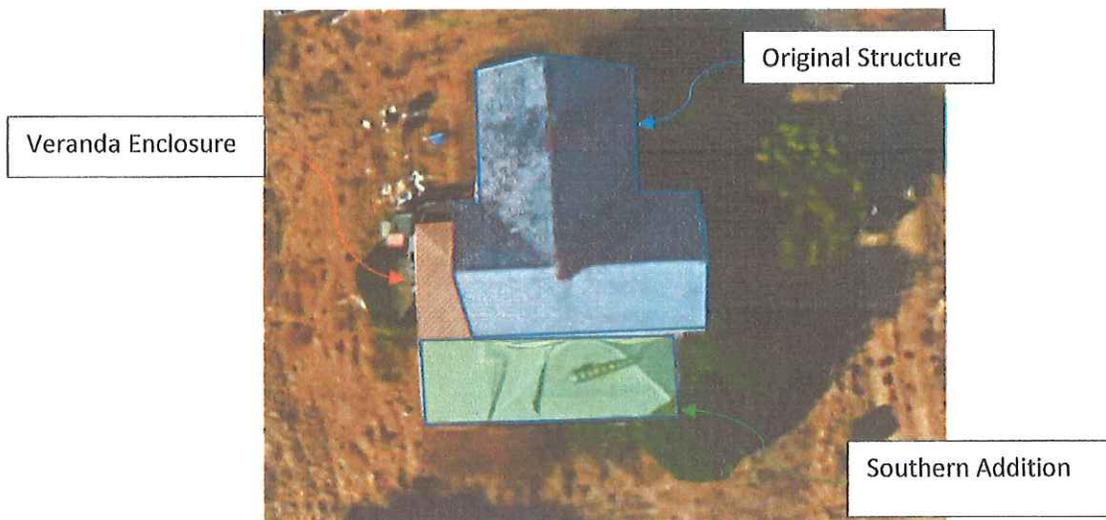
The above shows the approximate locations of the additions

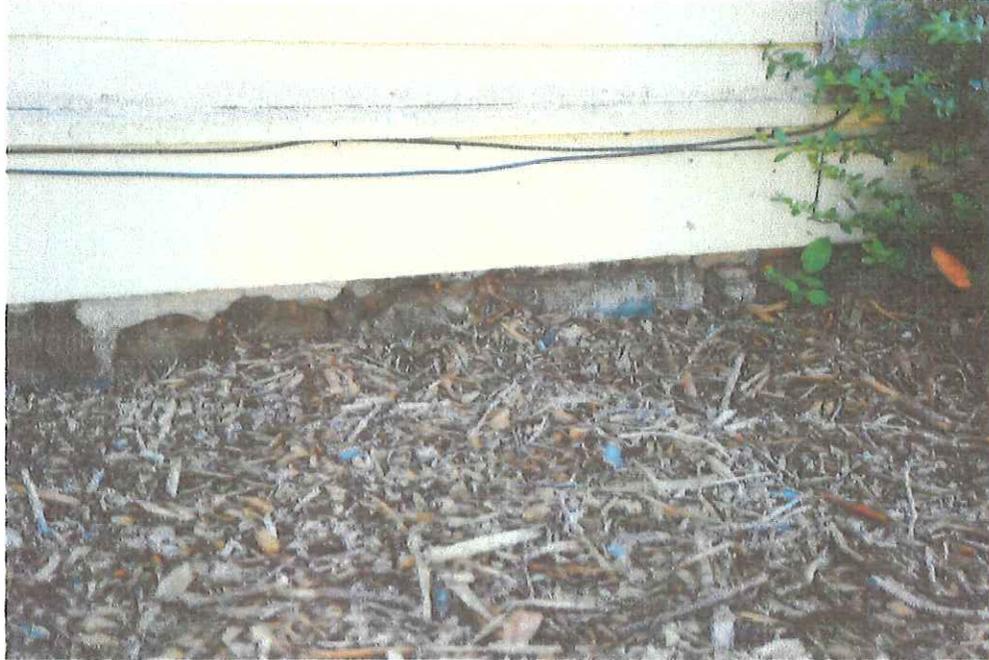
The home was constructed on a laid rock foundation.

We were unable to locate any type of foundation anchor system in the area of the original structure. The supporting structure of the home are timbers and poles resting on the rock supports.

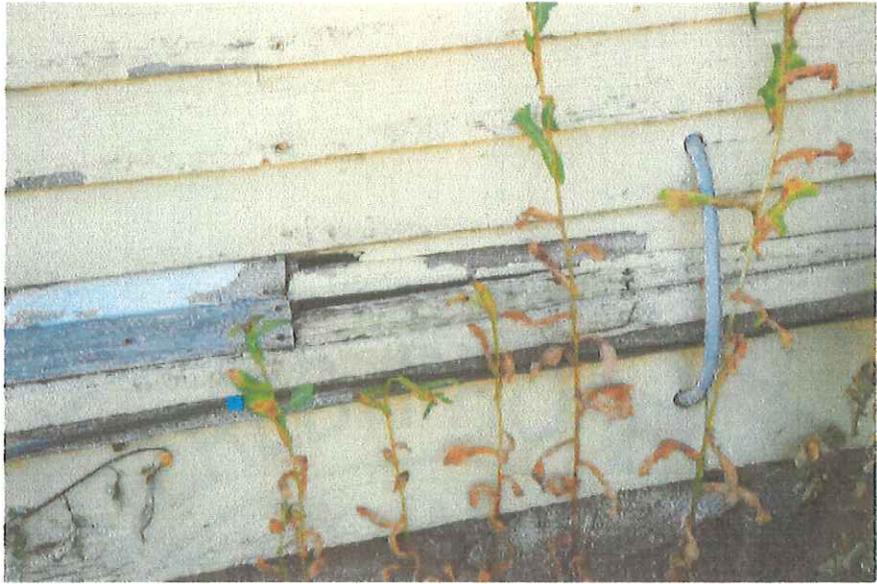
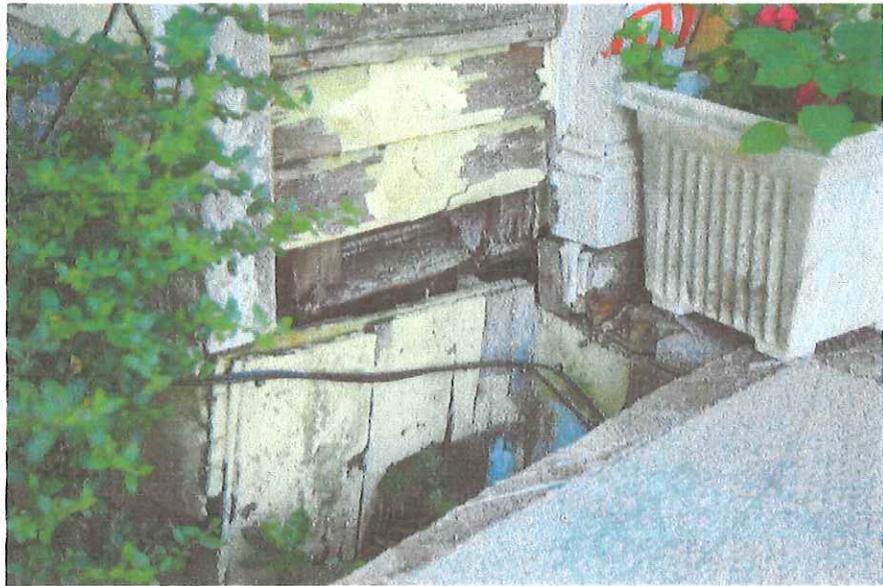
The exterior of the home has several areas with deterioration and disrepair.

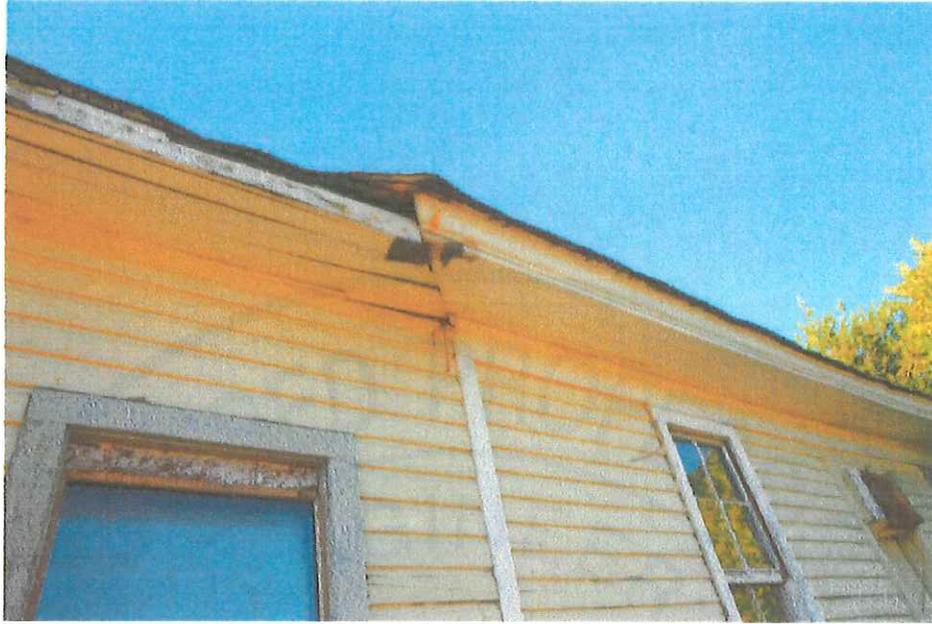
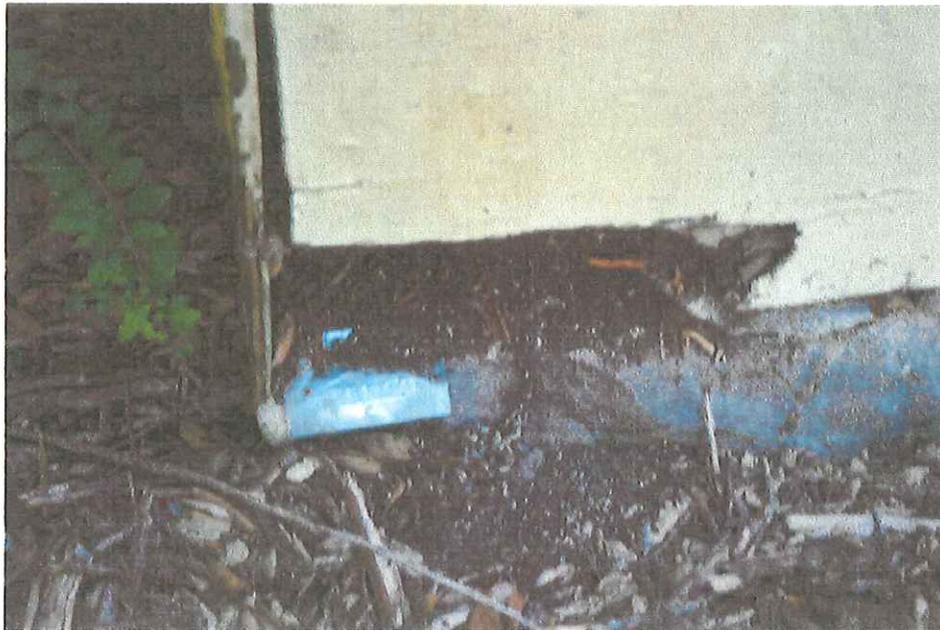
We noted the presence of significant wood dry rot and termite damage to the supporting structure of the home.

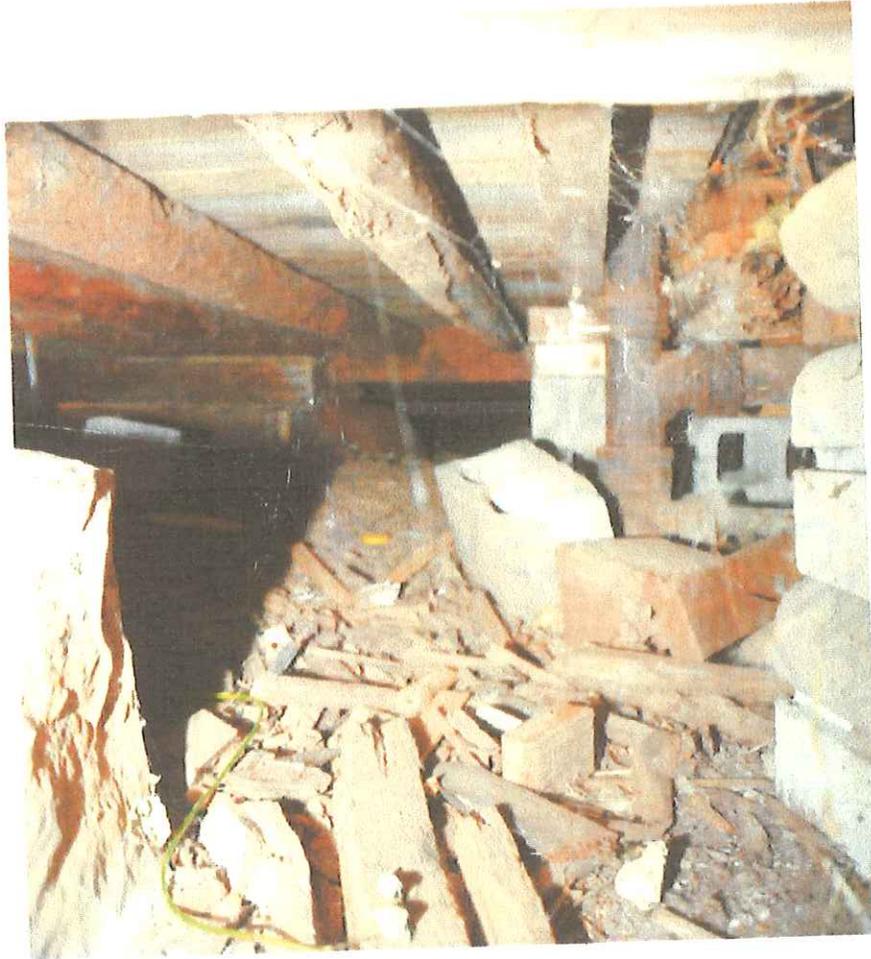
The under floor area of the home has a large quantity of old wood material. The presence of this material increases the presence of insects and wood damaging elements to the home.

The deterioration of the supporting system is evident in the presence of changes in floor elevations, sags and sloping floors.

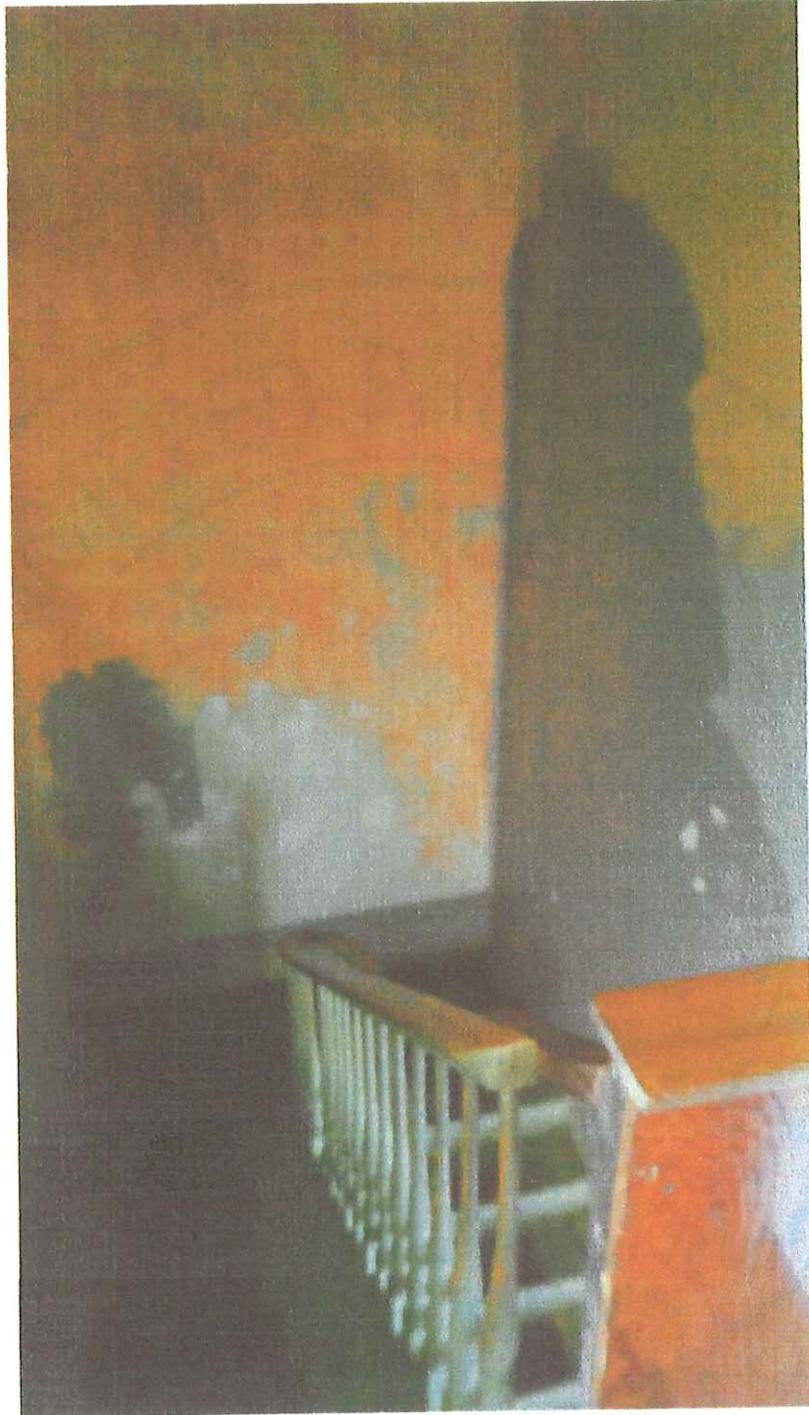
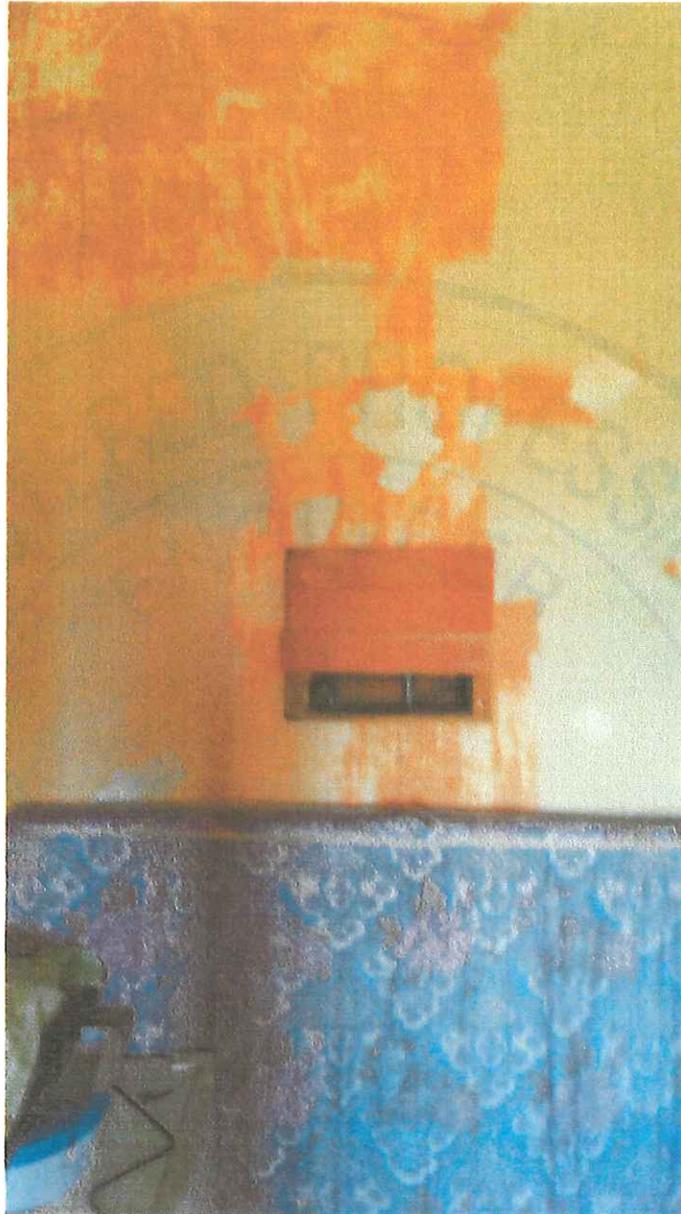
The interior of the home has some issues that would require modification and repair to be safe and usable for the Public.
