# Standards for Rehabilitation & Guidelines for Rehabilitating Historic Buildings

## Standards for Rehabilitation

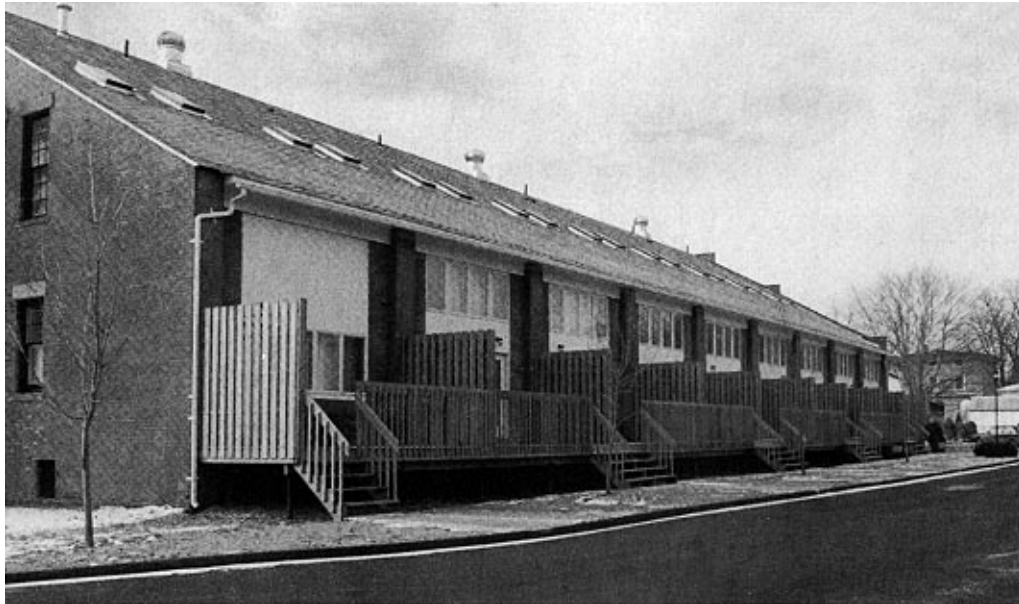
*(a) An armory complex was rehabilitated for rental housing. (b) This view of the rear elevation shows the paired, nine-over-nine wood sash windows and high sills that characterized the building. (c) After inappropriate rehabilitation work, the same rear elevation is shown with new skylights added to the roof, prefabricated panels filling the former brick areas, and new wood decks and privacy fences. Because the work changed the historic character, the project did not meet the Standards.*

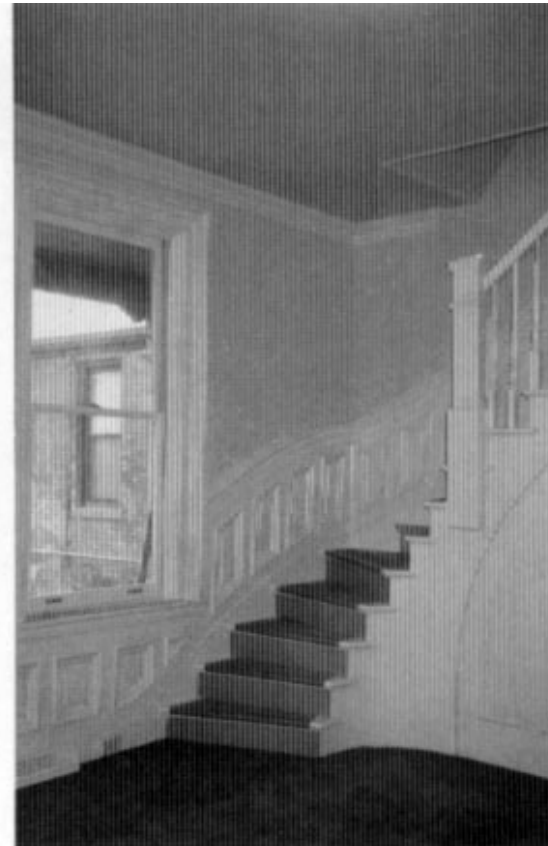
*Rehabilitating historic dwelling units often includes some level of lead-paint hazard abatement. Whenever lead-base paint begins to peel, chip, craze, or otherwise comes loose (a), it should be removed in a manner that protects the worker as well as the immediate environment. In this example (b), the deteriorating lead-paint was removed throughout the apartment building and a compatible primer and finish paint applied.*
