Silver Bay Monitoring Program

2011 Long Term Benthic Monitoring and Bioaccumulation Survey in Sawmill Cove, Ak

Germano & Associates, Inc.

April 2012

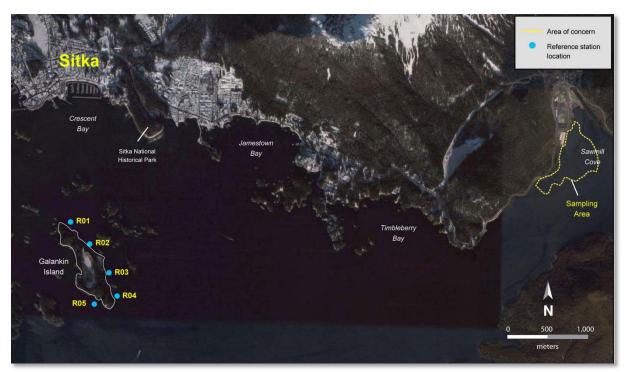
Figure 1-1. Sawmill Cove AOC and Galankin Island reference sites designated for 2011 monitoring.

Sawmill Cove is located near the mouth of Silver Bay in southeast Alaska approximately three miles east of the City and Borough of Sitka (Figure 1-1). The cove was the receiving point for effluent and storm water discharges from the Alaska Pulp Mill, which produced pulp at the site from 1959 to 1993. Operations at the mill resulted in the accumulation of wood solids and associated contaminants on the seafloor from an historic outfall adjacent to the site (see Figure 1-2).

Performance Measure 2 sediment data, consisting of 17 dioxin/furan analytes, total organic carbon (TOC), total ammonia, and total sulfides were measured at 15 sediment stations – five each located within Stratum 1, Stratum 2, and at the Galankin Island reference site (Figure 1-2). The reference location was used in statistical comparisons for all parameters, especially to account for potential dioxin contamination from regional sources other than the historic operation of the Alaska Pulp Mill. Potential regional sources of dioxin include forest fires, burning of municipal trash, and leaching from treated pier pilings, all of which can result in anthropogenic background concentrations in the part-per-trillion range. Reference and AOC station locations are shown in Figures 1-1 and 1-2, respectively.

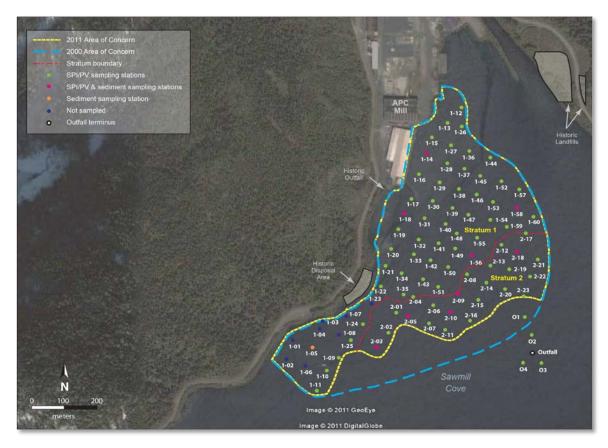
Figure 1-2. 2011 AOC Stratum 1 and Stratum 2 sediment sampling stations. Note: The 2011 AOC is approximately 16 percent smaller than the 2000 AOC due to removal of recovered area (G&A 2001).

The 2011 sampling design is based on an approximate 200-ft-interval grid throughout the AOC, with colocated SPI and PV images collected at each of 73 stations – 50 in Stratum 1 and 23 in Stratum 2. In addition, four stations were sampled outside the AOC, around an operational outfall (see Figure 1-2) to screen for potential confounding organic loading sources from the fish processing plant that now occupies the former site of the APC mill. Station locations within the AOC were in the same vicinity as those used in the 2000 baseline study (EVS 2001), permitting temporal comparison of results if needed.

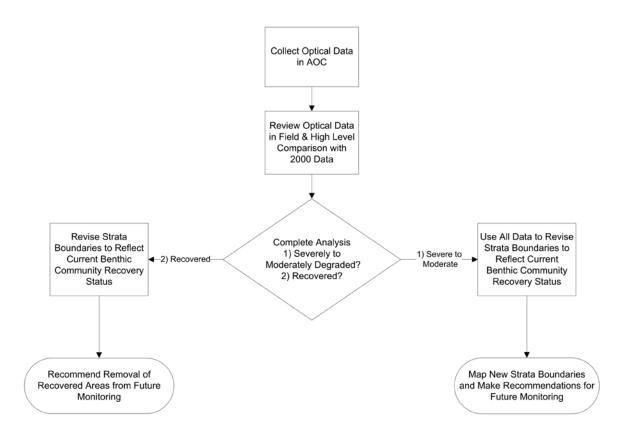
Figure 1-3. Performance Measure 1 SPI data collection, interpretation, and future monitoring decision criteria.

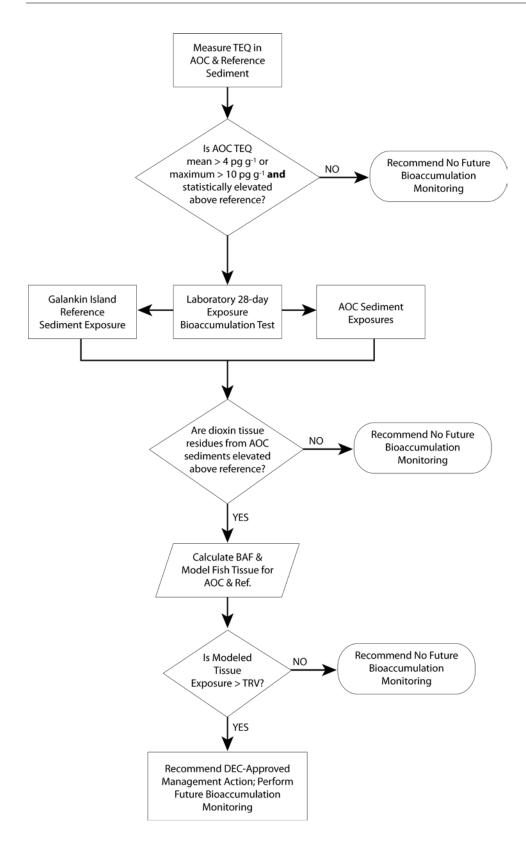
Figure 1-4. Flow diagram for execution of bioaccumulation evaluation (Performance Measure 2). BAF = Bioaccumulation Factor (tissue concentration/sediment concentration); TRV = species specific toxicity reference value for 2,3,7,8-TCDD adapted from Gatehouse (2004); TEQ = total dioxin TEQ for fish.

A tiered approach, depicted in Figure 1-4, was used to evaluate Performance Measure 2 dioxin data. The approach began with the analysis of AOC sediment to determine if dioxin toxicity equivalent (TEQ) concentrations (Van den Berg et al. 2006) were: 1) above thresholds used to evaluate other west coast sediment sites; and 2) significantly higher than local background sediment concentrations. Bioaccumulation testing was performed only after both conditions were met, because dioxin in environmental media has natural (e.g., forest fires) as well as anthropogenic sources, especially at low part-per-trillion concentrations.

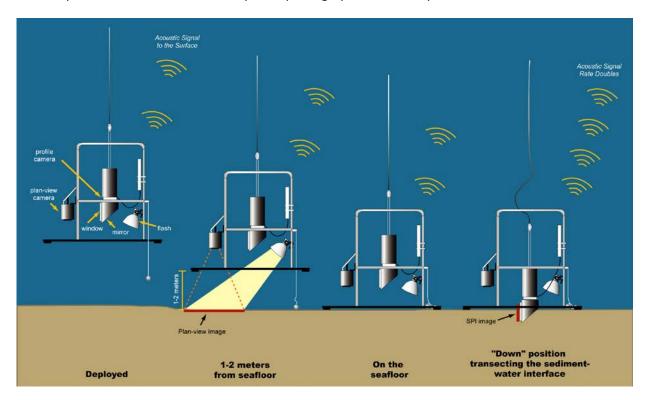
Figure 2-1. Diagram showing deployment of the SPI/PV camera system used in Sawmill Cove.

SPI/PV photographs were acquired (Figure 2-1) at each of 73 AOC stations using high resolution digital cameras in underwater housings that were mounted on a stainless-steel frame and lowering the system to the seafloor. Three replicate SPI images and corresponding PV photos were taken at each station. An Ocean Imaging Model 3731 digital SPI system, Ocean Imaging Model DSC16000 plan-view underwater camera, and two Ocean Imaging Model 400-37 Deep Sea Scaling lasers were deployed using the vessel's picking booms and purse winch. A Kodak® Color Separation Guide was photographed through the SPI camera at the start of the survey for subsequent image calibration during laboratory analysis.

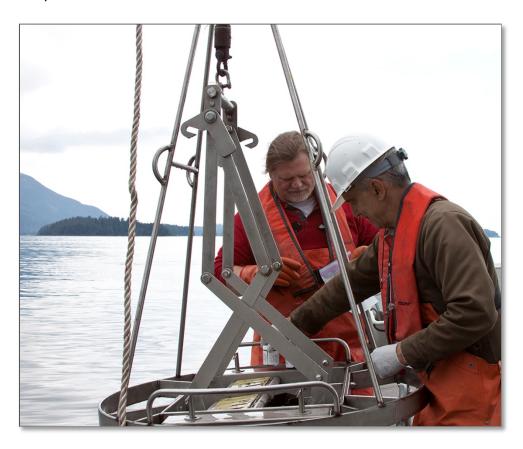
Figure 2-2. Sediment sample collection from the Van Veen grab in Sawmill Cove.

Sediment samples were collected using a 0.1 m² stainless steel Van Veen grab sampler (shown in Figure 2-2) that was decontaminated before sampling at each station. Overlying water was removed and the top 3 cm of a small section of the grab was sub-sampled. Sediment samples designated for dioxin and organic carbon analyses were placed directly into labeled, certified-clean borosilicate glass containers with Teflon-lined lids.

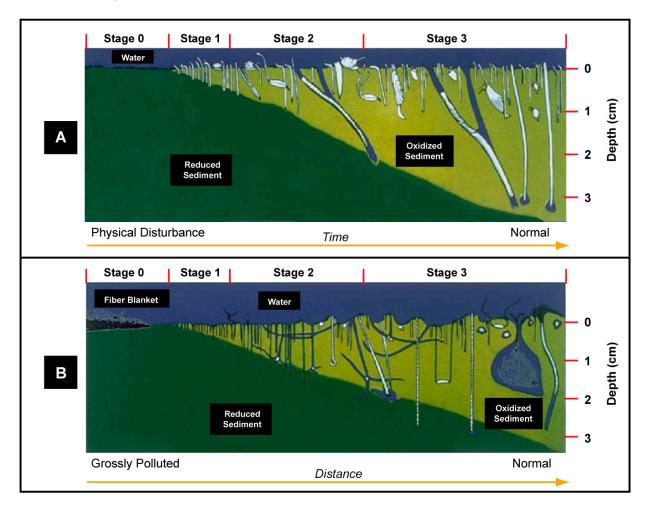
Figure 2-3. Diagram of soft-bottom benthic community response to disturbance (A, top panel) or organic enrichment (B, bottom panel). From Rhoads and Germano, 1982.

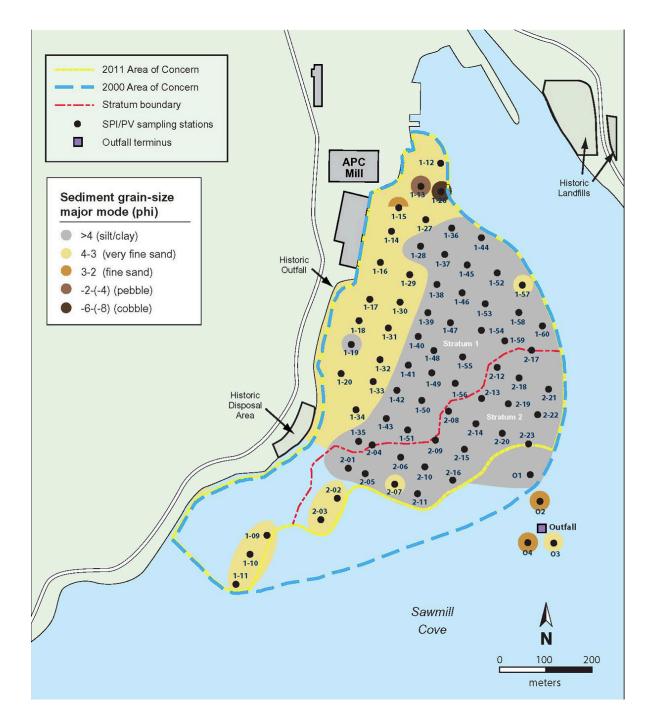
Figure 3-1. Sediment grain-size major mode (phi units) in the AOC during the May 2011 survey.

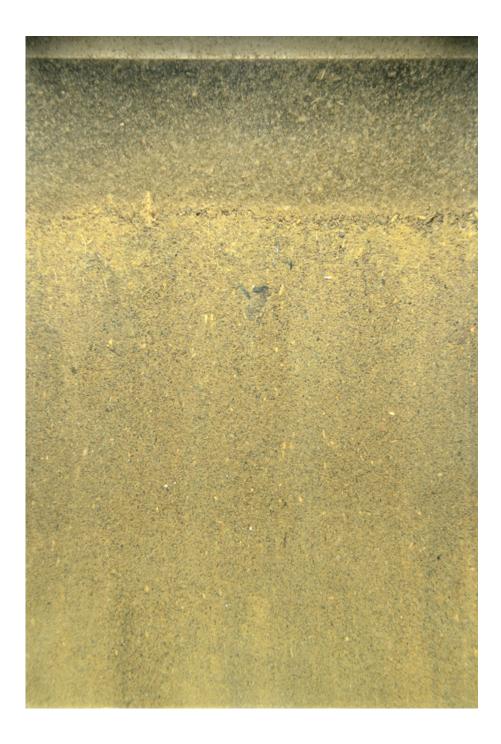
Figure 3-2. The higher fraction of very fine sand mixed in with wood fibers and silt-clay sediments was typical of the stations sampled closest to the shoreline of the former APC site. Scale: width of profile image = 14.4 cm.

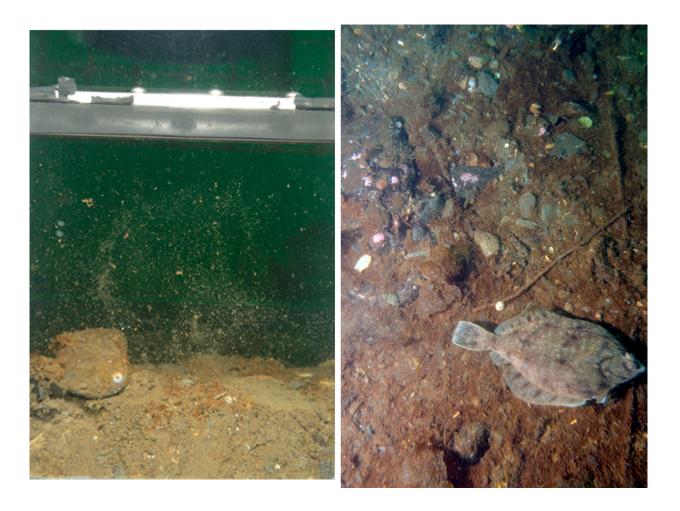
Figure 3-3. This plan view image (right) and profile image (left) from Station 1-13 shows the poorly-sorted cobble-silt bottom in the northeast area of the AOC. Stations closest to shore in the southwest corner of the AOC also couldn't be sampled due to the hard bottom and steep slope of the area. Scale: width of profile image = 14.4 cm; width of plan view image = 56 cm.

Measured values for the aRPD depth ranged from 0.0 to 11.0 cm throughout the entire site, with an overall site average depth of 1.9 cm (Figure 3-10). Only a relatively small number of stations (12 out of 73, or 16%) had aRPD values greater than 3 cm, and most of those were in Stratum 1. As was the case in the 2000 survey, aRPD values were substantially lower at stations closest to the shore, with many stations having no measurable aRPD values (Figure 3-11). Values at 4 stations could not measured because of inadequate prism penetration (Stations 1-13 and 1-26, see Figures 3-3 and 3-4), unusually

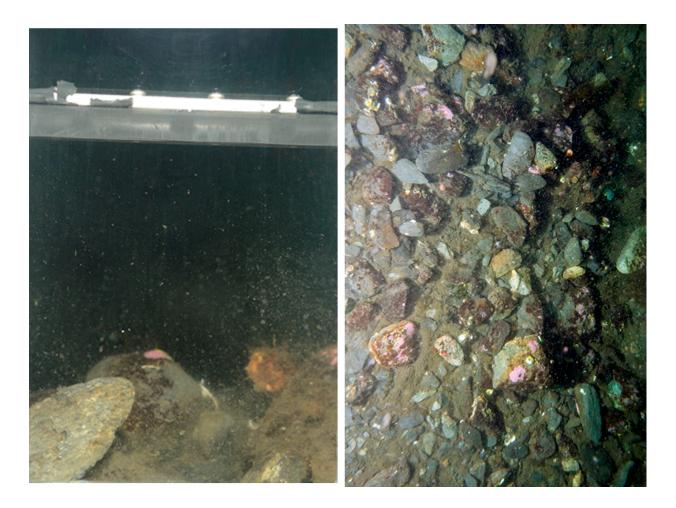
Figure 3-4. This plan view image (right) and profile image (left) from Station 1-26 shows a similar hard cobble bottom to the sampling results from the 2000 baseline survey. No accumulation of wood waste or excess organics would be expected in areas like this within the AOC, so these stations can be considered fully recovered. Scale: width of profile image = 14.4 cm; width of plan view image = 86.1 cm.

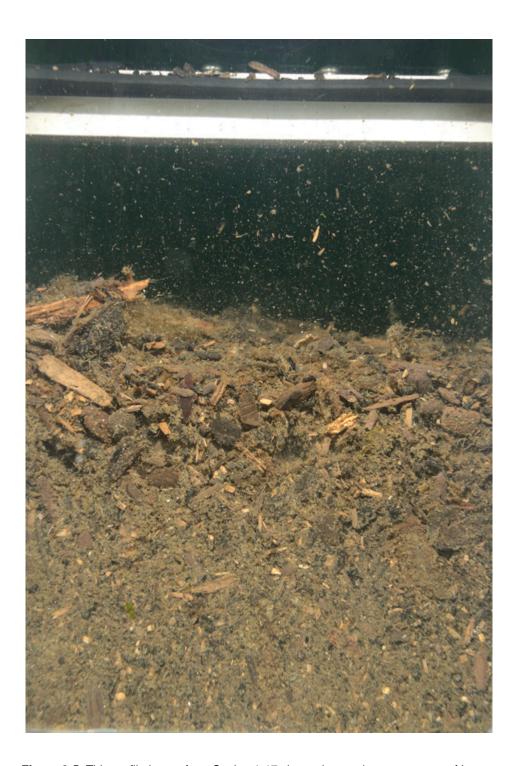
Figure 3-5. This profile image from Station 1-17 shows the persistent presence of large chips/chunks of word waste similar to those found in the 2000 baseline survey; the refractory nature of the wood particles results in extremely slow decomposition rates. Scale: width of profile image = 14.4 cm.

high wood particle content so that there was no color change in the sediment profile (Station 1-17, see Figure 3-5), or camera prism over-penetration so that the sediment-water interface was not visible (Station 1-35).

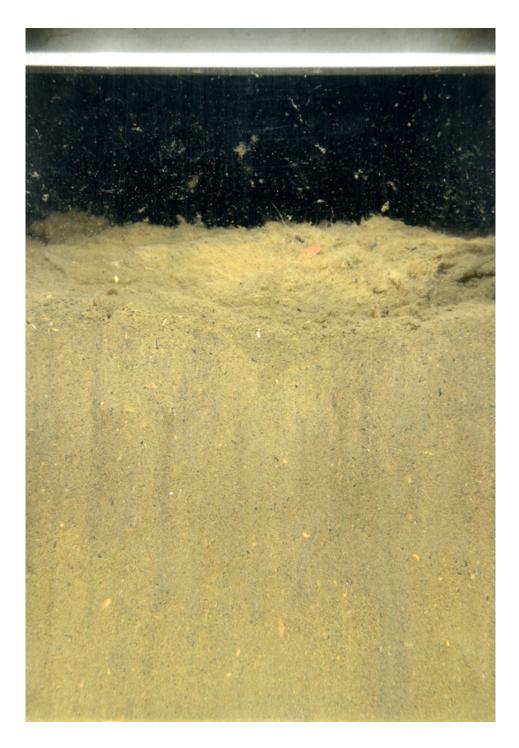
Figure 3-6. Small wood fibers are still readily apparent in the predominantly silt-clay sedimentary matrix seen at Station 1-51, typical of most stations in the deeper areas of Stratum 1. Note the layer of fluffy organic detritus which has settled on the sediment surface. Scale: width of image = 14.4 cm.

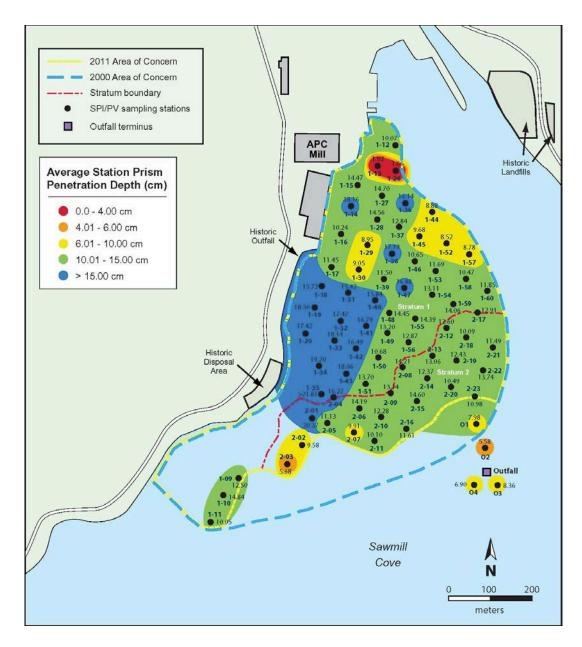
Figure 3-7. Spatial distribution of average station camera prism penetration depth (cm) in Sawmill Cove, May 2011.

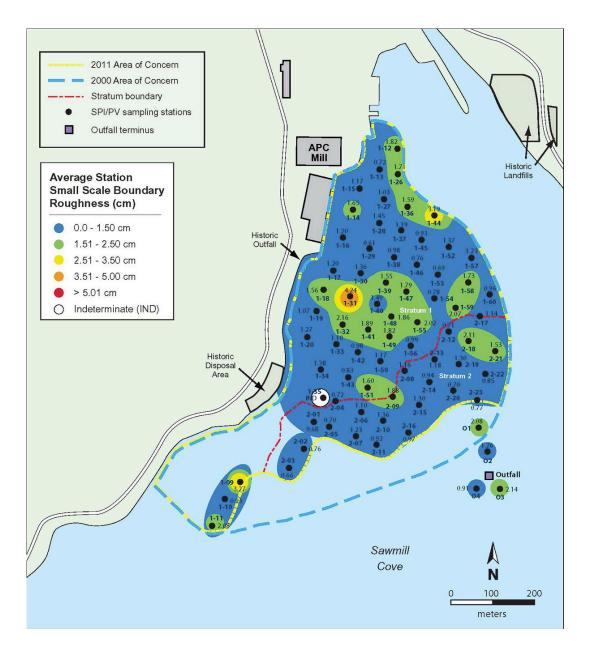
Figure 3-8. Spatial distribution of average station small-scale boundary roughness values (cm) in Sawmill Cove, May 2011.

Small-scale surface boundary roughness ranged from 0.6 to 4.2 cm with an overall site average value of 1.5 cm (Figure 3-8); boundary roughness values were quite similar in both strata, with the highest value occurring at Station 1-31. The high value at Station 1-31 was because of one outlier value in one of the replicate images (Figure 3-9) and not representative of the two images at this station. Approximately 60% of the boundary roughness values were due to biogenic processes (fecal mounds, burrow openings) altering sediment surface topography (Appendix B), while the other 40% were due to physical structures (wood/rocks/logs) or bottom slope.

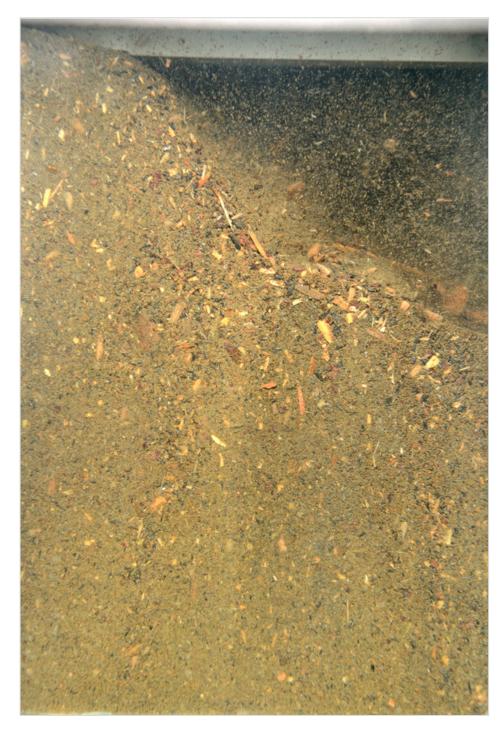
Figure 3-9. This profile image from Station 1-31 had an unusually high boundary roughness value (9.8 cm) due to a sloping bottom. Scale: width of image = 14.4 cm.

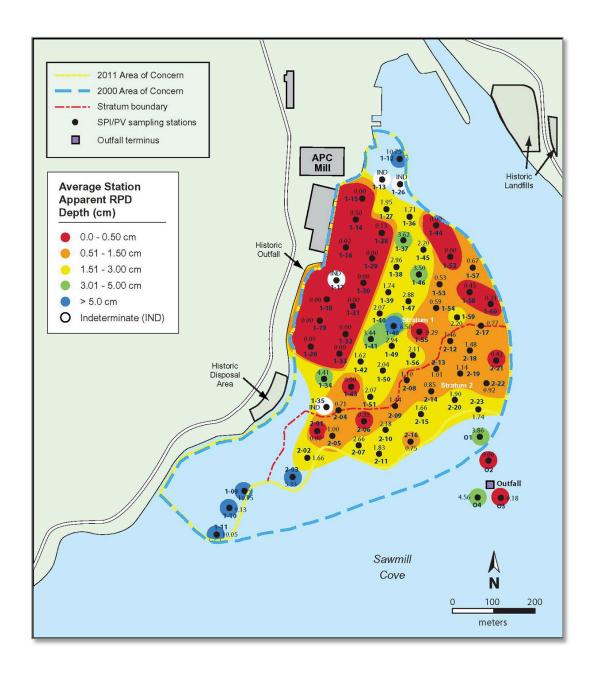
Figure 3-10. Spatial distribution of average station aRPD depths (cm) in Sawmill Cove, May 2011.

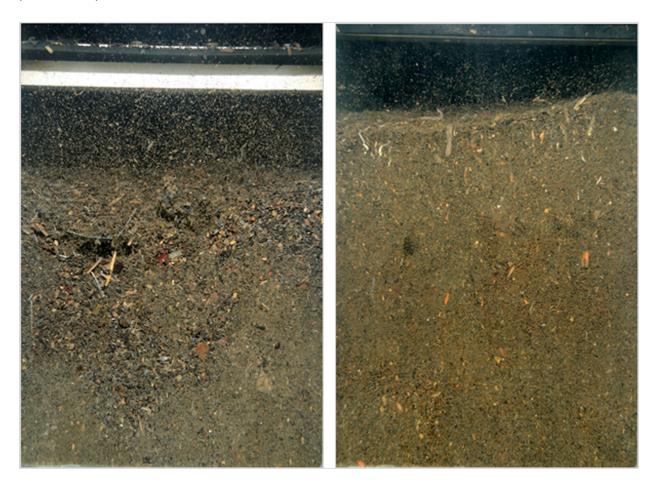
Figure 3-11. These profile images from Station 1-19 (left) and 1-32 (right) are typical of the locations where sediment-oxygen demand was so high that no detectable aRPD could be measured. Scale: width of each profile image = 14.4 cm.

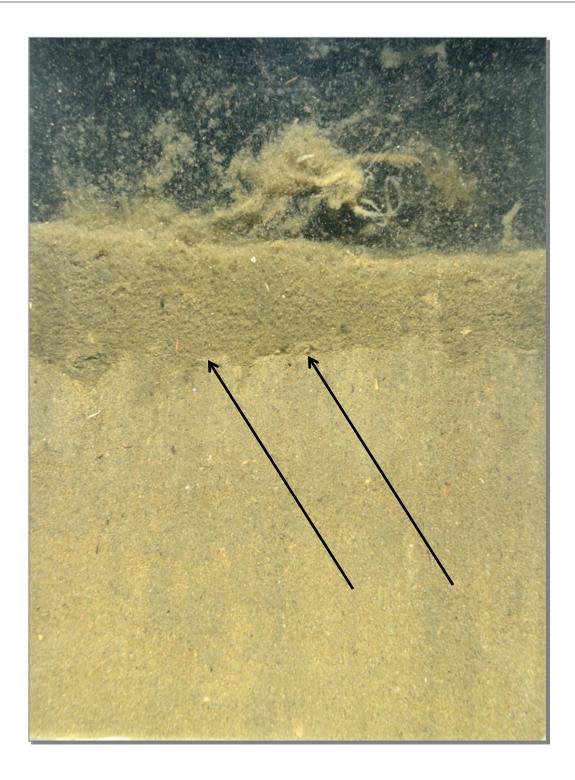
Figure 3-12. The contact boundary (arrow) between the recently-settled phytoplankton detritus and sediment surface is readily apparent in this profile image from Station 1-45. Scale: width of image = 14.4 cm

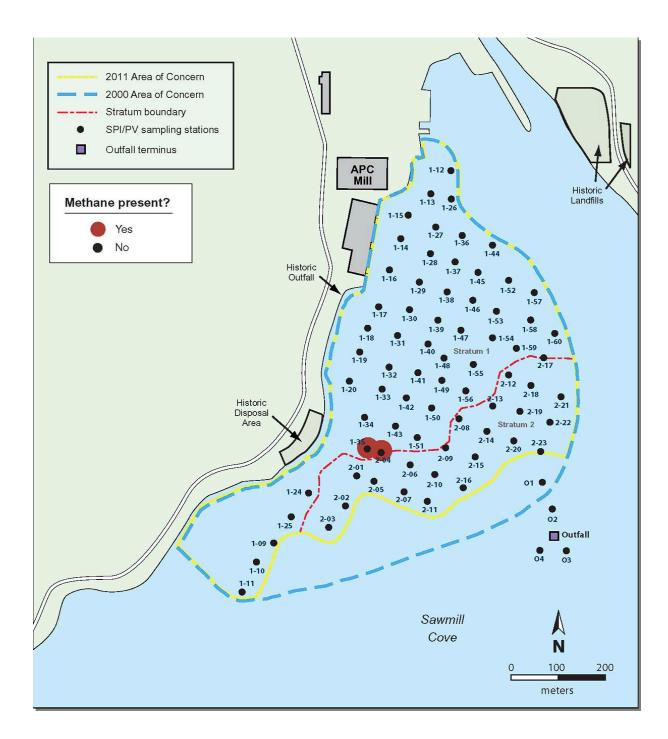
Figure 3-13. Spatial distribution of subsurface methane detected in Sawmill Cove, May 2011.

There were multiple sources of organic enrichment contributing to the sediment oxygen demand (SOD) in the AOC detected in the May 2011 survey: wood waste from the former APC operations, natural phytoplankton detritus from the water column spring bloom, and fish waste being generated by the new fish processing plant that is operating in the former mill site and being discharged from the outfall just beyond the AOC. Visual evidence of wood waste could been seen at all but two of the stations sampled (Stations 1-13 and 1-26; see Appendix B), and only trace amounts of wood waste could be seen at four of the stations in Stratum 1 (Stations 1-9 through 1-11 in the southwest corner of the site and at Station 1-57). Surface fluff layers of phytoplankton detritus were quite common in the fine-grained stations in the deeper parts of the AOC where the bottom flattened out from the steep slope that exists near the shoreline (Figure 3-12). Even though SOD was quite pronounced at many locations (red areas in Figure 3-10), subsurface methane was only detected at two locations (Figure 3-13).

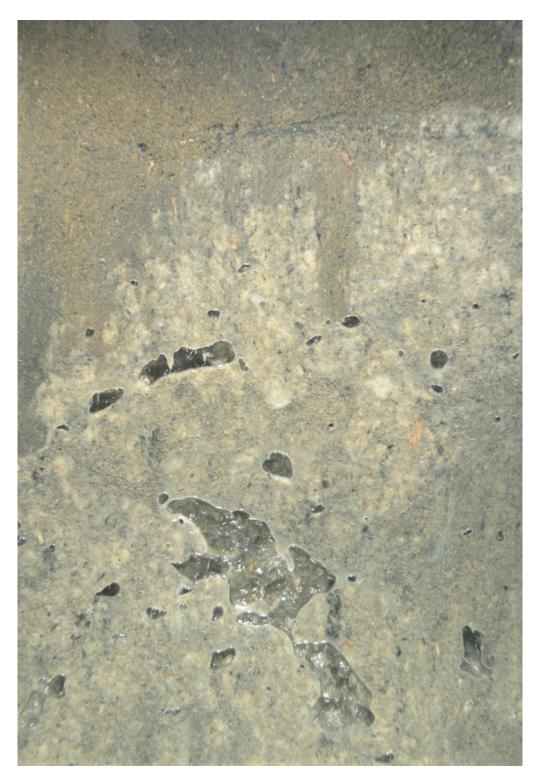
Figure 3-14. This profile image from Station 1-35 shows an accumulation of decomposing fish tissues that exceeds the penetration depth of the camera prism and subsurface methane gas being generated by anaerobic decomposition of the organic waste. Scale: width of image = 14.4 cm.

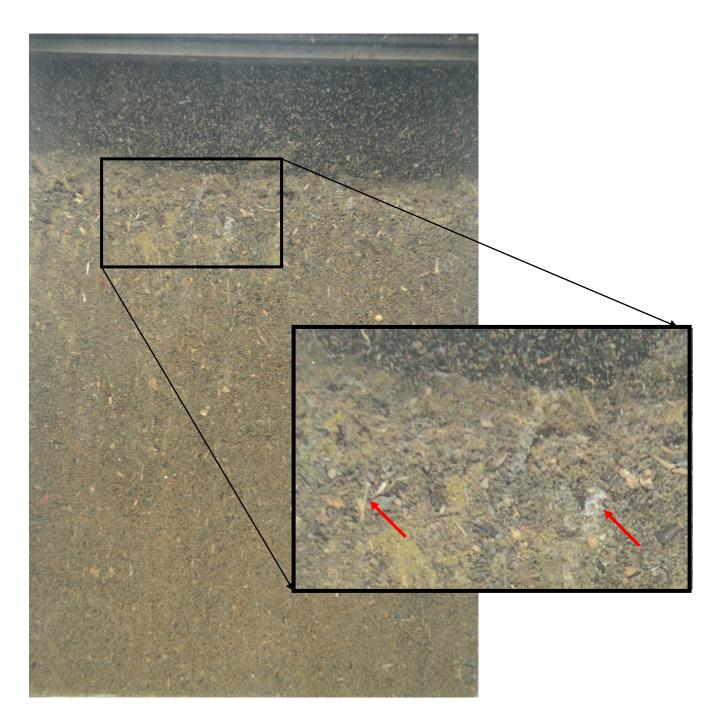
Figure 3-15. This profile image from Station 1-32 shows scattered fish bones/vertebrae in the upper few centimeters of sediment (see magnified inset). Scale: width of profile image = 14.4 cm.

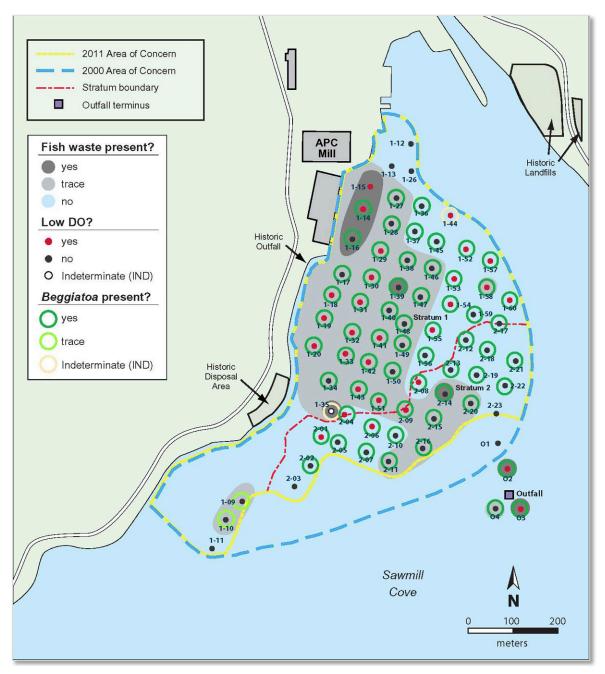
Figure 3-16. Spatial distribution of fish waste, *Beggiatoa* colonies, and presence of low dissolved oxygen in the benthic boundary layer at locations sampled in Sawmill Cove, May 2011.

found in either trace amounts or accumulated deposits at almost half of the stations surveyed (Figure 3-16).

surveyed (Figure 3-16). Out of the 73 stations sampled in the AOC, there were only 8 stations where thiophilic bacteria were not detected. The presence of the thick mats (Figure 3-18) of thiophilic bacteria provided an excellent indication of areas where accumulation of labile organic matter was the greatest (Figure 3-19).

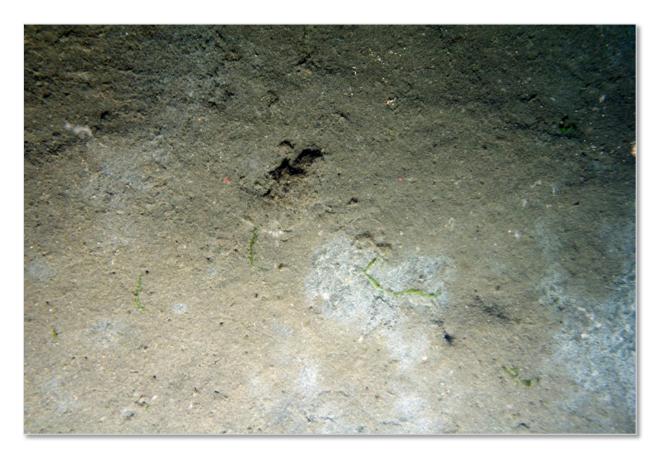
Figure 3-17. This plan view image from Station 1-48 shows isolated white patches on the sediment surface indicating the presence of *Beggiatoa* colonies in response to lowered dissolved oxygen in the benthic boundary layer. Scale: width of image = 92.2 cm.

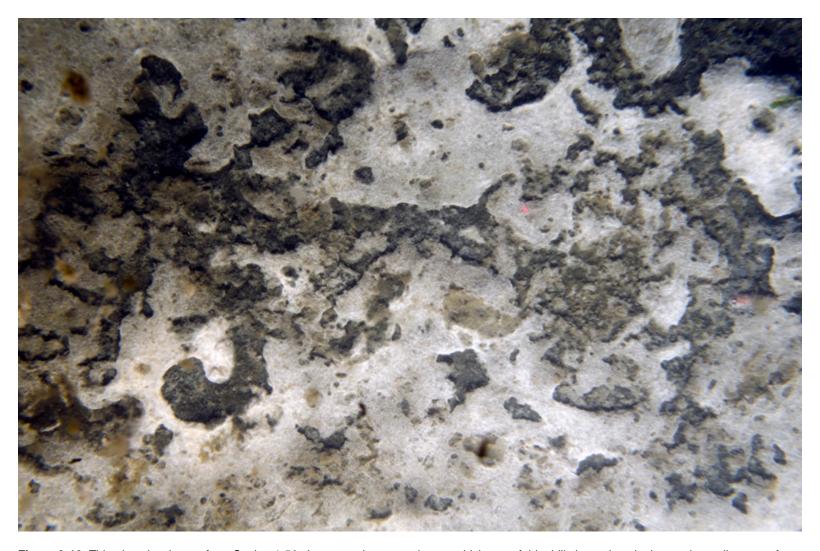
Figure 3-18. This plan view image from Station 1-50 shows an almost continuous, thick mat of thiophilic bacteria colonies on the sediment surface. Scale: width of plan view image = approx 80 cm.

Once all these sources of organic input exceed the capacity of the benthic ecosystem to process the available organic carbon, the excess amounts will adversely affect the sediment in the form of high SOD; the high SOD will either result in low aRPD values or potentially low dissolved oxygen in the benthic boundary layer which will stimulate population growth of thiophilic (sulfur-loving) bacterial colonies such as *Beggiatoa*. Thiophilic bacterial colonies were found either in scattered colonies, small patches (Figure 3-17), or thick mats on the sediment surface (Figure 3-18) at the majority of stations

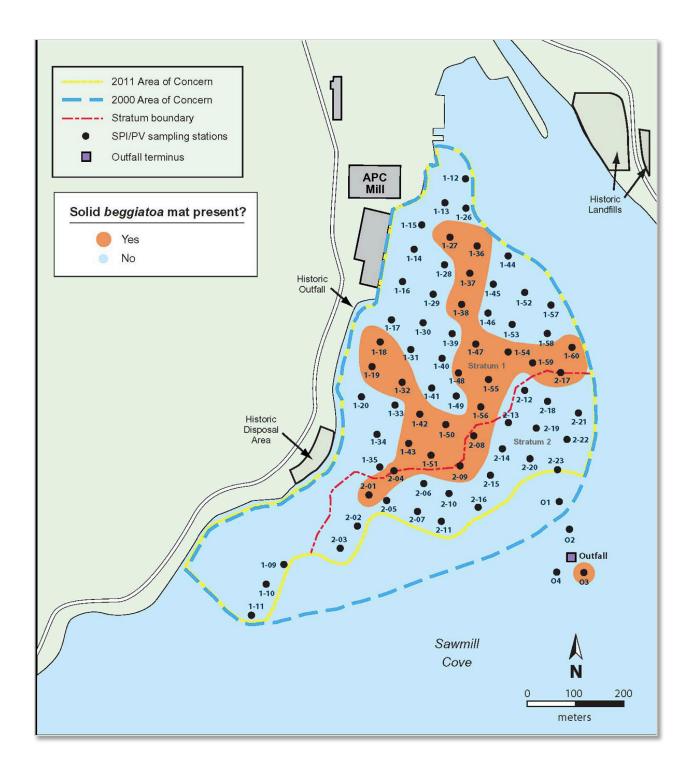
Figure 3-19. Locations in Sawmill Cove where thick bacterial mats (see previous figure) were detected on the sediment surface in plan view images.

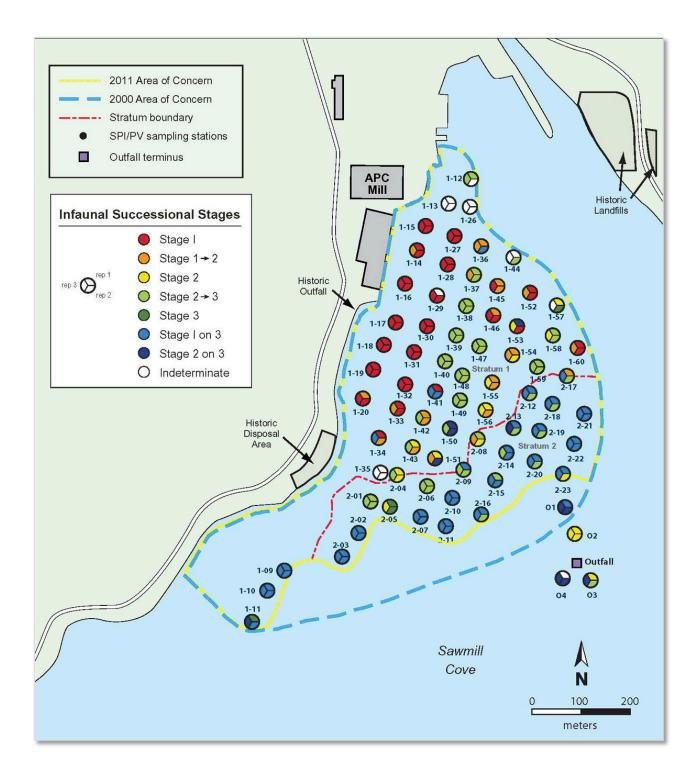
Figure 3-20. Spatial distribution of benthic infaunal successional stages in Sawmill Cove, May 2011.

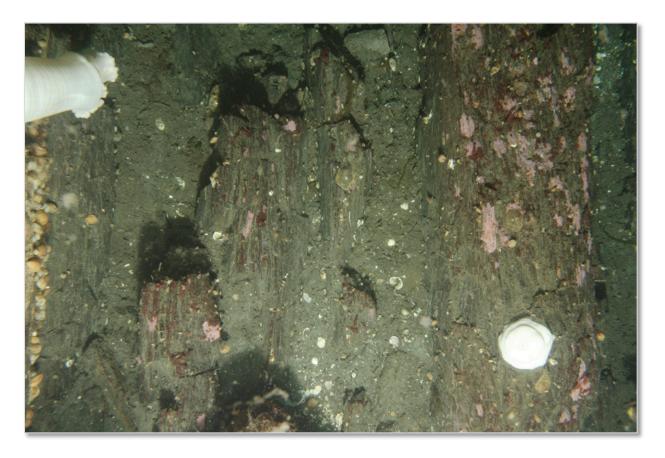
Figure 3-21. This plan view image from Station 1-32 shows portions of larger logs on the sediment surface that have been colonized by fouling epifauna (algae, anemones, tunicates, etc.). Scale: width of image = 131 cm.

The results from the combined SPI/PV survey provided a comprehensive update to the earlier baseline study results from eleven years ago. The substitution of the plan view camera system for the towed-video was an excellent replacement; not only were synoptic, large-scale aerial views obtained at the same locations where the profile images were collected, but the earlier problems encountered with towing the video camera through a field of unknown obstructions were eliminated (much of the video footage from the 2000 survey was of limited value because of the height above the bottom at which the camera needed to be towed to avoid obstructions combined with poor water visibility). Like the video survey during the 2000 baseline effort, the plan view images provided the perspective to view the presence of the larger pieces of wood (Figure 3-21) as well as the presence of epifaunal foragers (Figures 3-3 and 3-22).

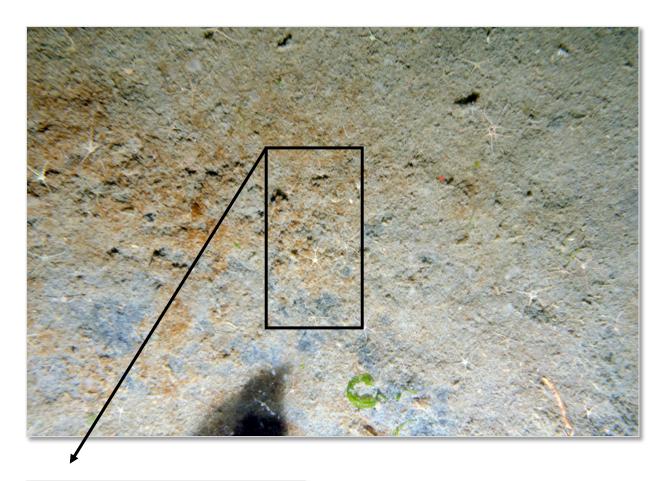
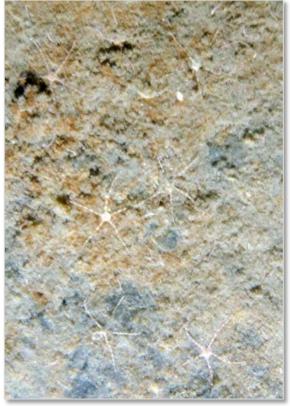
Figure 3-22. This plan view image from Station 1-12 and the enlarged inset shows a high density of ophiuroids (brittle stars) foraging on the sediment surface. The rust-colored layer on the sediment surface is most likely from some iron precipitation from groundwater discharge (see next figure) Scale: width of larger plan view image = 82 cm.

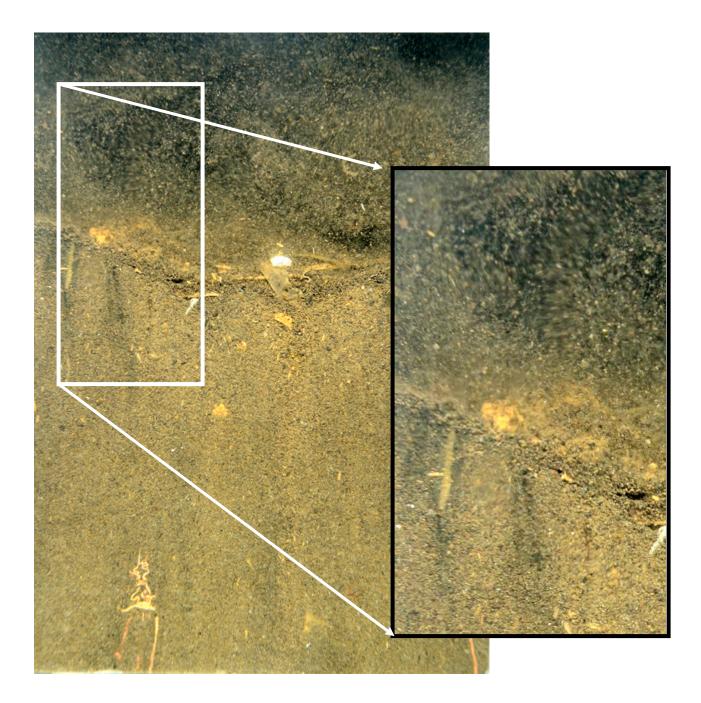
Figure 3-23. This corresponding profile image from Station 1-12 (also shown in Fig. 3-22) shows evidence of coastal groundwater (freshwater) discharge from sediment. The close-up magnified inset shows the distortions to the imaged particles both in the sediment and suspended in the overlying water due to density differences in the freshwater emerging from just below the sediment surface. Scale: width of larger profile image = 14.4 cm.

In addition to the small-scale (mm to cm) features detected in the profile images, there were a few locations on the steep sloped area closest to shore (see comment field in Appendix B) where evidence of groundwater discharge from the sediments was found (not surprising given the study site location and proximity to coastal freshwater source inputs; see Figure 3-23).

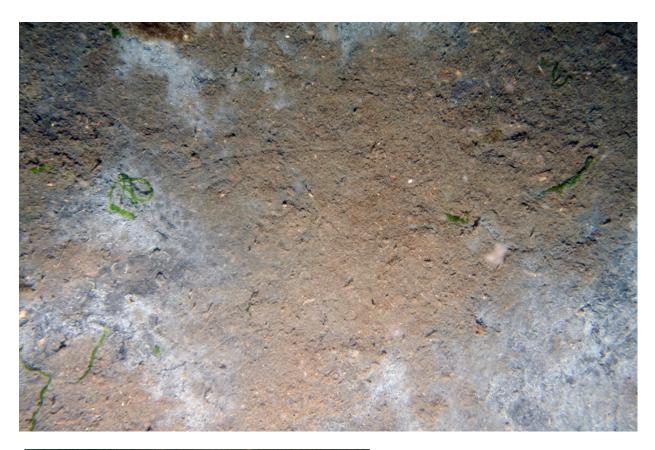
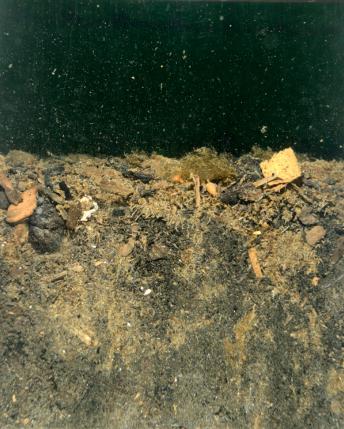
Figure 3-25. This plan view image from Station 1-29 (above) and profile image from Station 1-16 (left) show more examples of "cold temperature, brine-preserved" wood waste that appears relatively fresh. Scale: width of profile image = 14.4 cm; width of plan view image = 99.2 cm.

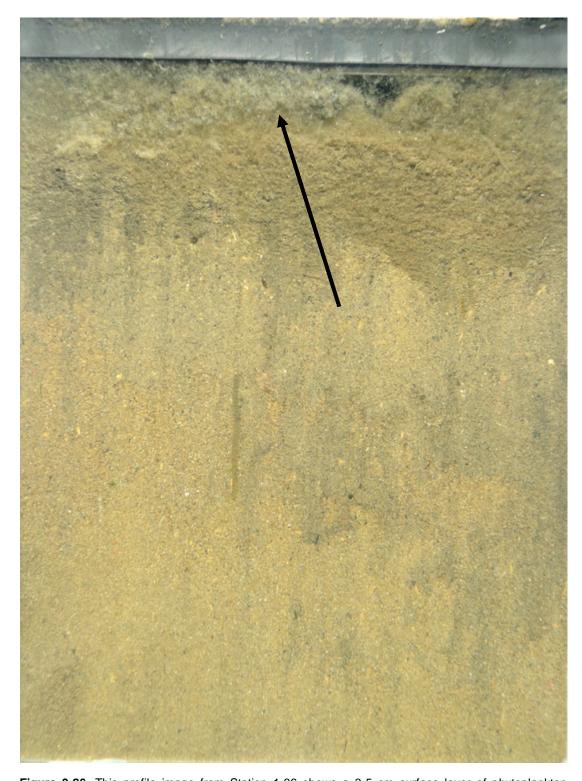
Figure 3-26. This profile image from Station 1-36 shows a 3-5 cm surface layer of phytoplankton detritus whose decomposition is already depleting boundary layer waters of dissolved oxygen as evidenced by the white strands of Beggiatoa seen most prominently in the left half of the image (arrow). Scale: width of profile image = 14.4 cm.

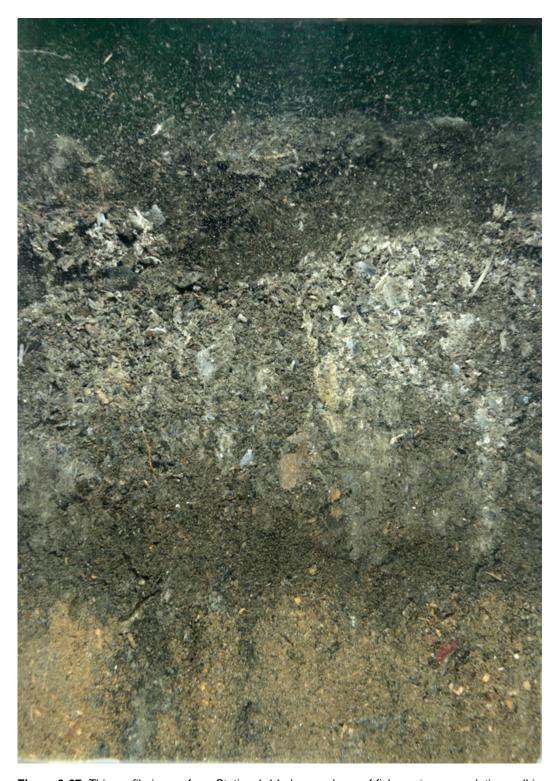
Figure 3-27. This profile image from Station 1-14 shows a layer of fish waste accumulation well in excess of 10 cm with extremely high SOD and no aRPD. Scale: width of image = 14.4 cm.

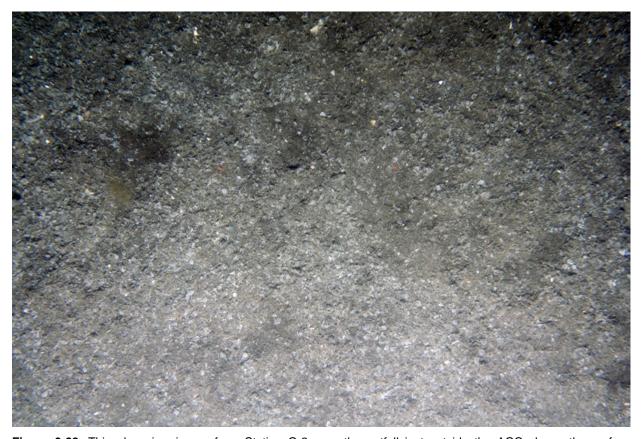
Figure 3-28. This plan view image from Station O-2 near the outfall just outside the AOC shows the surface expression of fish waste accumulations such as those seen in cross section in the previous figure. Scale: width of image = 91.9 cm.

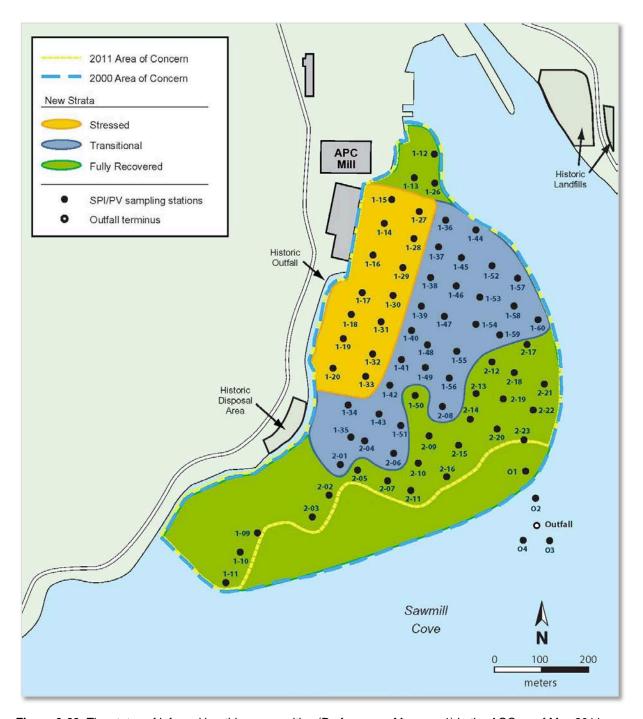
Figure 3-29. The status of infaunal benthic communities (Performance Measure 1) in the AOC as of May 2011.

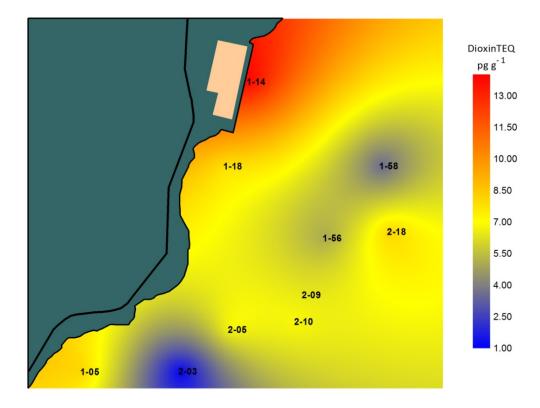
Figure 4-3. Spatial distribution of dioxin TEQ in AOC sediments.

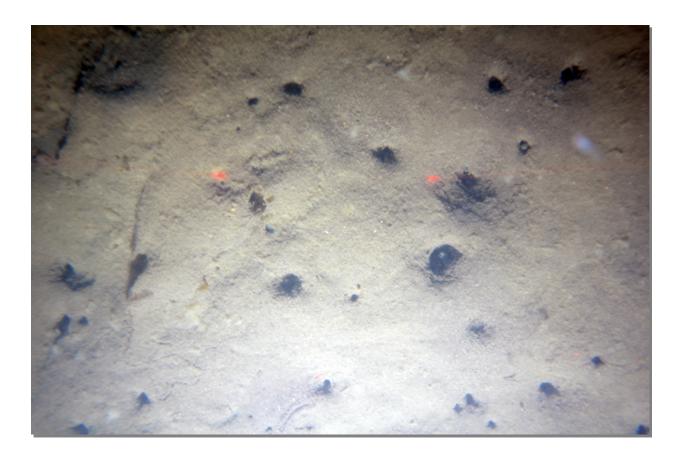
Figure 5-1. The burrow openings of Stage 3 deposit-feeding taxa are readily apparent in this plan view image from Station 1-09. Scale: width of image = 76.8 cm.

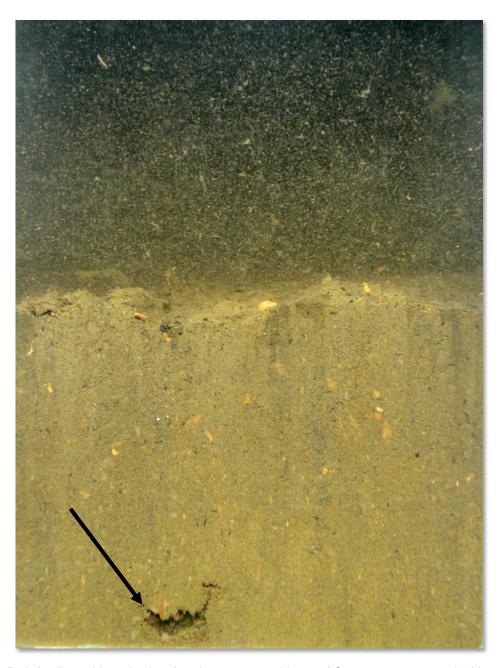
Figure 5-2. Both feeding voids and subsurface burrows are evidence of Stage 3 taxa as seen in this example of a feeding void at depth (arrow) in this profile image from Station 1-50. Scale: width of image = 14.4 cm.

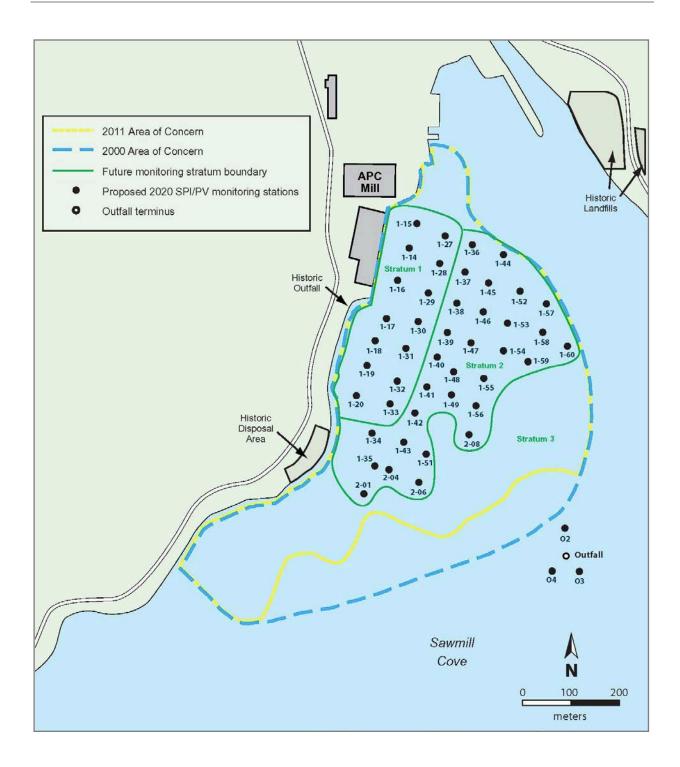
Figure 5-3. Recommended sampling locations for Strata 1 and 2 in the next round of monitoring scheduled for 2020.

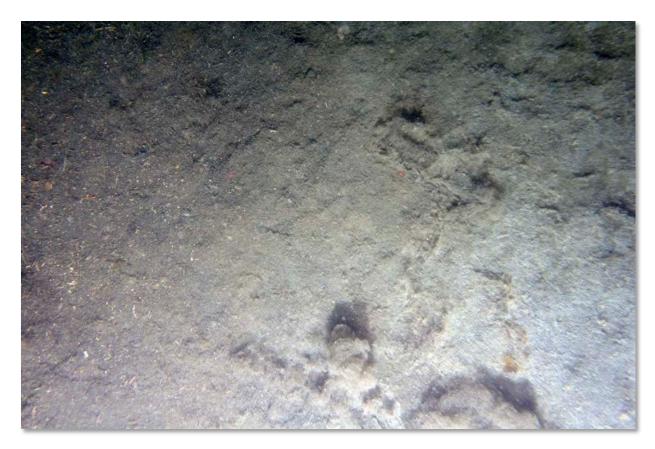
Figure 5-4. The near-bottom fluff layer of suspended labile organic detritus (both phytoplankton and fish waste) with a high sediment oxygen demand and co-occurring *Beggiatoa* colonies can be seen in the lower right corner of this plan view image, while typical sediment surface (wood chips, fibers, and silt-clay) can be seen in the upper left. Scale: width of image = 94.1 cm.
