**RUSSIAN RIVER ESTUARY OUTLET CHANNEL
ADAPTIVE MANAGEMENT PLAN
2018**

Sonoma County Water Agency

ESA

May 14, 2018

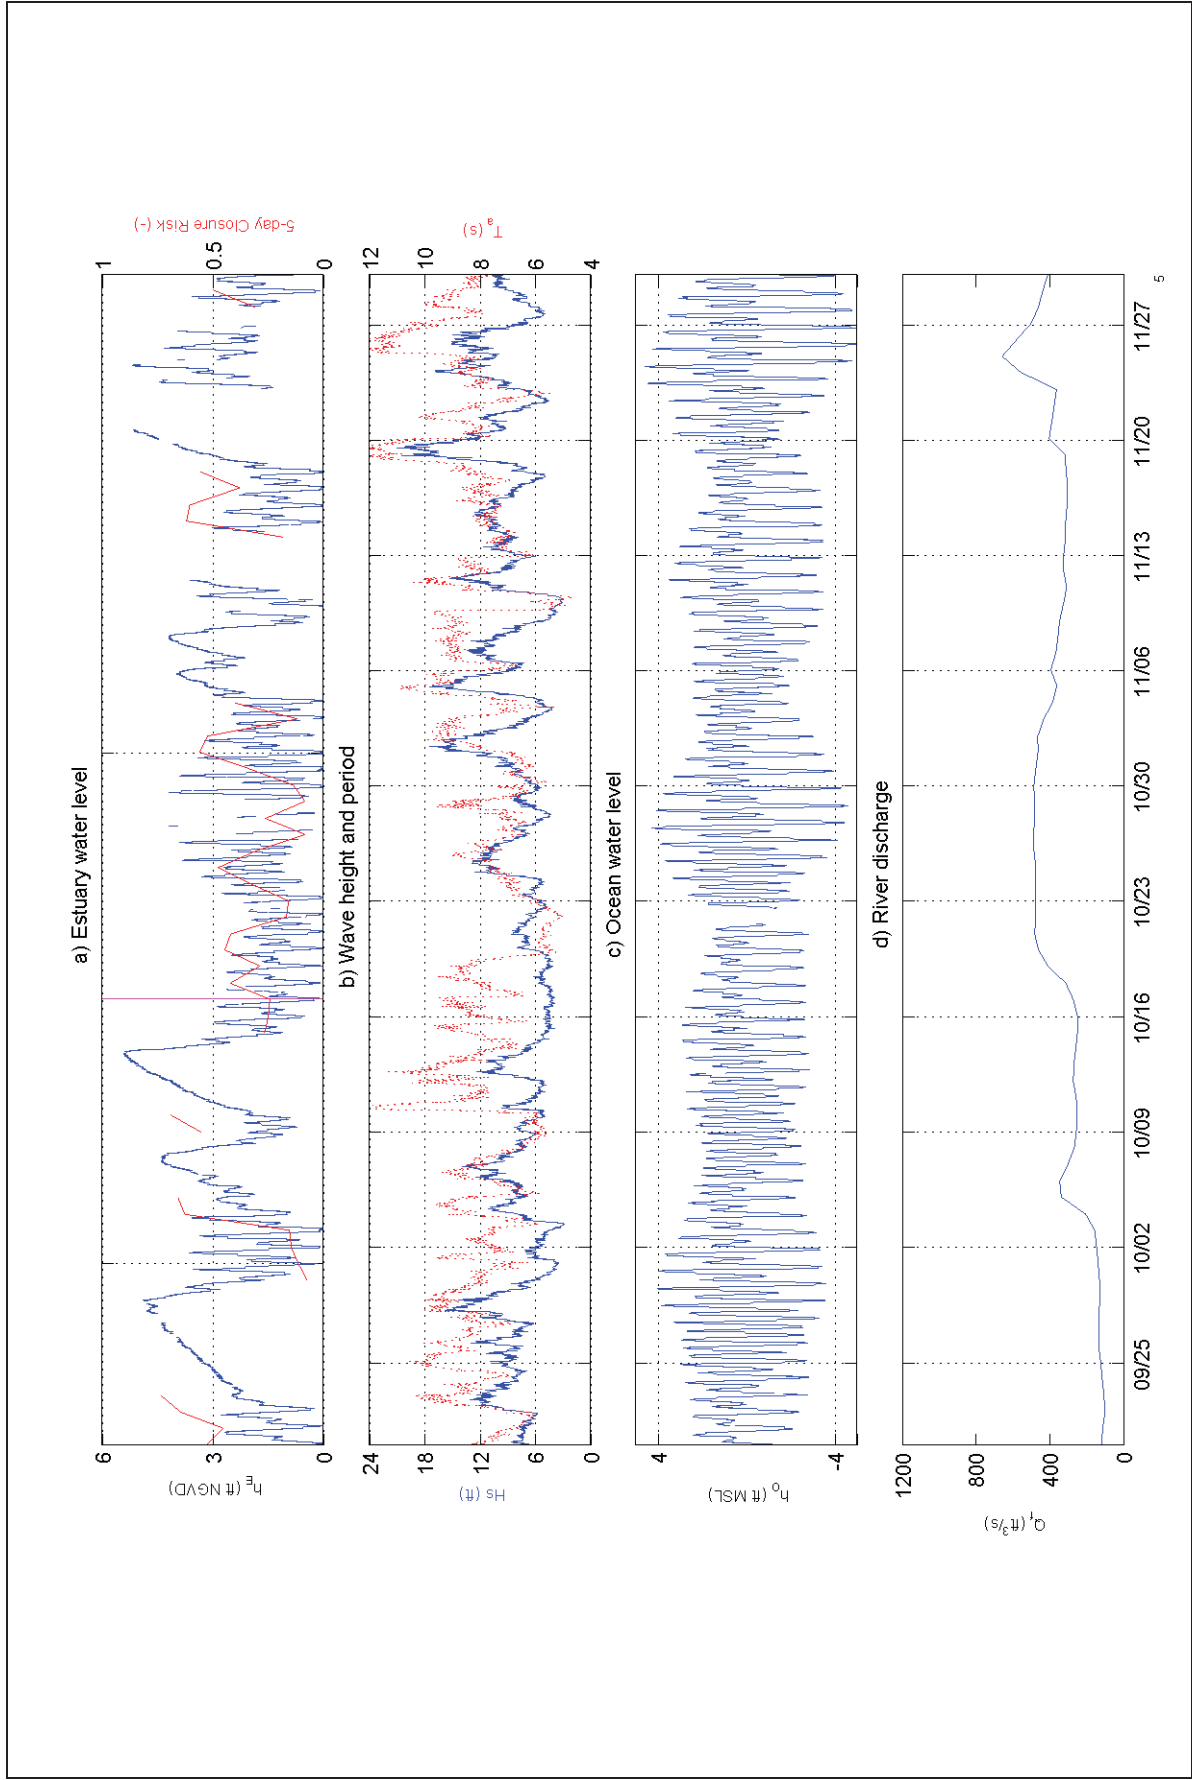
Figure 2
Estuary, Ocean, and River Conditions
September - November 2011

a) h_E =estuary water level (SCWA); pink bar = beach survey
 b) H_s =sig. wave height; T_a =avg. wave period (CDIP, Pt. Reyes, #029)
 c) h_o =ocean water level (NOAA, Pt. Reyes #9415020)
 d) Q_r =river discharge (USGS, Guerneville #11467000)

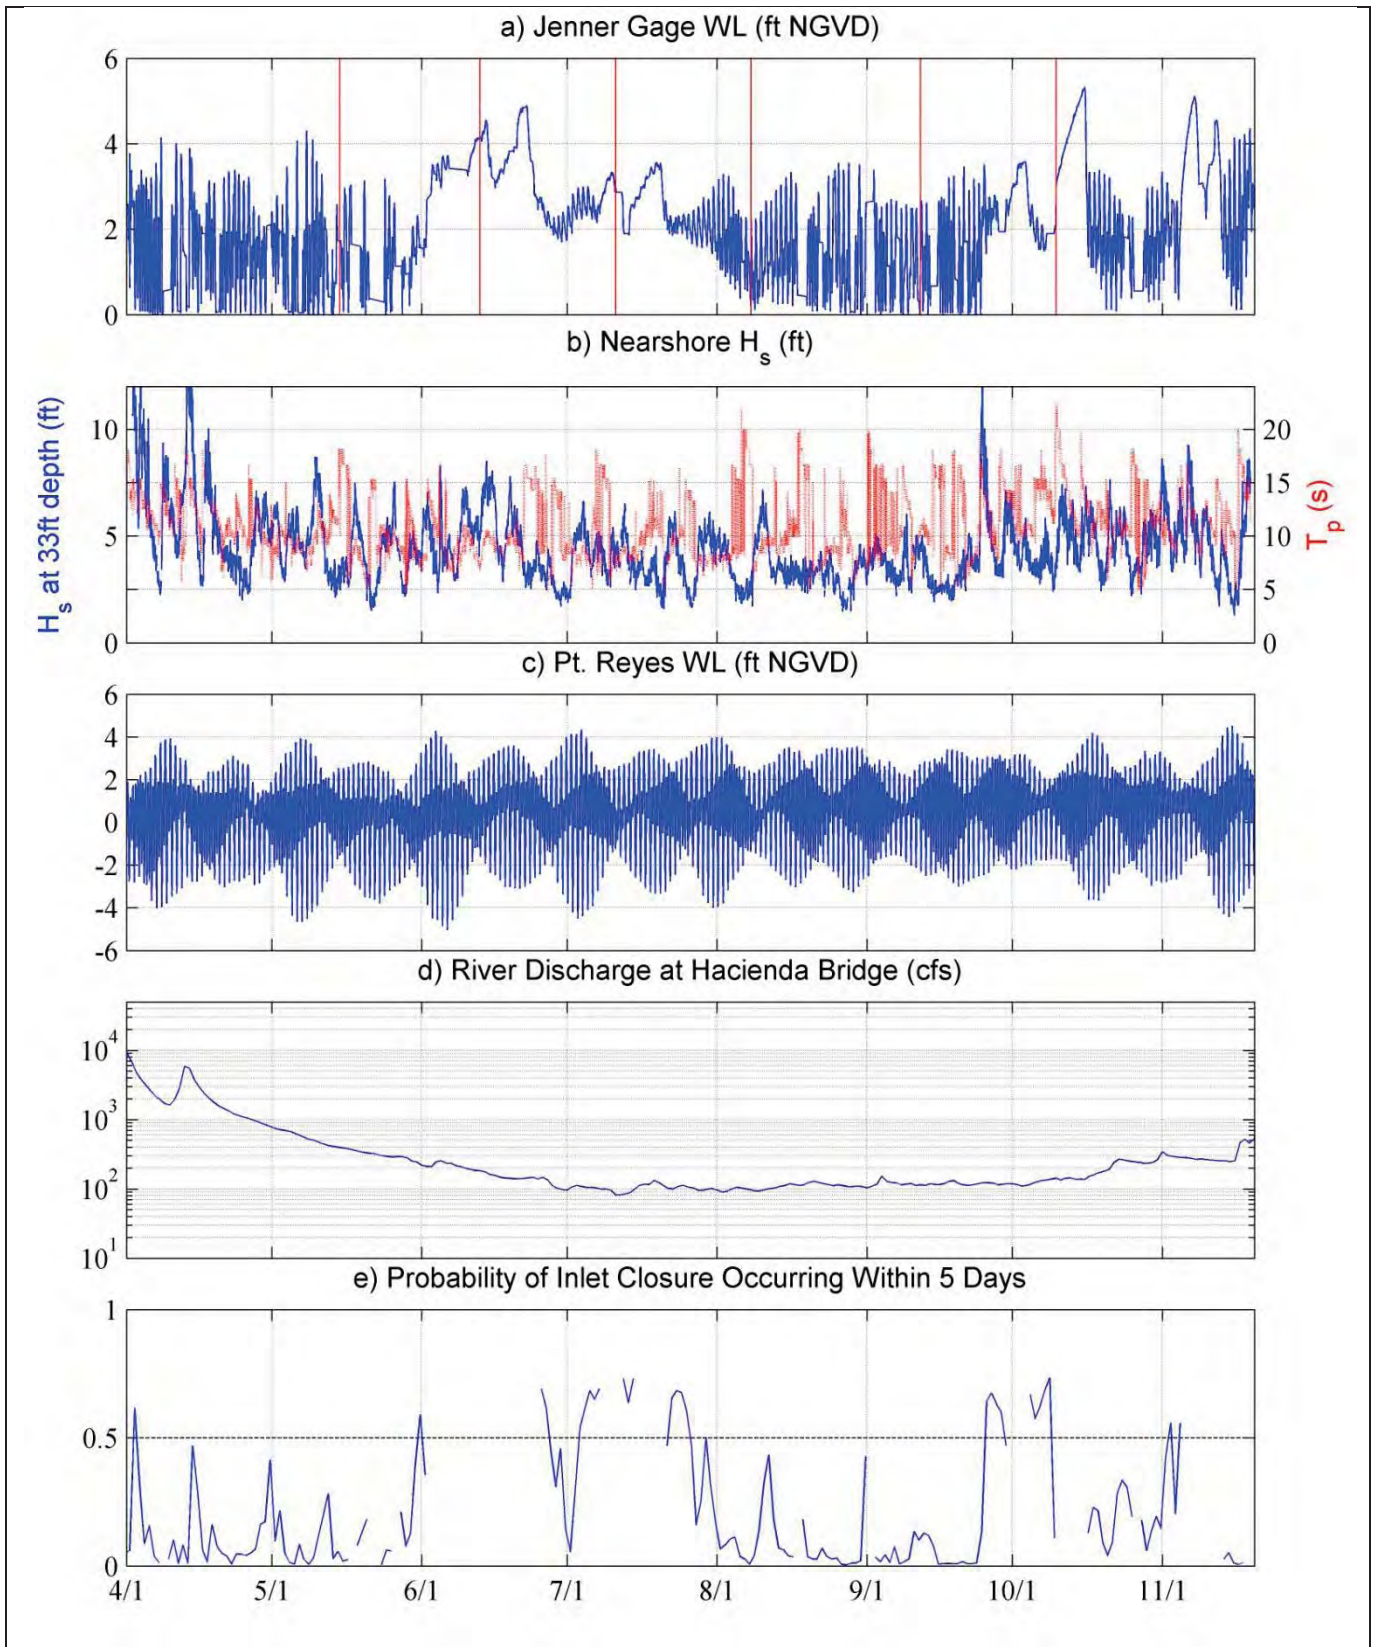
Figure 1
 Estuary, Ocean, and River Conditions Compared
 with Closure Probability:
 September – November 2012

- a) Jenner gage water level provided by SCWA; red bar = beach survey
- b) H_s = sig. wave height; T_p =peak wave period (CDIP, Pt. Reyes, #029)
- c) Ocean water level provided by NOAA (Pt. Reyes #9415020)
- d) River discharge provided by USGS (Guerneville #11467000)
- e) Five-day closure probability provided after Behrens et al. (2013)

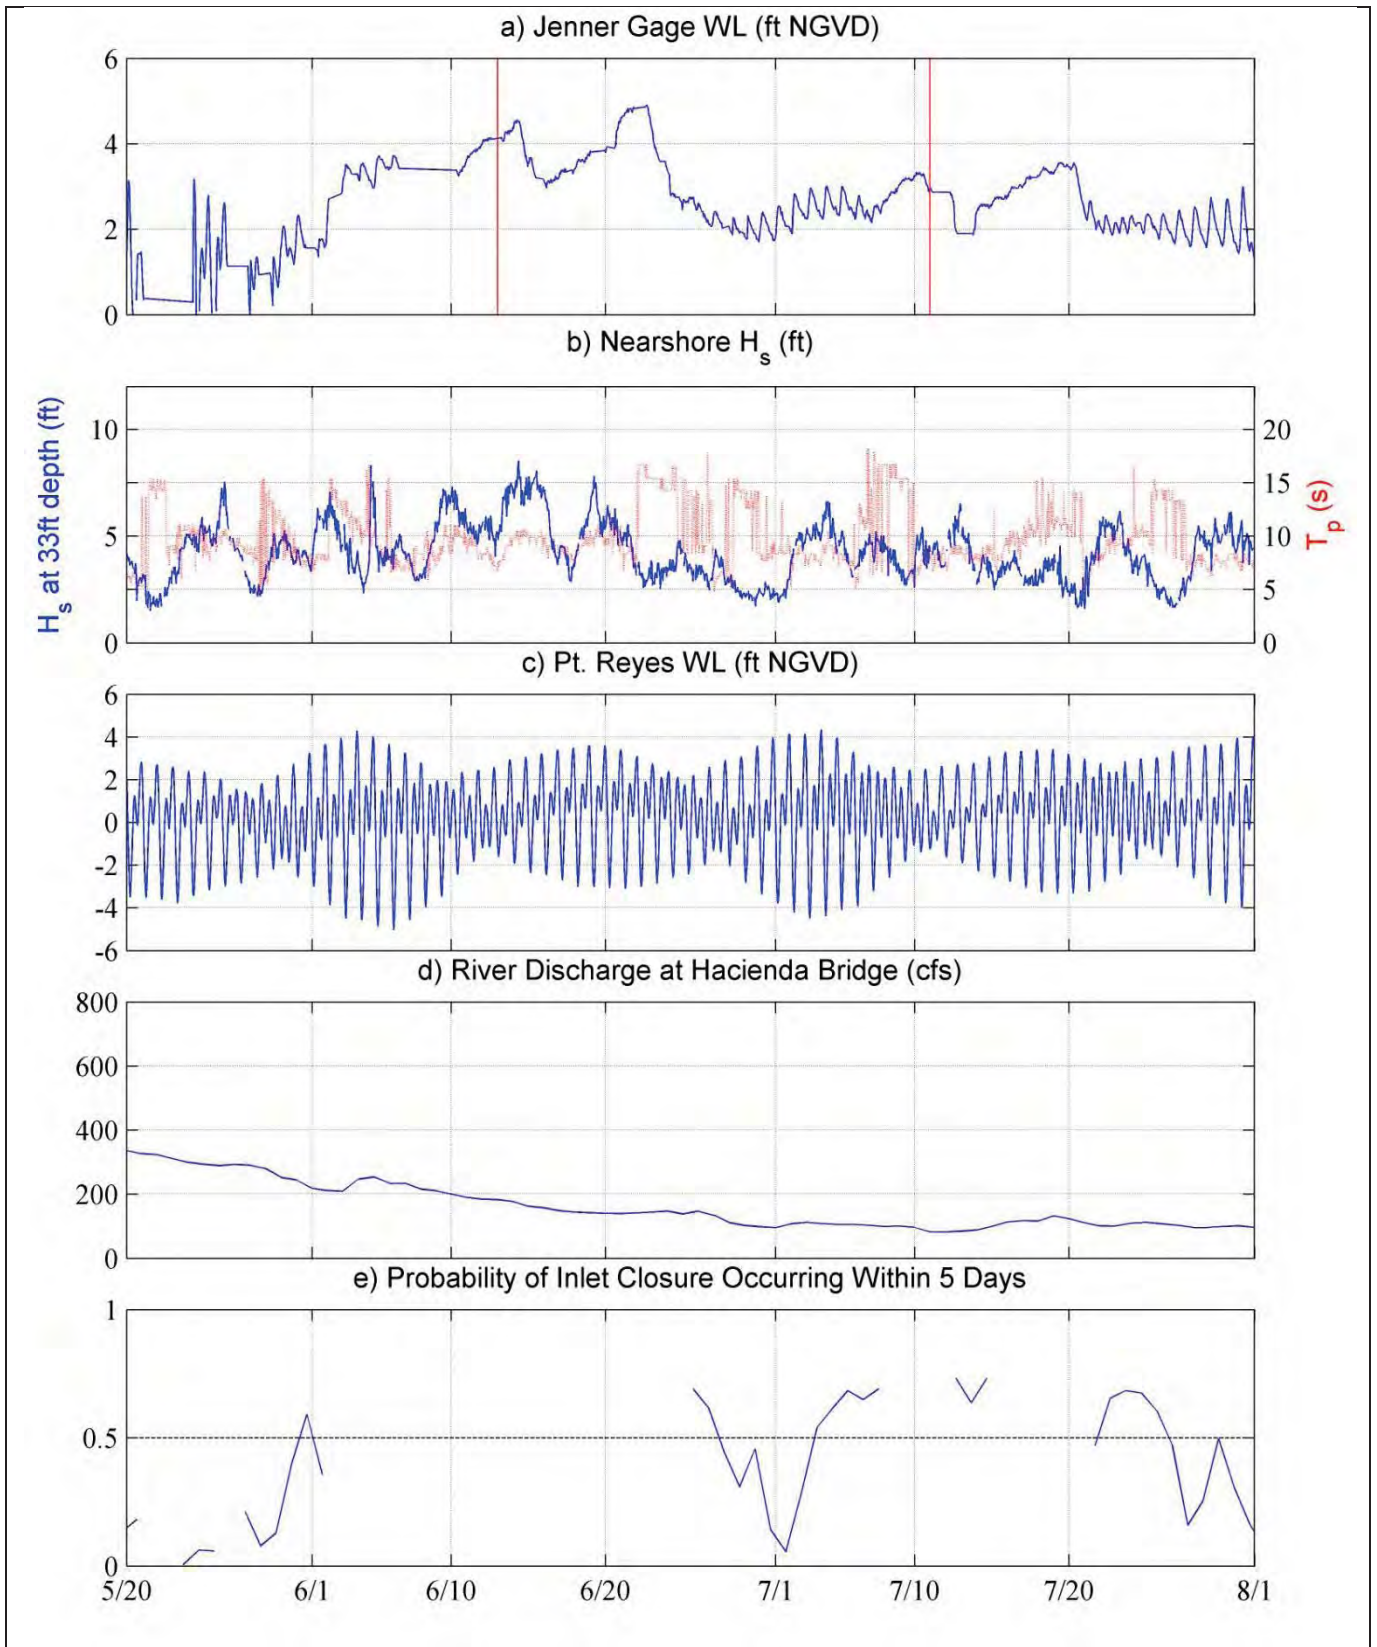
Figure 2
 Estuary, Ocean, and River Conditions Compared
 with Closure Probability:
 May 20 – August 1, 2012

- a) Jenner gage water level provided by SCWA; red bar = beach survey
- b) H_s = sig. wave height; T_p = peak wave period (CDIP, Pt. Reyes, #029)
- c) Ocean water level provided by NOAA (Pt. Reyes #9415020)
- d) River discharge provided by USGS (Guerneville #11467000)
- e) Five-day closure probability provided after Behrens et al. (2013)

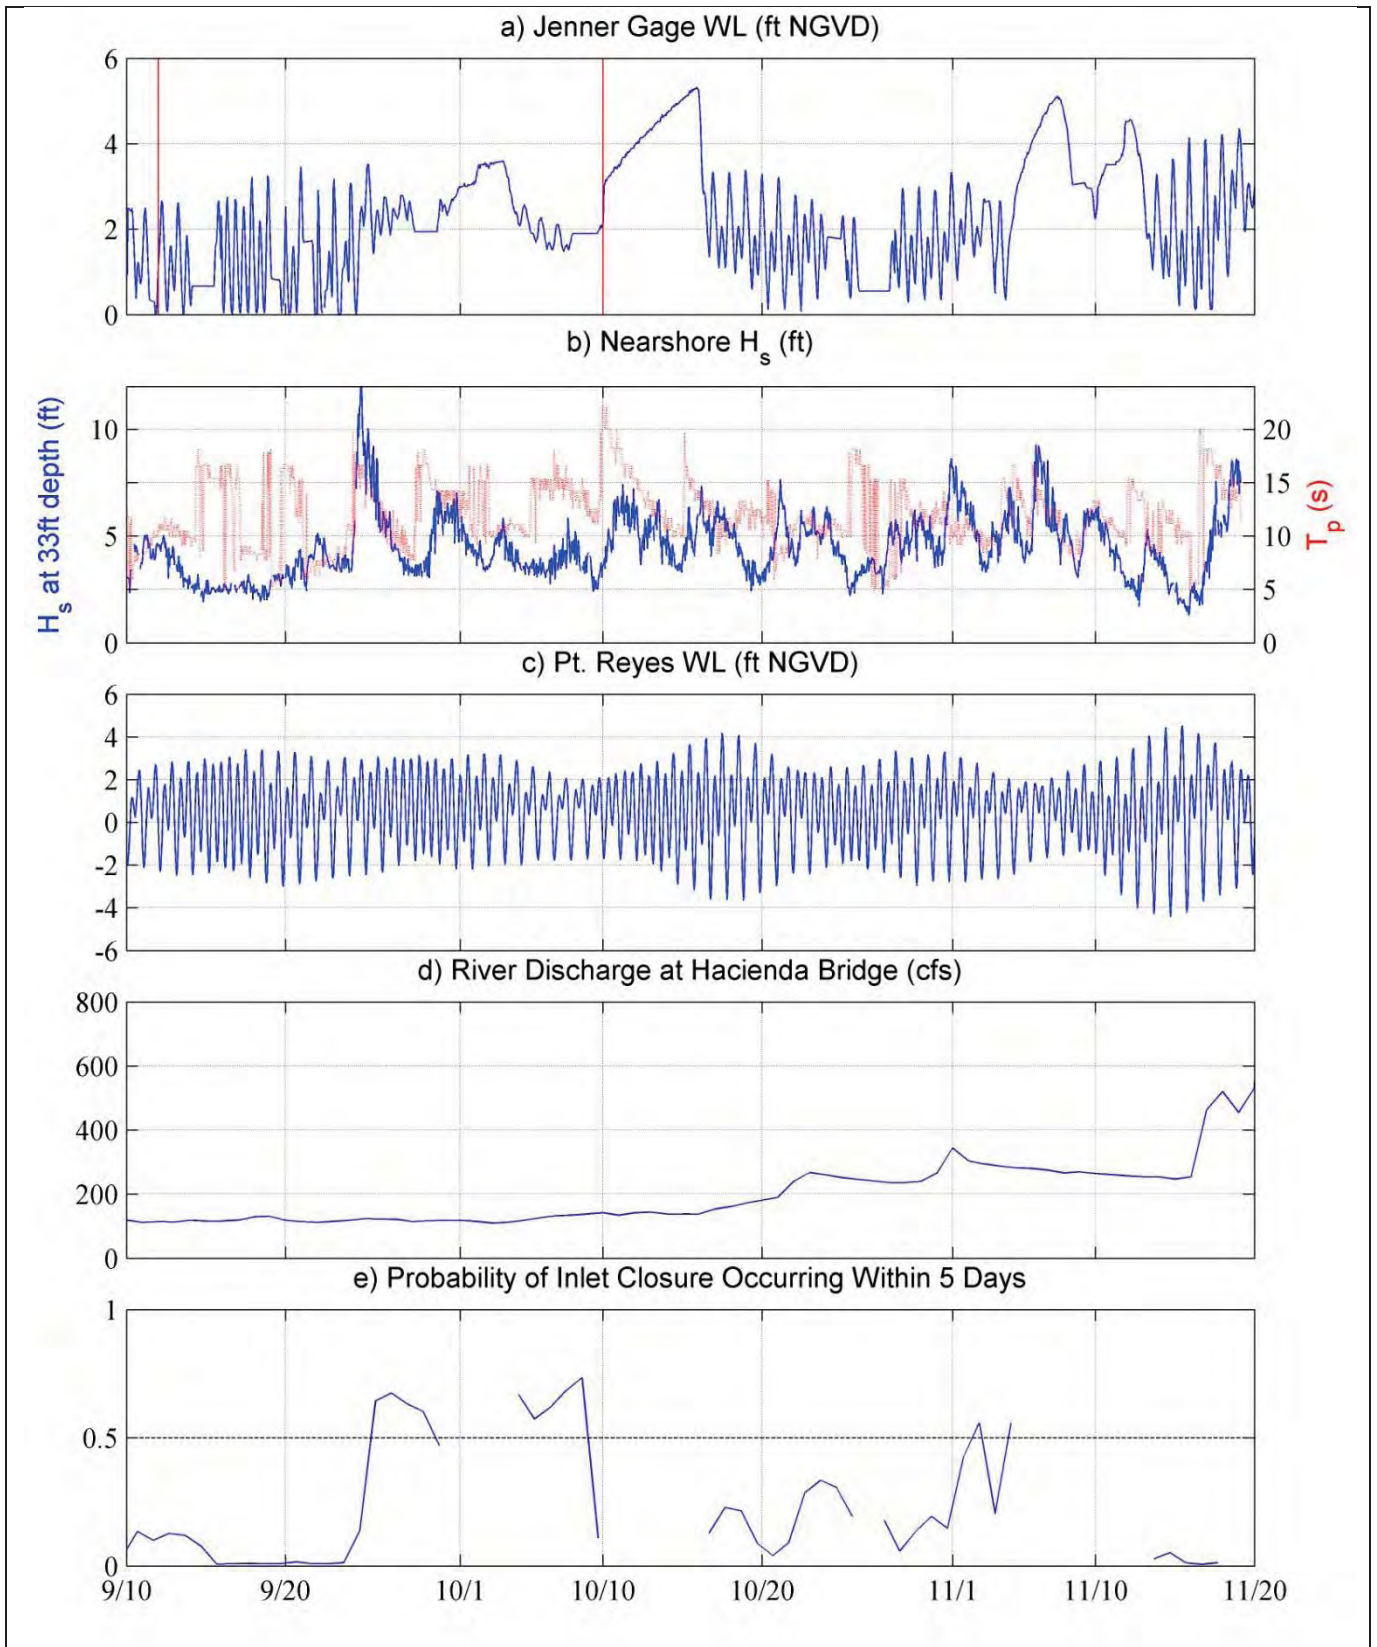
Figure 3
 Estuary, Ocean, and River Conditions Compared
 with Closure Probability:
 September 10 – November 20, 2012

- a) Jenner gage water level provided by SCWA; red bar = beach survey
- b) H_s = sig. wave height; T_p = peak wave period (CDIP, Pt. Reyes, #029)
- c) Ocean water level provided by NOAA (Pt. Reyes #9415020)
- d) River discharge provided by USGS (Guerneville #11467000)
- e) Five-day closure probability provided after Behrens et al. (2013)

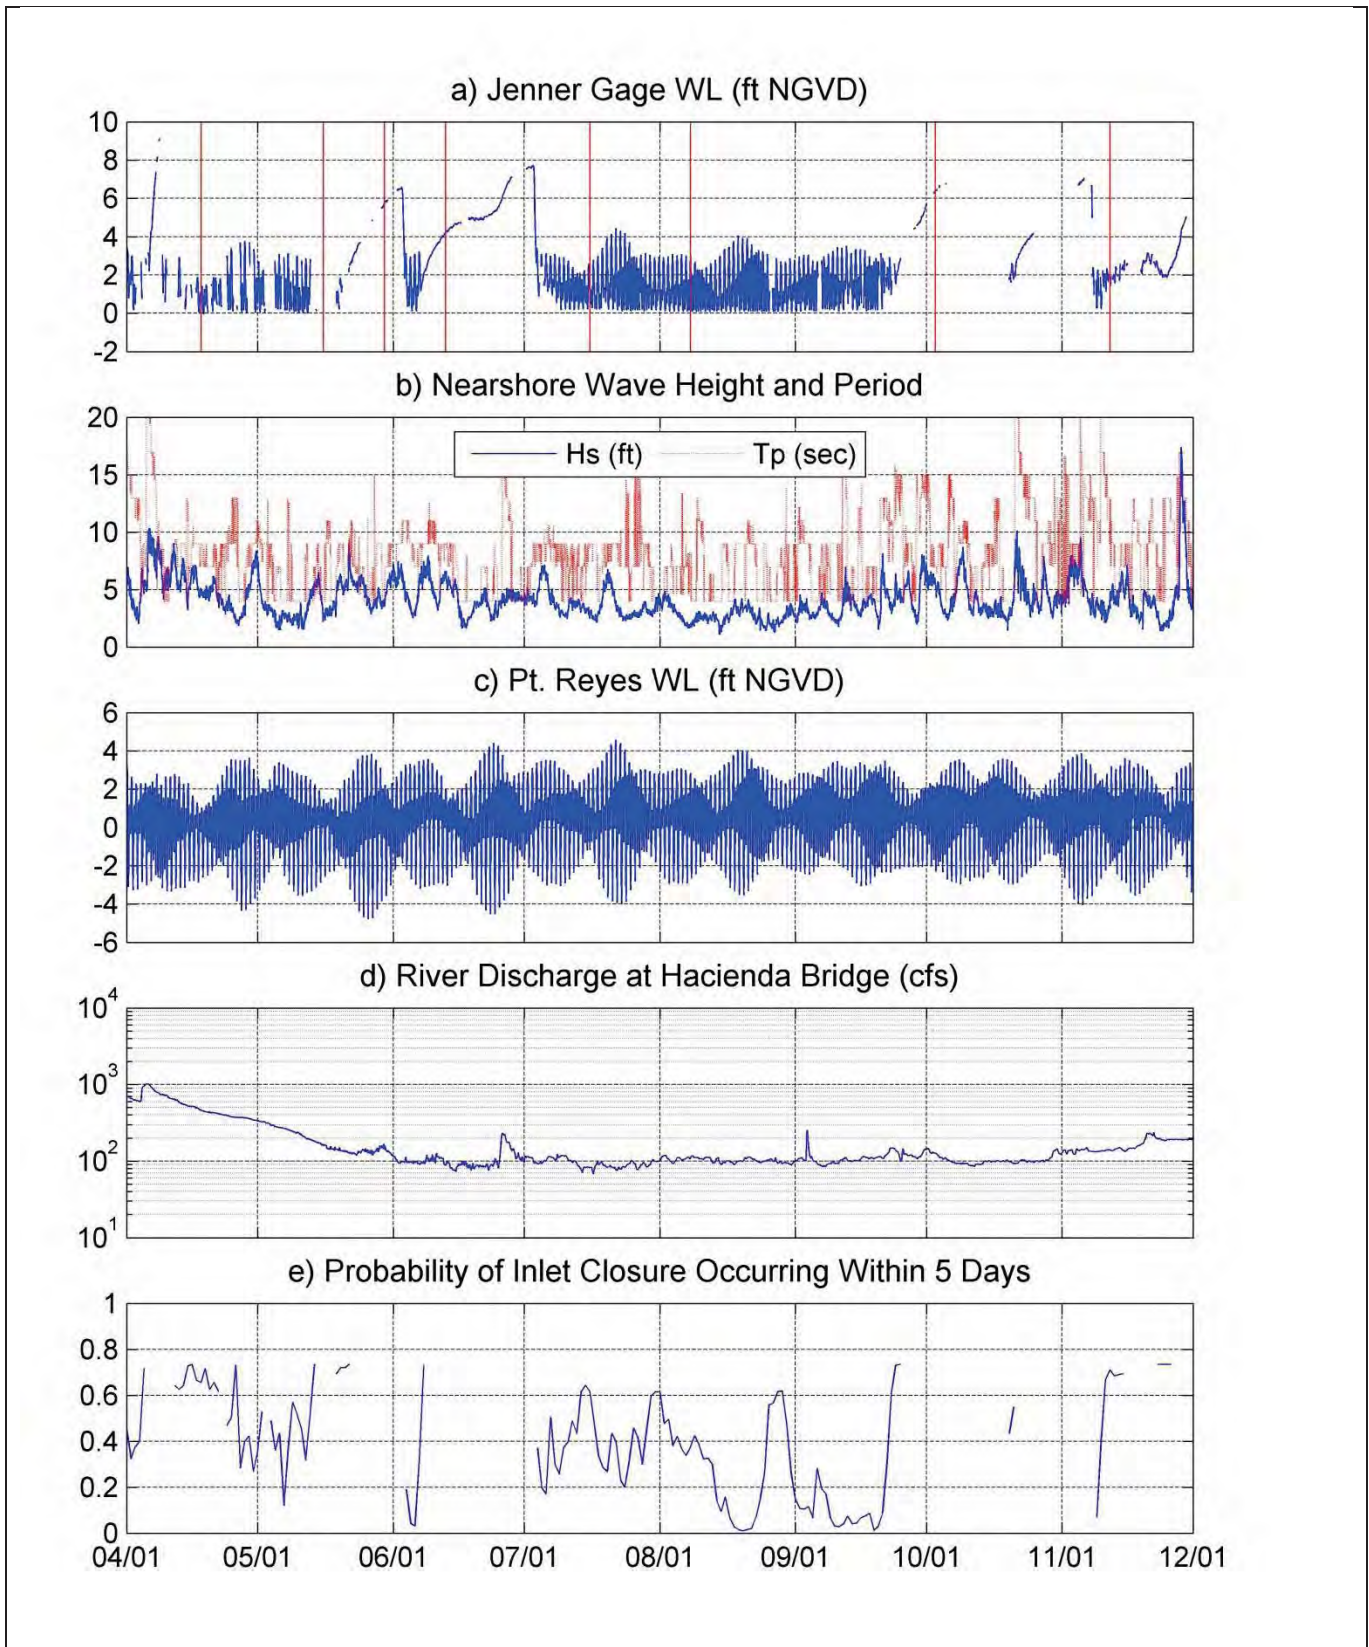
Figure 1
 Estuary, Ocean, and River Conditions Compared
 with Closure Probability:
 April – November 2013

- a) Jenner gage water level provided by SCWA; red bar = beach survey
- b) H_s = sig. wave height; T_p = peak wave period (CDIP, Pt. Reyes, #029)
- c) Ocean water level provided by NOAA (Pt. Reyes #9415020)
- d) River discharge provided by USGS (Guerneville #11467000)
- e) Five-day closure probability provided after Behrens et al. (2013)

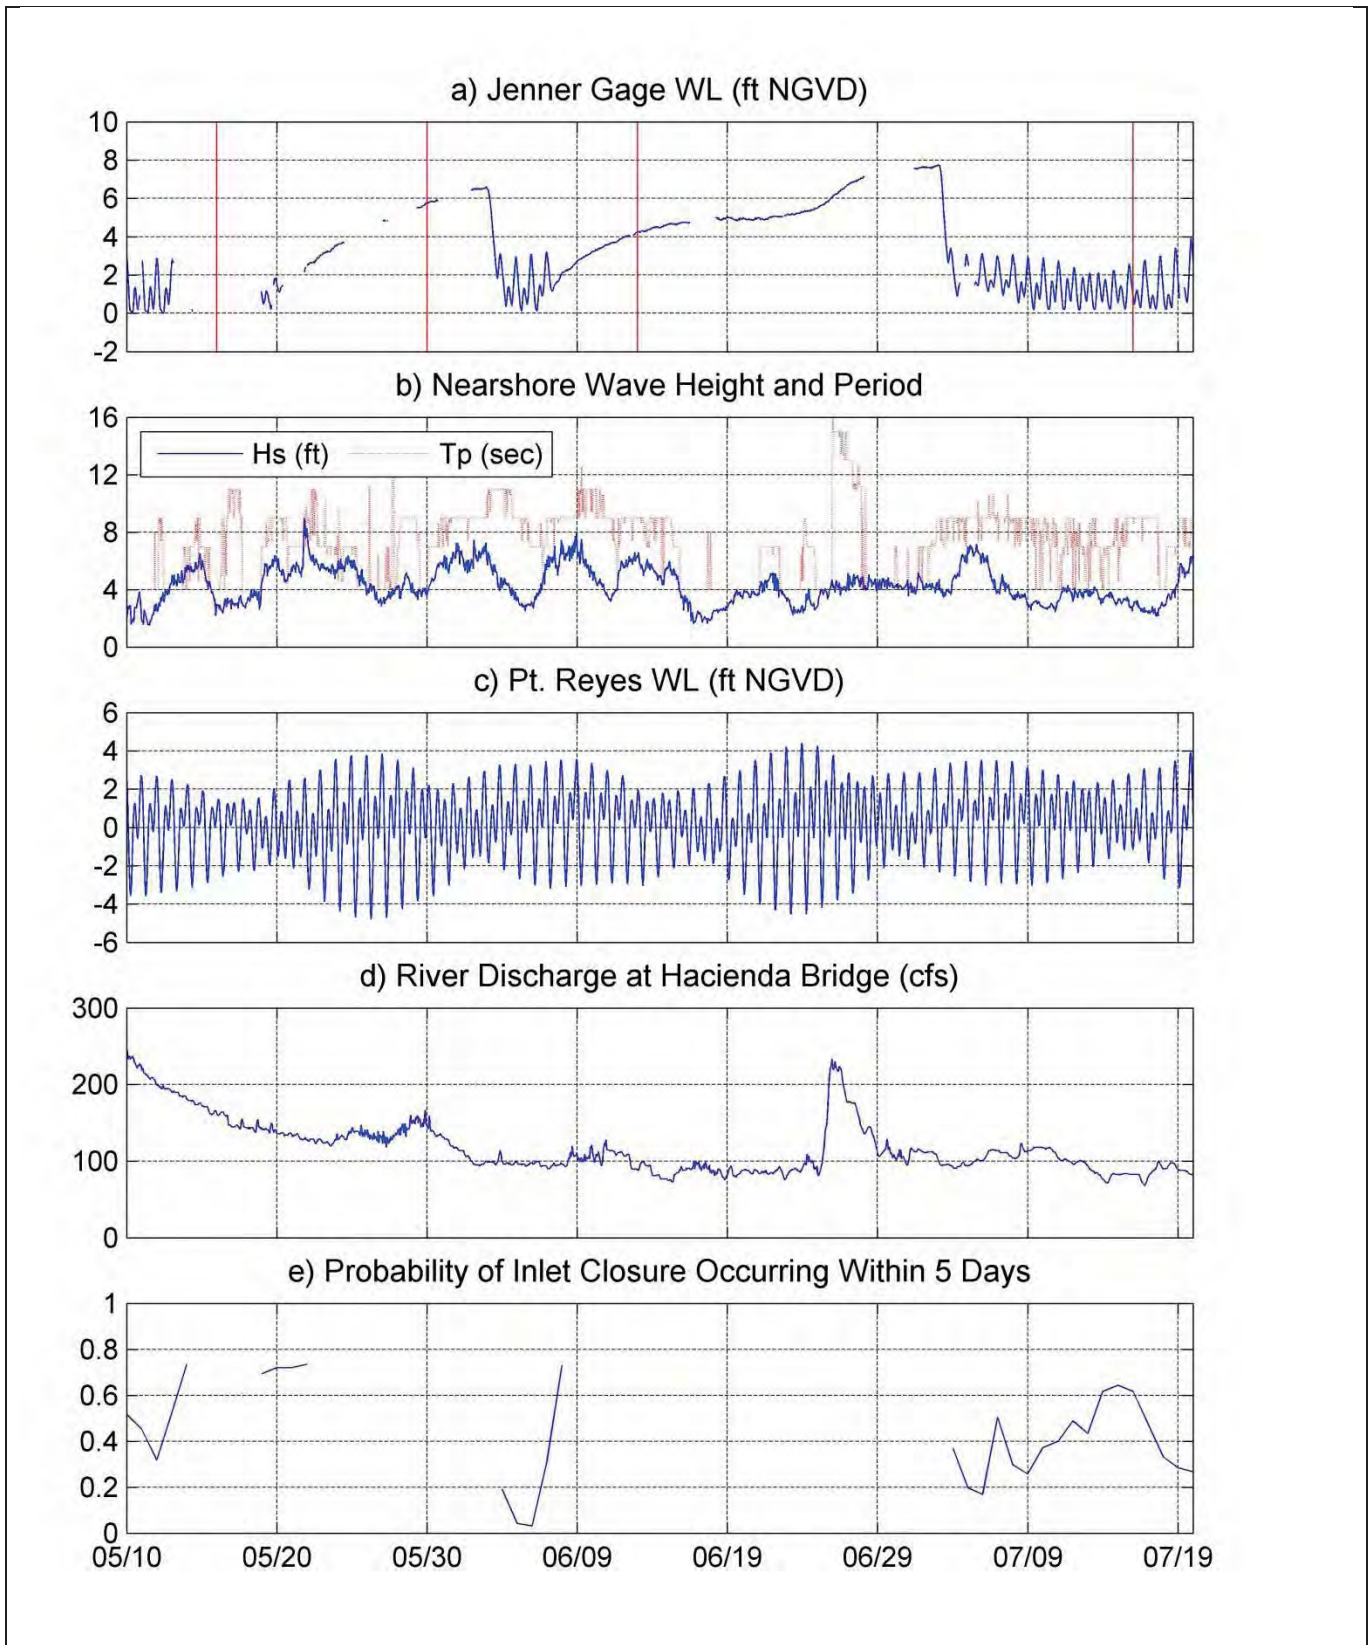
Figure 2
Estuary, Ocean, and River Conditions Compared
with Closure Probability:
May – July 2013

- a) Jenner gage water level provided by SCWA; red bar = beach survey
- b) H_s = sig. wave height; T_p =peak wave period (CDIP, Pt. Reyes, #029)
- c) Ocean water level provided by NOAA (Pt. Reyes #9415020)
- d) River discharge provided by USGS (Guerneville #11467000)
- e) Five-day closure probability provided after Behrens et al. (2013)

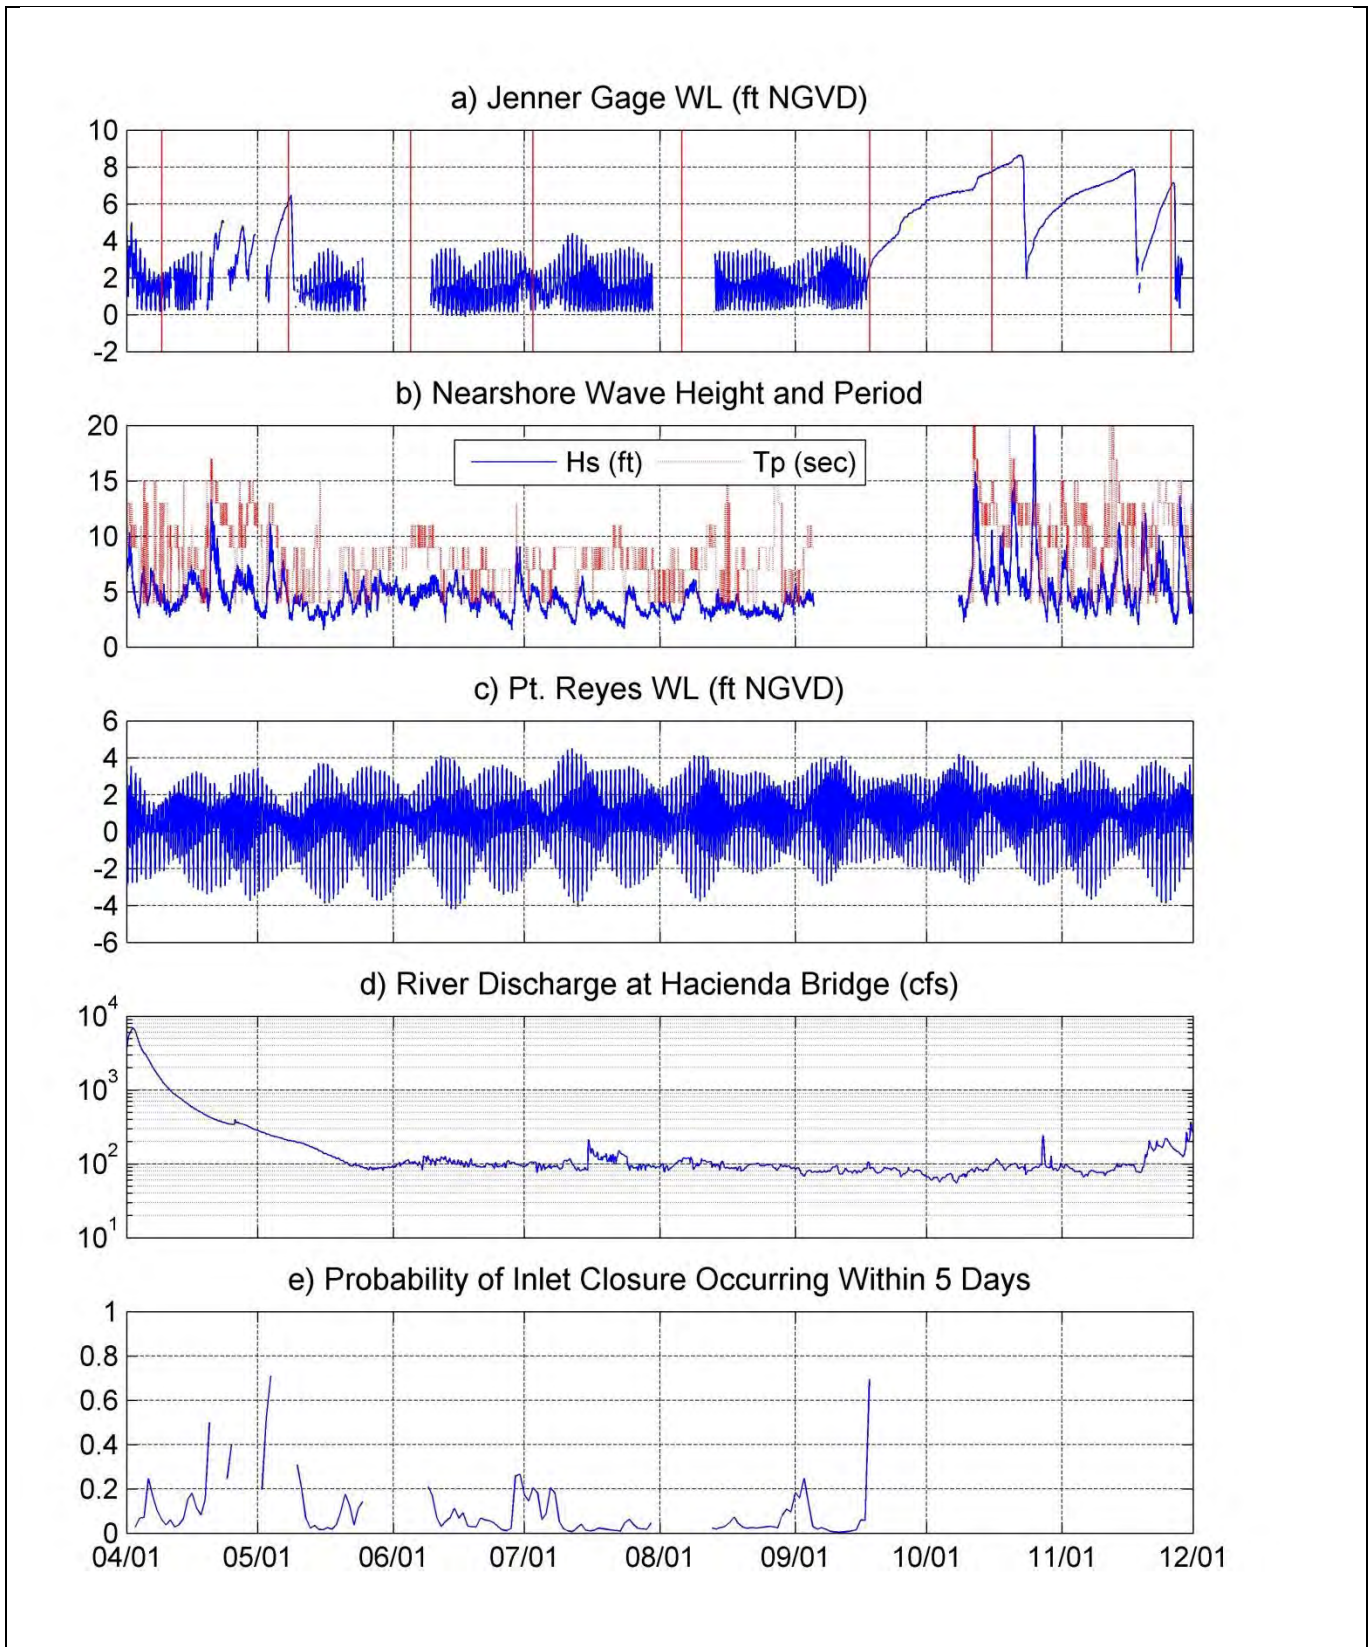
Figure 1
 Estuary, Ocean, and River Conditions Compared
 with Closure Probability:
 April – November 2014

- a) Jenner gage water level provided by SCWA; red bar = beach survey
- b) H_s = sig. wave height; T_p =peak wave period (CDIP, Pt. Reyes, #029)
- c) Ocean water level provided by NOAA (Pt. Reyes #9415020)
- d) River discharge provided by USGS (Guerneville #11467000)
- e) Five-day closure probability provided after Behrens et al. (2013)

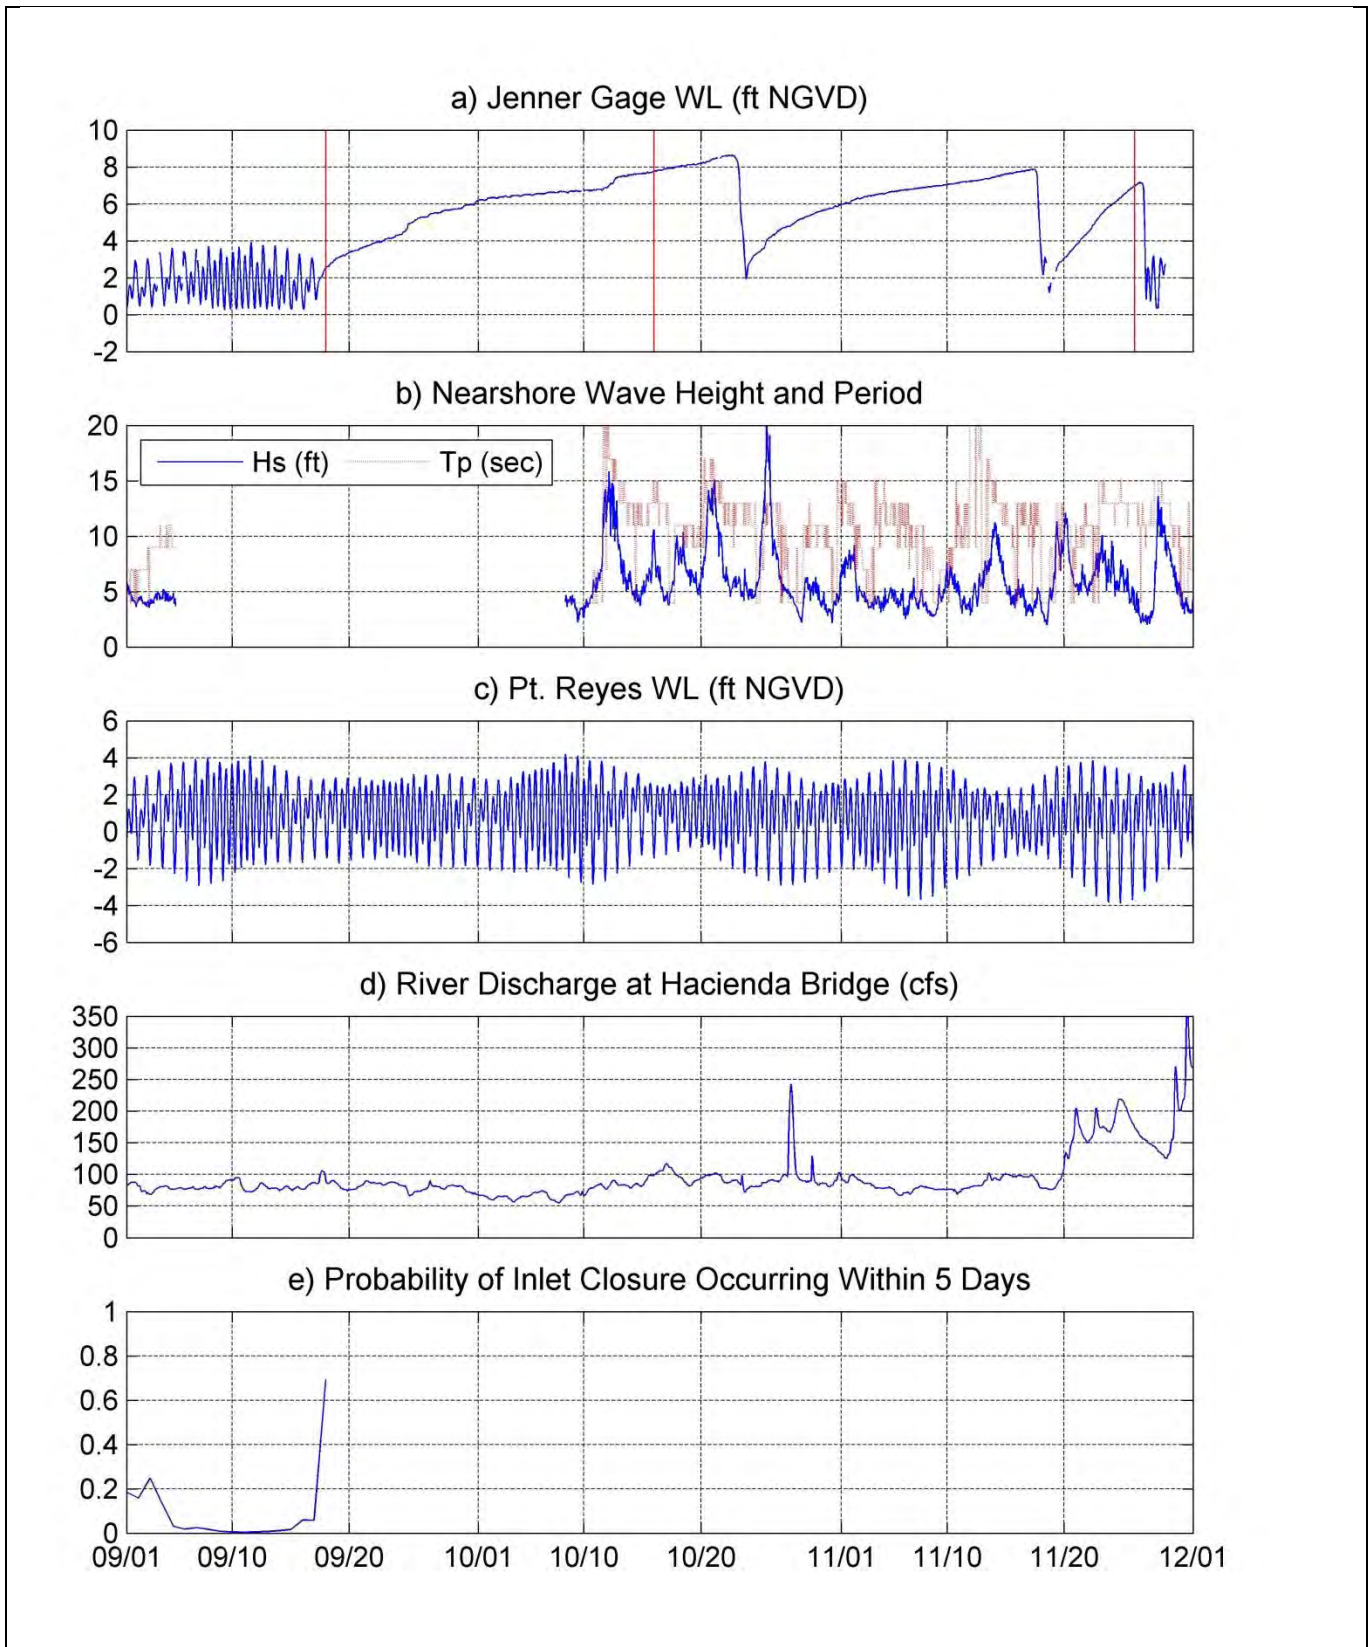
Figure 2
 Estuary, Ocean, and River Conditions Compared
 with Closure Probability:
 September – November 2014

- a) Jenner gage water level provided by SCWA; red bar = beach survey
- b) H_s = sig. wave height; T_p = peak wave period (CDIP, Pt. Reyes, #029)
- c) Ocean water level provided by NOAA (Pt. Reyes #9415020)
- d) River discharge provided by USGS (Guerneville #11467000)
- e) Five-day closure probability provided after Behrens et al. (2013)

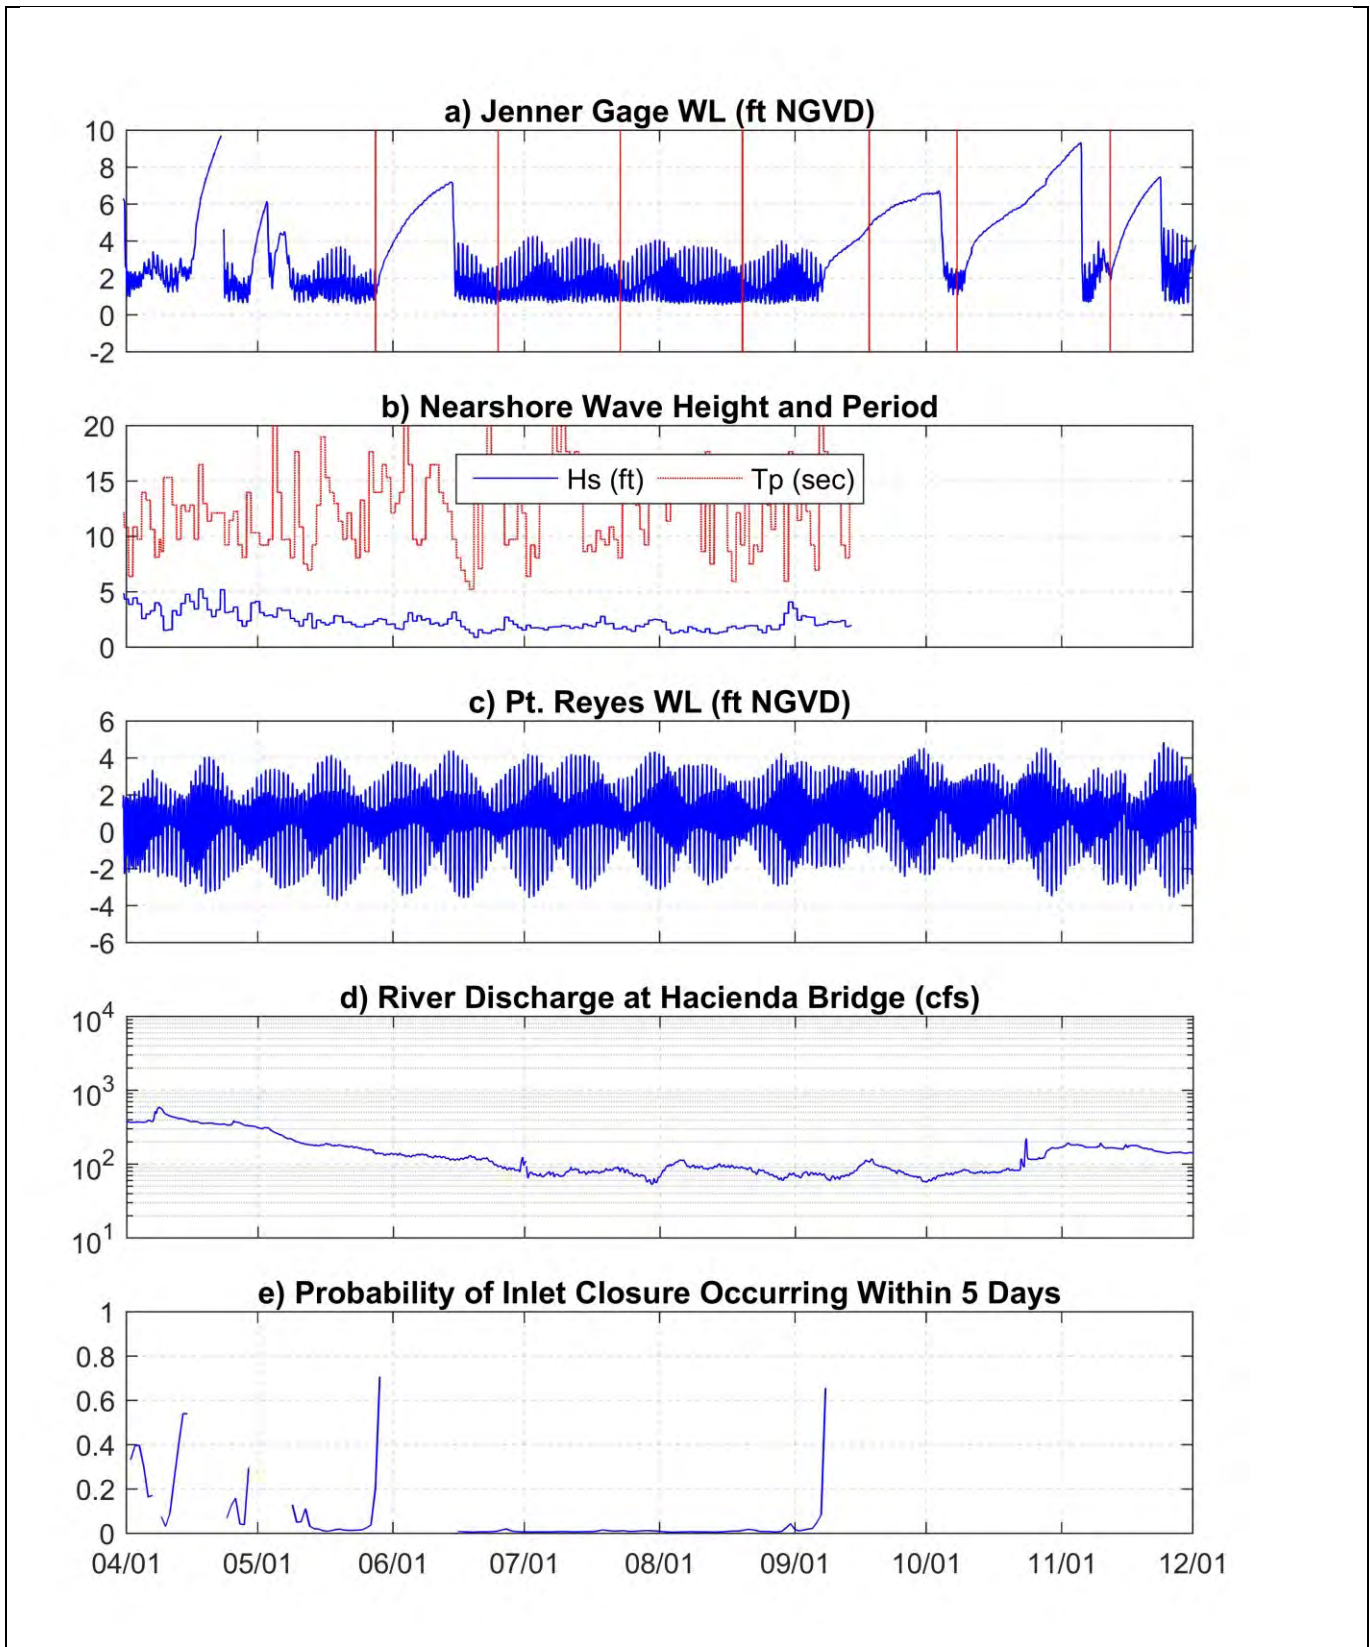
Figure 1
 Estuary, Ocean, and River Conditions Compared
 with Closure Probability:
 April – November 2015

- a) Jenner gage water level provided by SCWA; red bar = beach survey
- b) H_s = sig. wave height; T_p =peak wave period (CDIP, Pt. Reyes, #029)
- c) Ocean water level provided by NOAA (Pt. Reyes #9415020)
- d) River discharge provided by USGS (Guerneville #11467000)
- e) Five-day closure probability provided after Behrens et al. (2013)
