**RUSSIAN RIVER ESTUARY OUTLET CHANNEL
ADAPTIVE MANAGEMENT PLAN
2018**

Sonoma County Water Agency

ESA

May 14, 2018

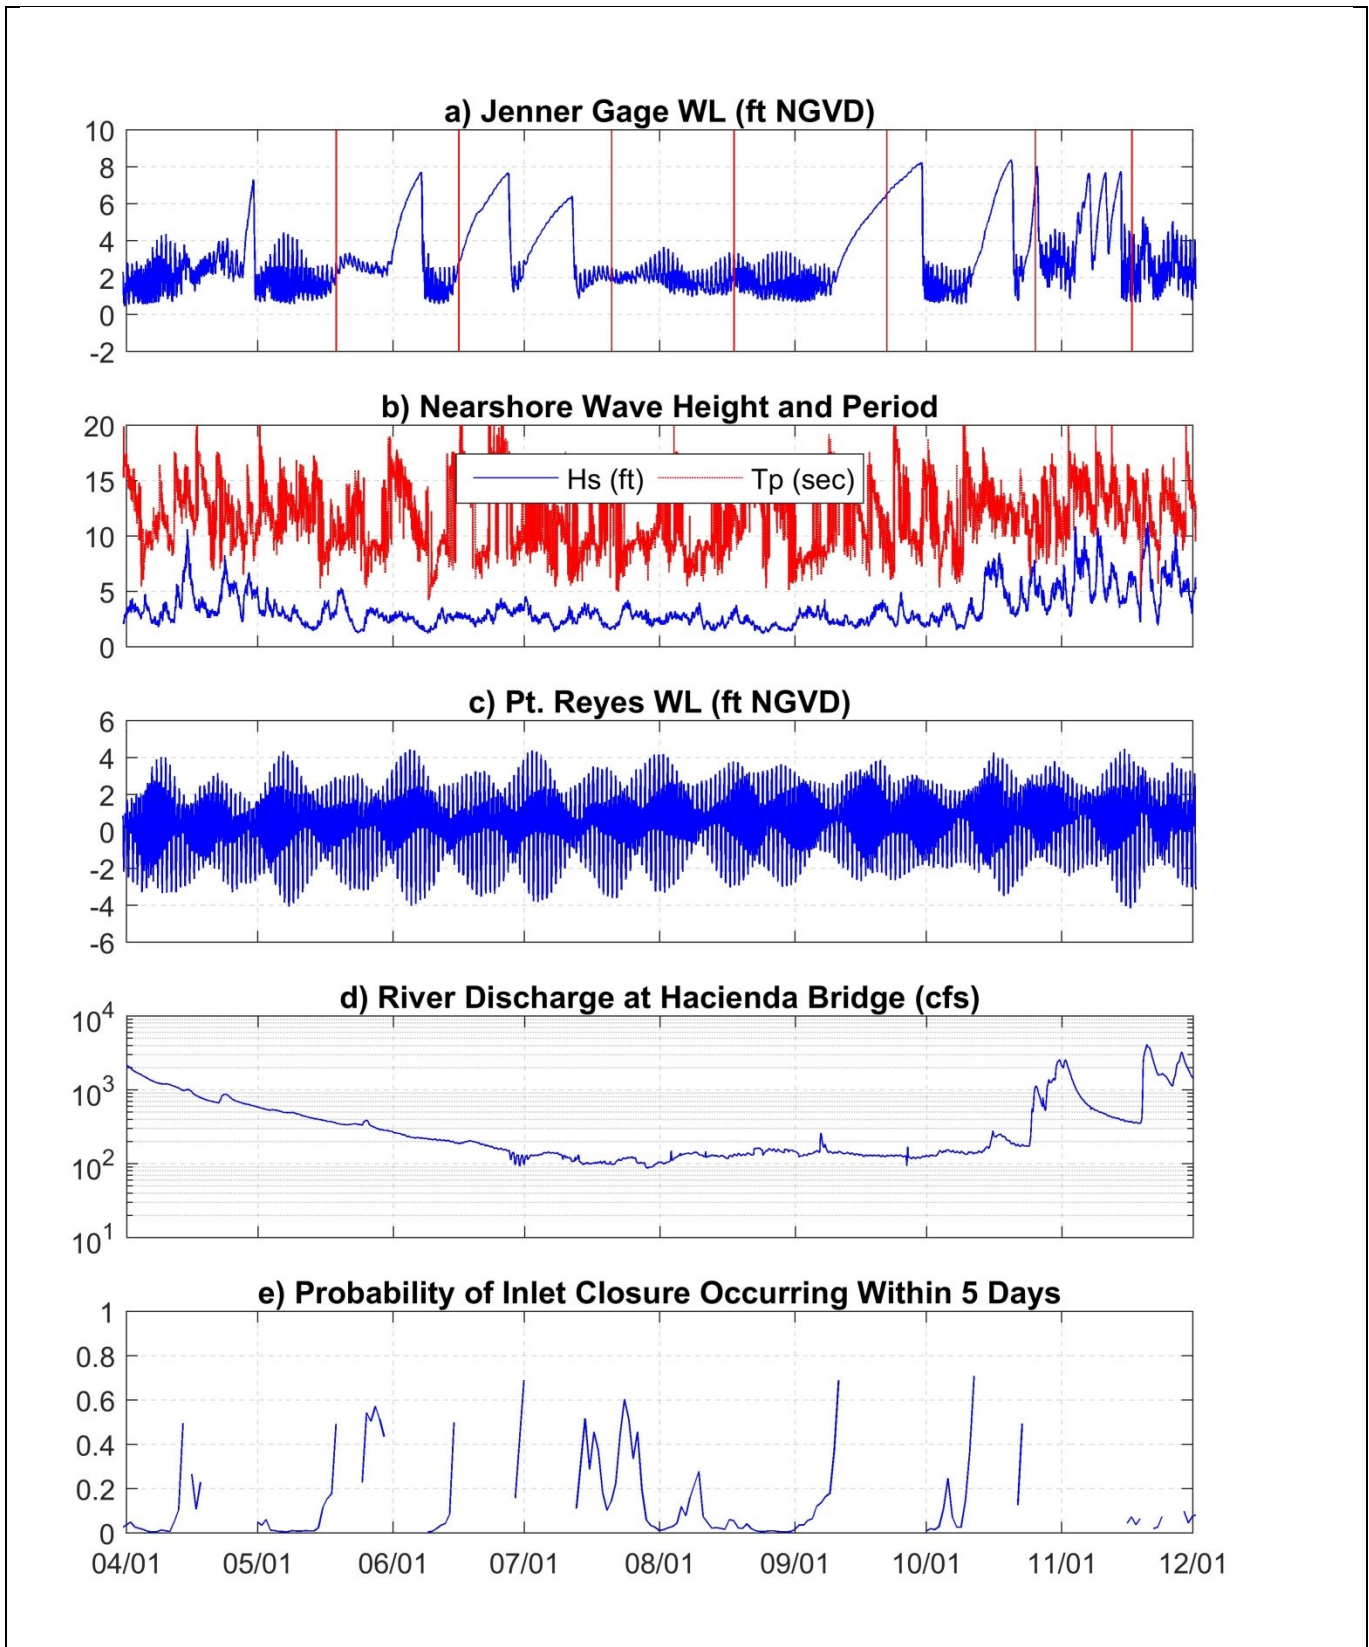
Figure 1
 Estuary, Ocean, and River Conditions Compared
 with Closure Probability:
 April – November 2016

- a) Jenner gage water level provided by SCWA; red bar = beach survey
- b) H_s = sig. wave height; T_p=peak wave period (CDIP, Pt. Reyes, #029)
- c) Ocean water level provided by NOAA (Pt. Reyes #9415020)
- d) River discharge provided by USGS (Guerneville #11467000)
- e) Five-day closure probability provided after Behrens et al. (2013)

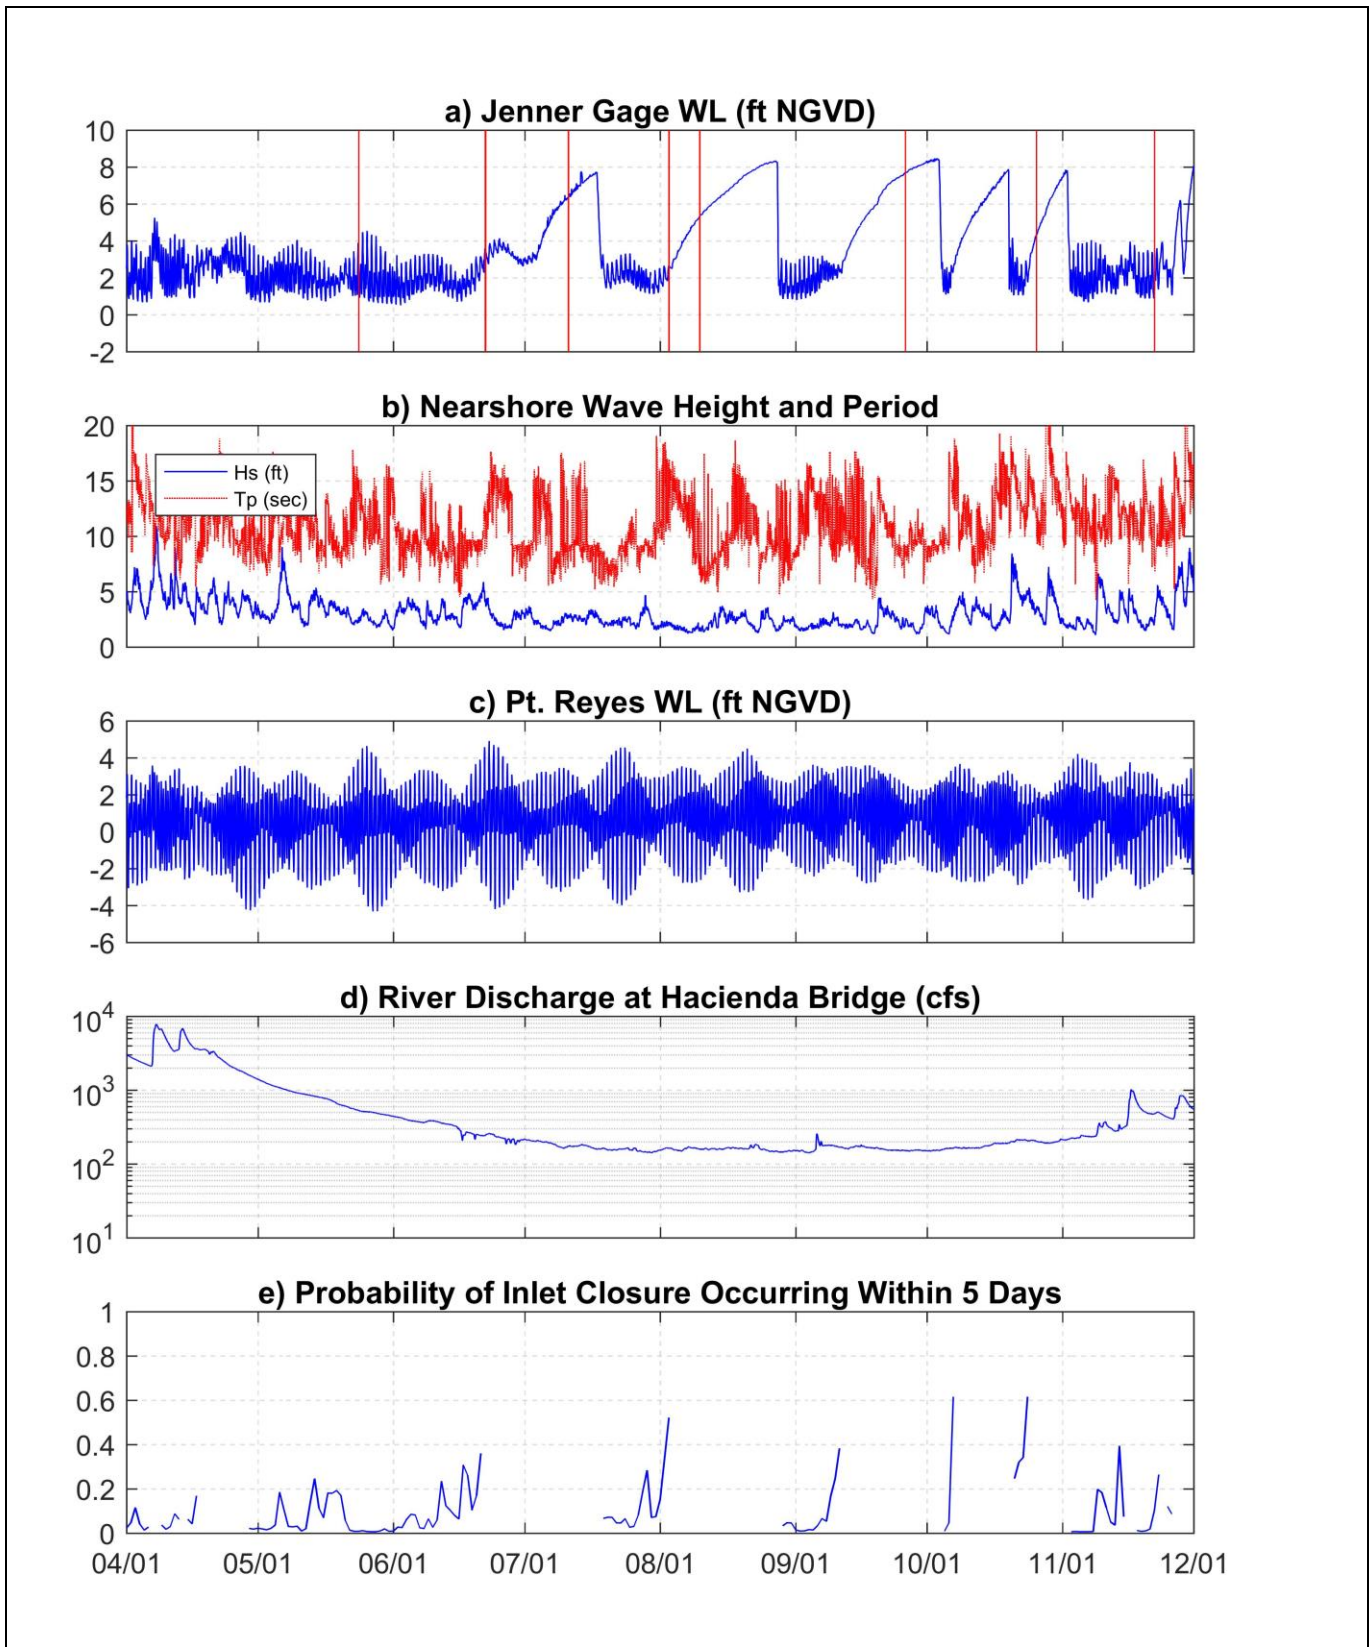
Figure 1
 Estuary, Ocean, and River Conditions Compared
 with Closure Probability:
 April – November 2017

- a) Jenner gage water level provided by SCWA; red bar = beach survey
- b) H_s = sig. wave height; T_p=peak wave period (CDIP, Pt. Reyes, #029)
- c) Ocean water level provided by NOAA (Pt. Reyes #9415020)
- d) River discharge provided by USGS (Guerneville #11467000)
- e) Five-day closure probability provided after Behrens et al. (2013)

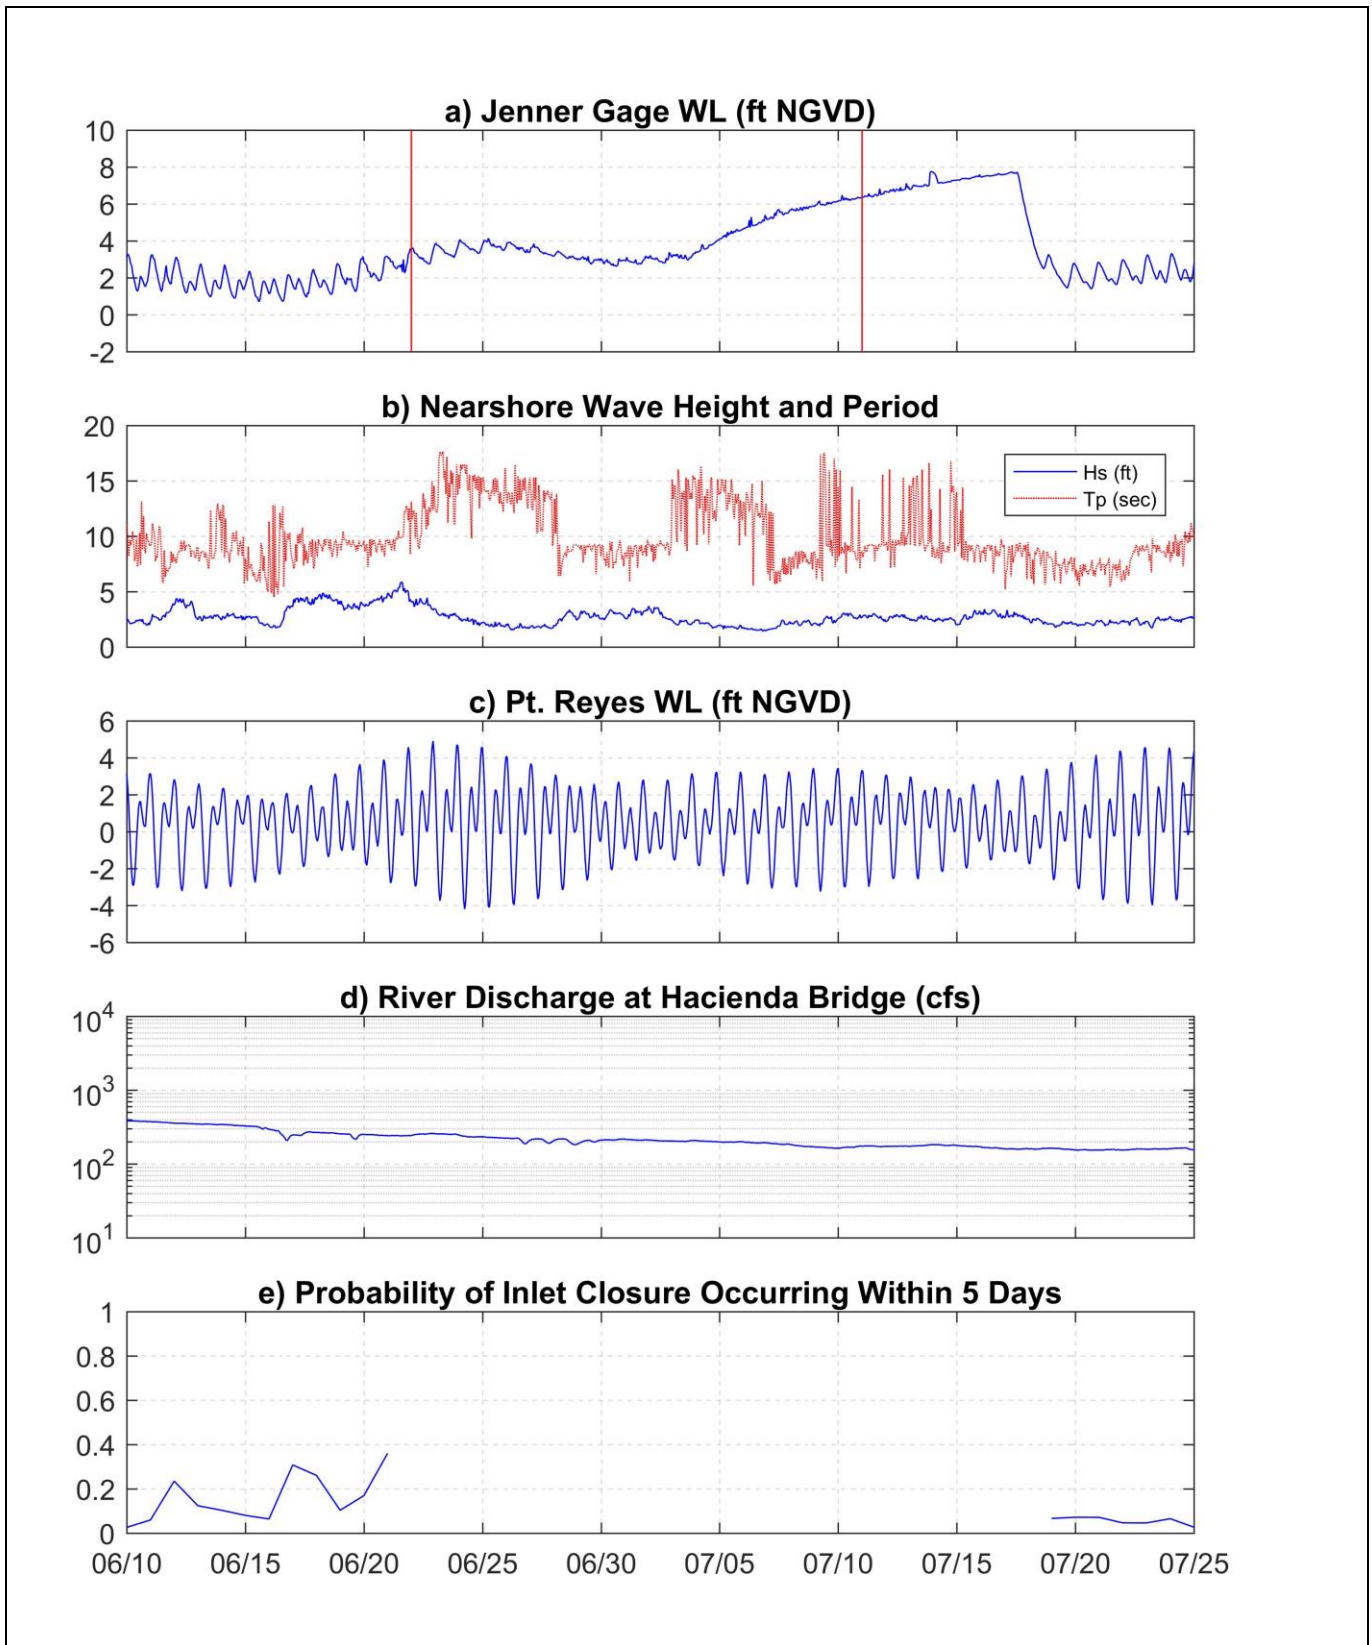
Figure 2
 Estuary, Ocean, and River Conditions Compared
 with Closure Probability:
 June – July 2017

- a) Jenner gage water level provided by SCWA; red bar = beach survey
- b) H_s = sig. wave height; T_p =peak wave period (CDIP, Pt. Reyes, #029)
- c) Ocean water level provided by NOAA (Pt. Reyes #9415020)
- d) River discharge provided by USGS (Guerneville #11467000)
- e) Five-day closure probability provided after Behrens et al. (2013)

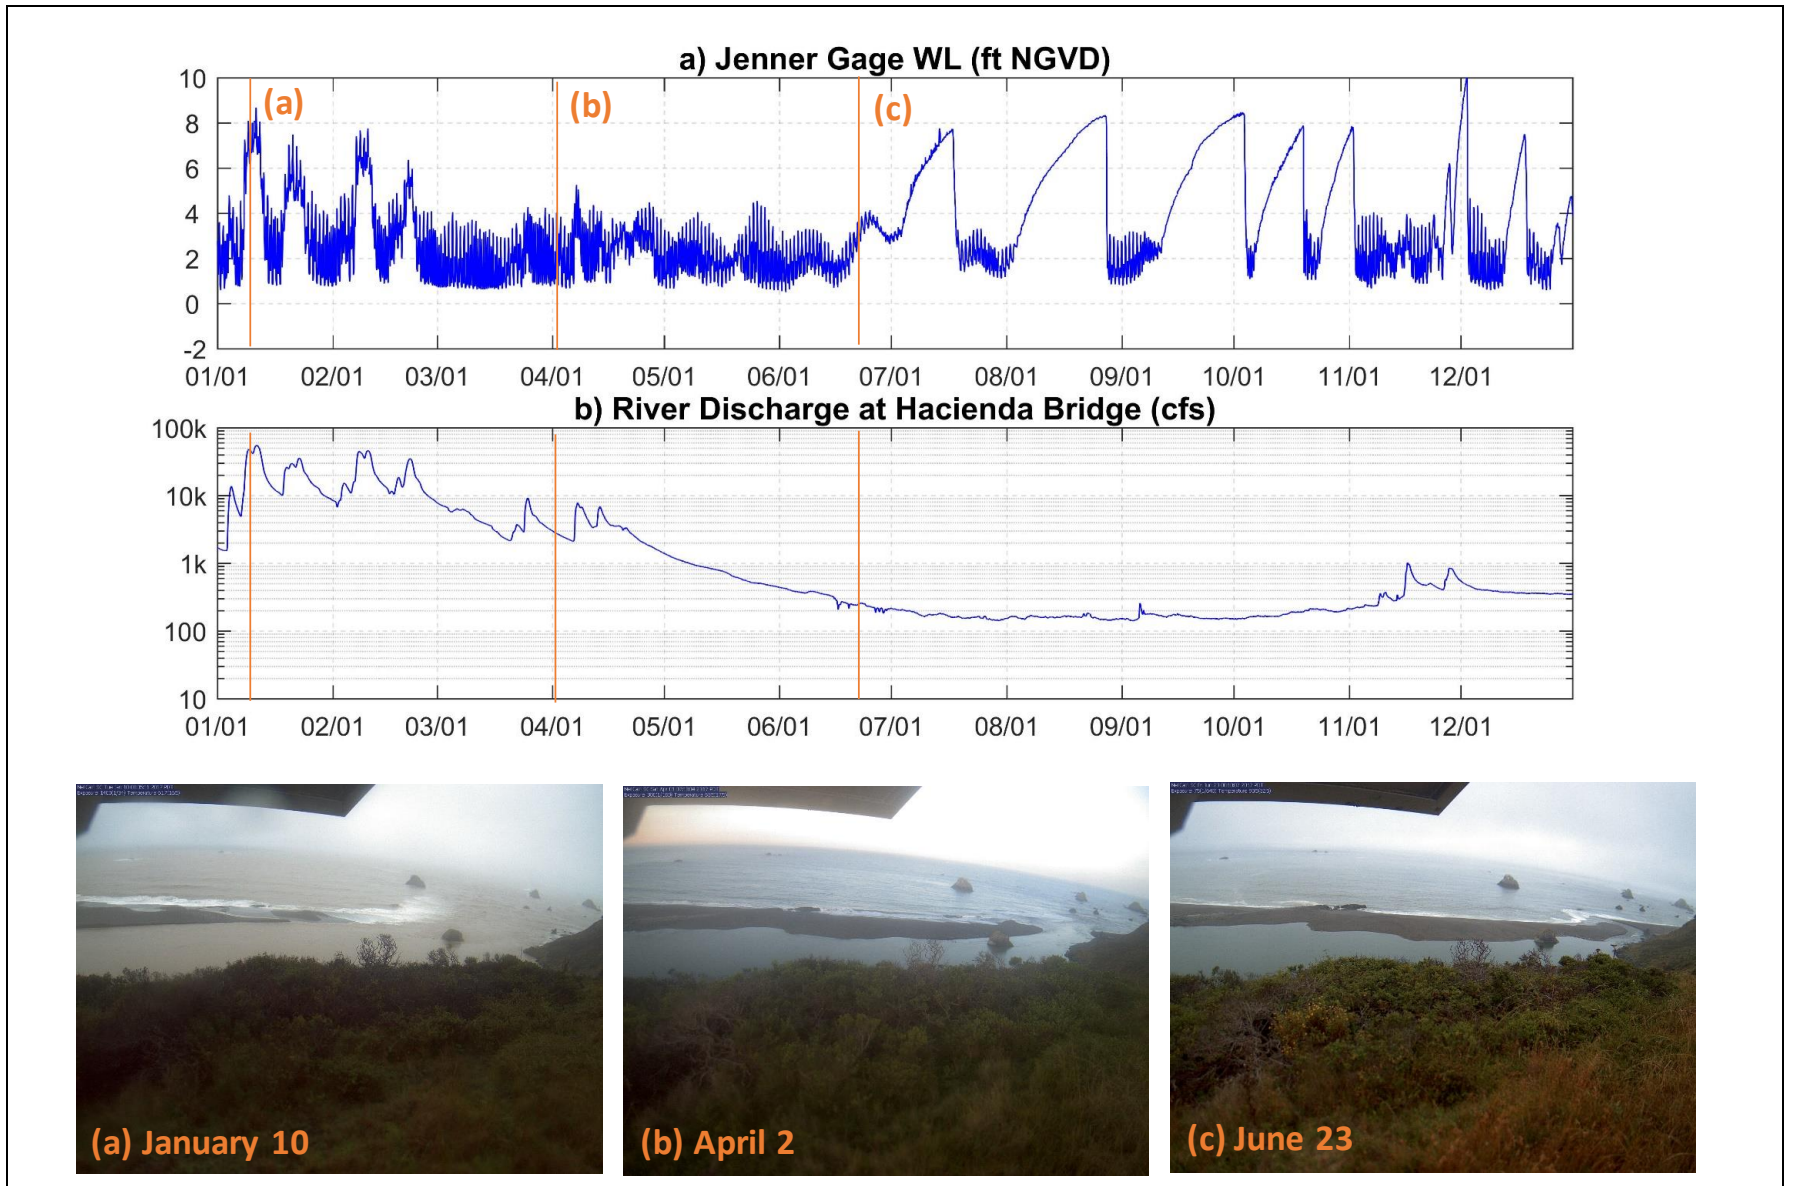
(a) Russian River during fluvial flooding on January 10th, 2017, (b) During moderate discharge conditions on April 2nd, 2017, and (c) during natural perched conditions on June 23rd, 2017.
