Goat Rock Beach Jetty Feasibility Study

April 20, 2016

Russian River Estuary Community Meeting

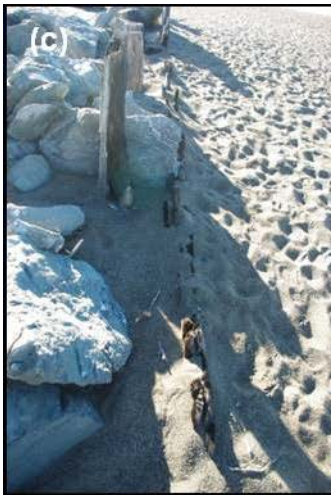
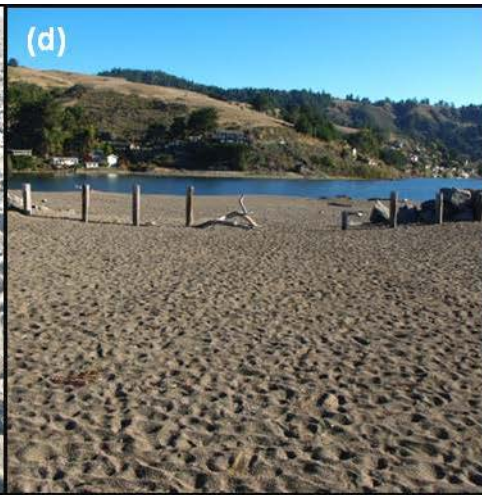
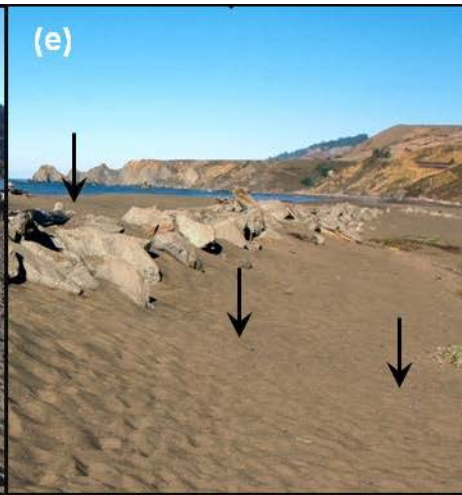
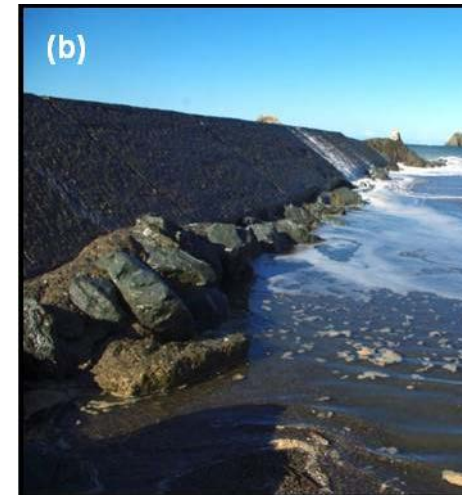
Jetty's Components

Access elements

Groin

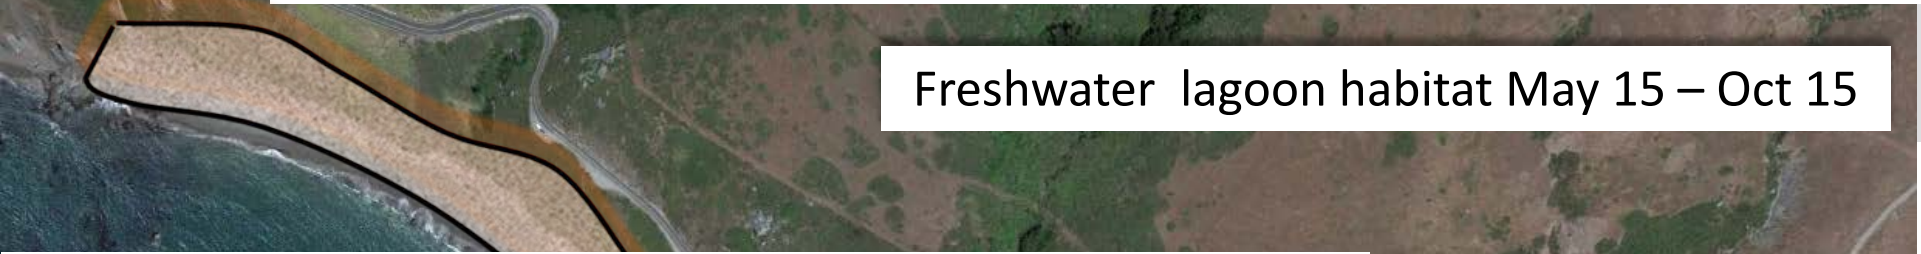
Jetty's Relationship to Estuary Water Surface Elevations

Freshwater lagoon habitat May 15 – Oct 15

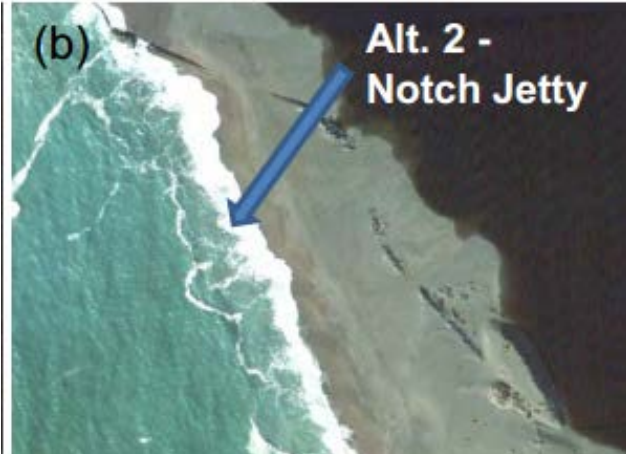
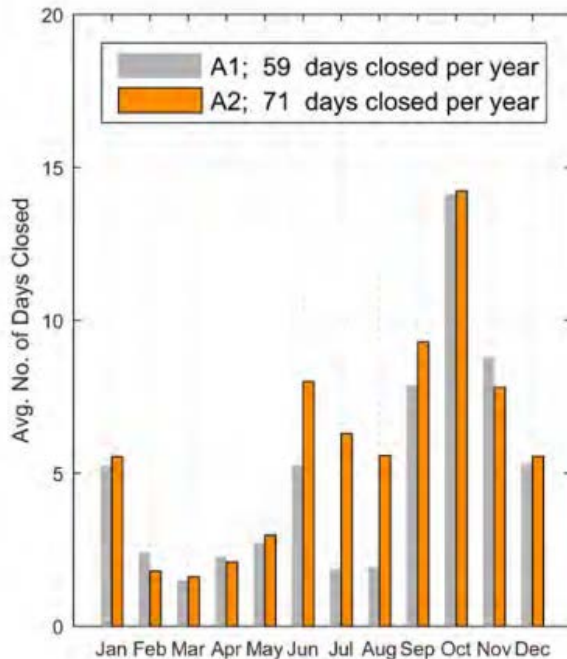
Alternative 2 – Notch Jetty

- No change in seepage or wave overwash
- May increase inlet migration south of groin by up to 250 ft
- Largest potential to increase in water surface elevations (up to 18% annually, 37% during management period)
- Implementation challenges: channel erosion, equipment access, fish passage, reverting to north of groin, increase management, fixed elevation relative to SLR
- Smaller traffic and access impacts during construction
- Estimated cost: \$1.6M

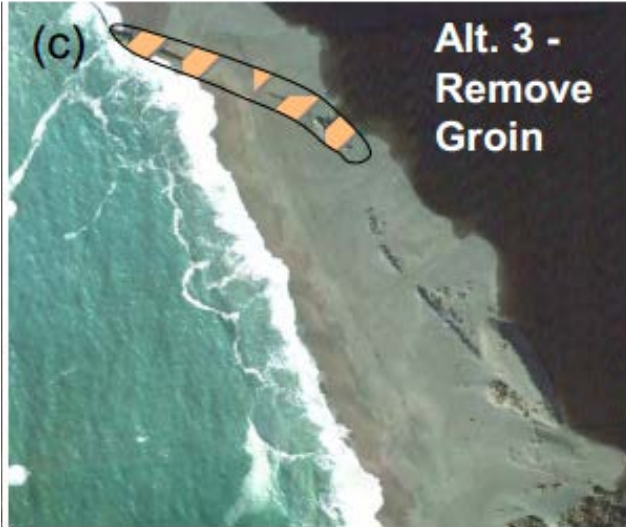
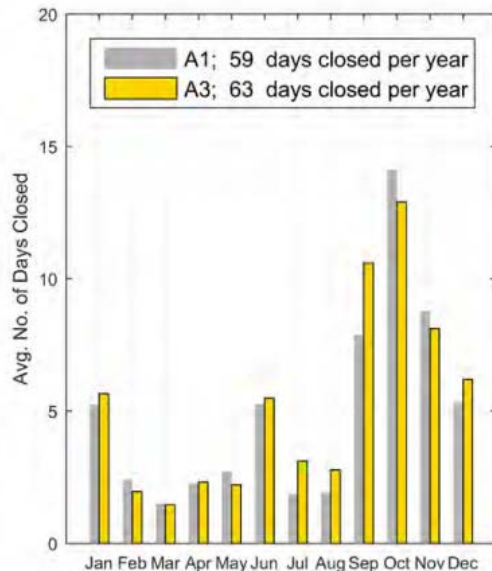
Alternative 3 – Remove Groin

- Some increase in seepage (~20%)
- No change in wave overwash
- May increase inlet migration south of groin by up to 400 ft
- Similar closure, water levels, and beach management as current conditions
- Larger traffic and access impacts during construction
- Estimated cost: \$15.3M
- Alt 3a – Degrade in Place
 - Leaves groin materials dispersed on the beach
 - Estimated costs: \$2.1M

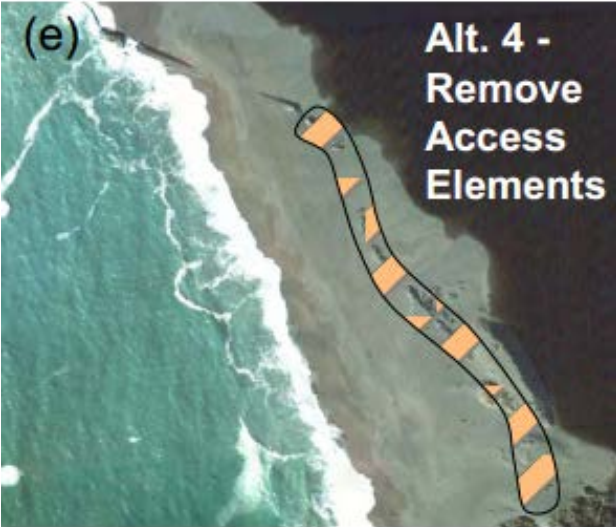
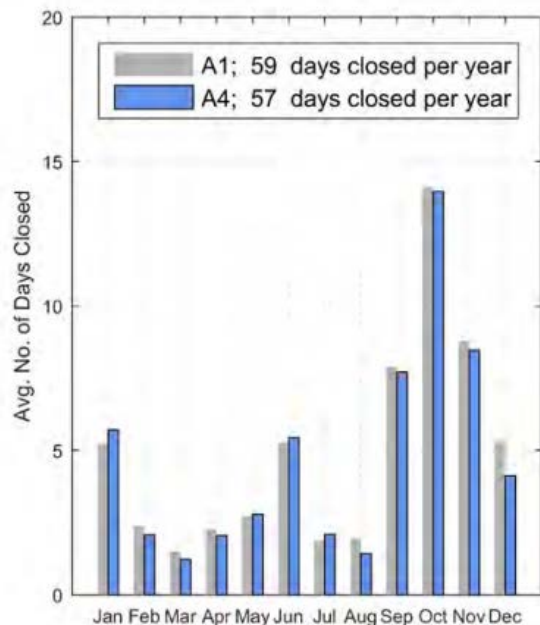
Alternative 4 – Remove Access Elements

- Larger increase in seepage (~40%)
- Larger increase in wave overwash
- Likely to maintain inlet north of groin
- Similar closure, water levels, and beach management as current conditions
- Moderate traffic and access impacts during construction
- Estimated cost: \$3.9M

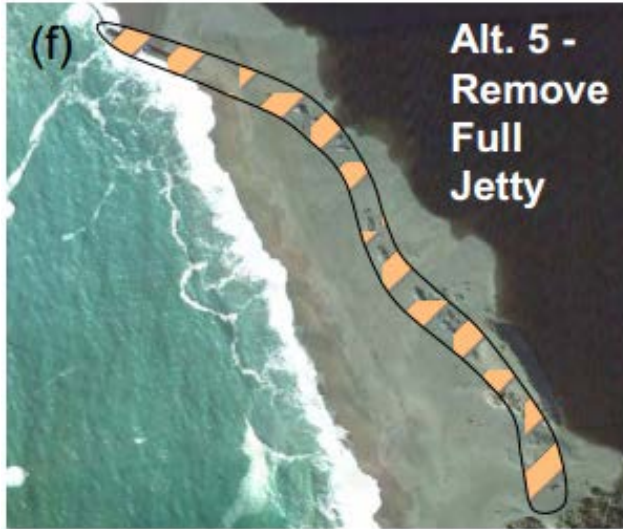
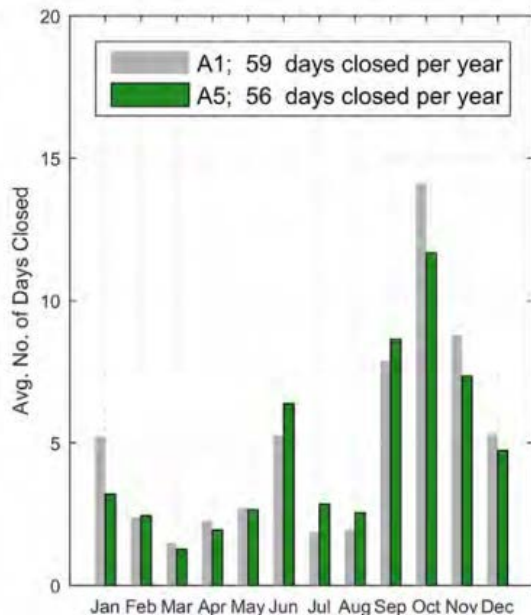
Alternative 5 – Remove Full Jetty

- Largest increase in seepage (~60%)
- Largest increase in wave overwash
- May increase inlet migration by up to 1,000 ft
- Similar closure, water levels, and beach management as current conditions
- Largest traffic and access impacts during construction
- Estimated cost: \$18.1M
