## **Current Conditions Inventory Report**

### **Dry Creek: Warm Springs Dam to Russian River**

**Sonoma County, CA**

**December 2, 2010**

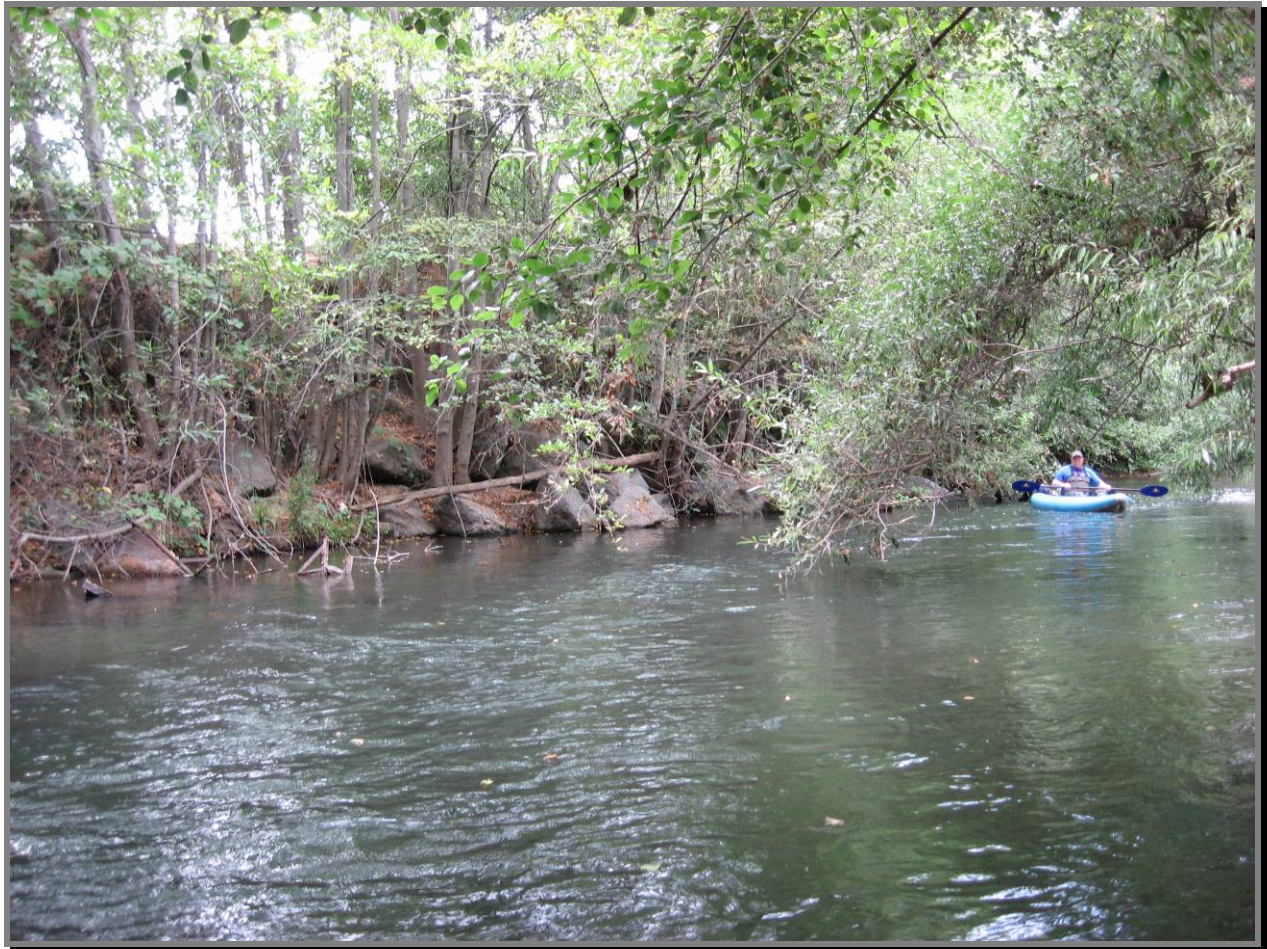
Photograph 3: Historic bank stabilization site.

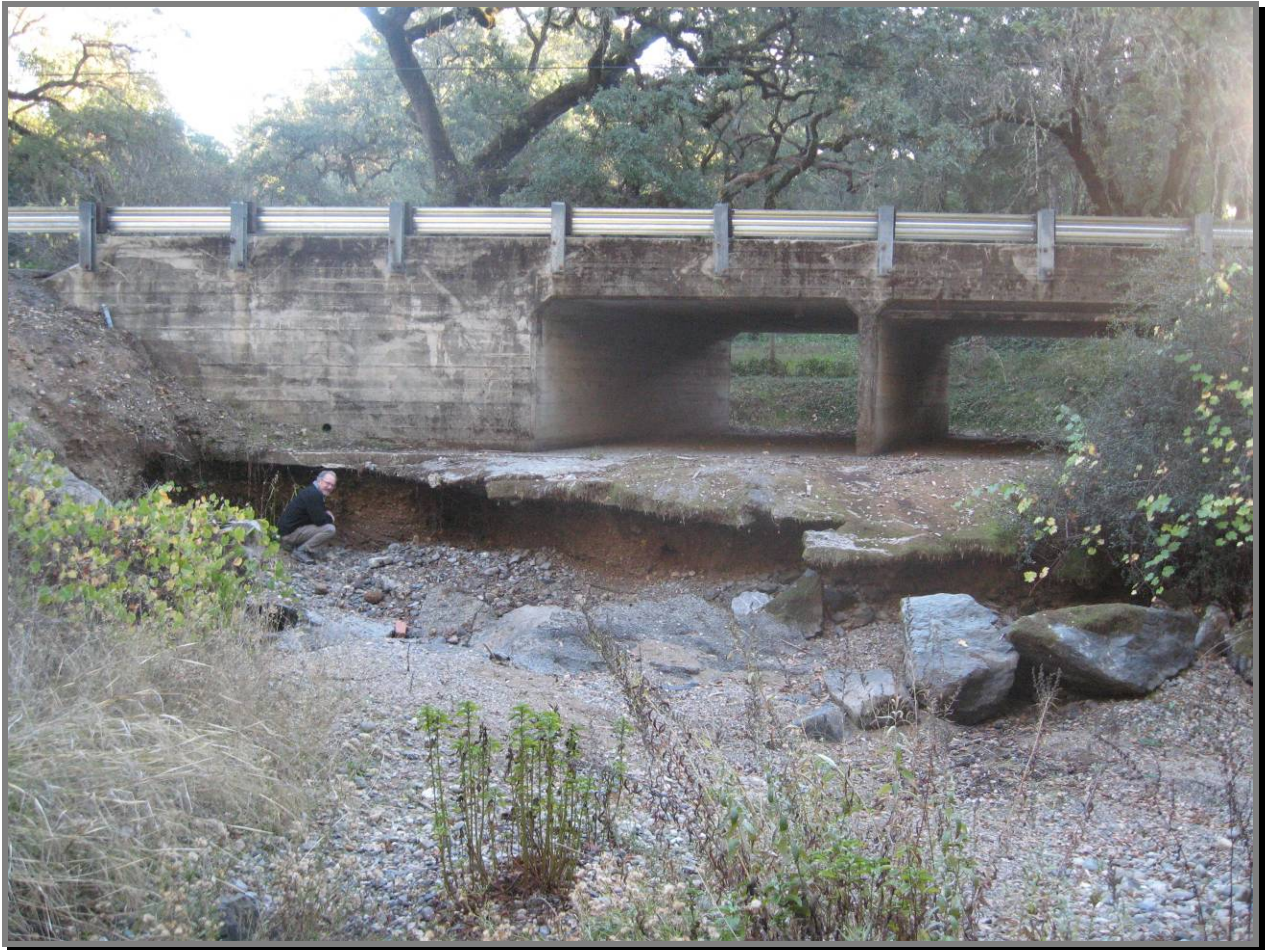
The reduction in bed material supply is moderated by successive tributaries entering Dry Creek. The most significant of these in terms of bed material supply include Dutcher Creek (RM 11.8; Photograph 4), Pena Creek (RM 11), Crane Creek (RM 6.3) and Mill Creek (RM 0.6), based on observations of bed material size, angularity and mineralogy near the respective confluences (Photograph 5). Pena, Crane and Mill Creeks all enter Dry Creek from the West, with headwaters in relatively steep topography in Franciscan Formation geology. Pena and Mill Creeks are the two largest tributaries to Dry Creek, each with watershed area of 22 sq. mi., representing nearly 10% of total Dry Creek drainage area (230 sq. mi.) each.

Photograph 4: Evidence of stream bed incision in Dutcher Creek, below the Dutcher Creek Road Bridge.

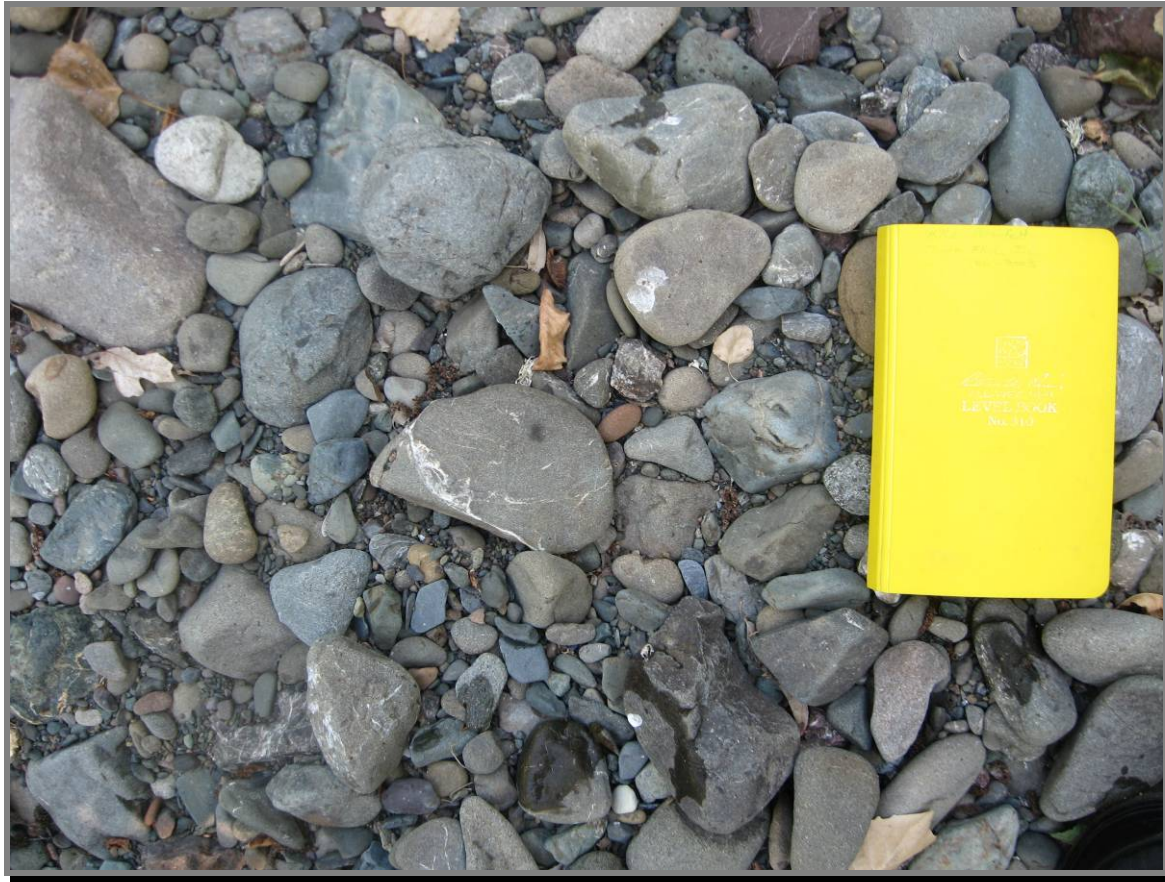
Photograph 5: Gravel deposit at Pena Creek confluence.

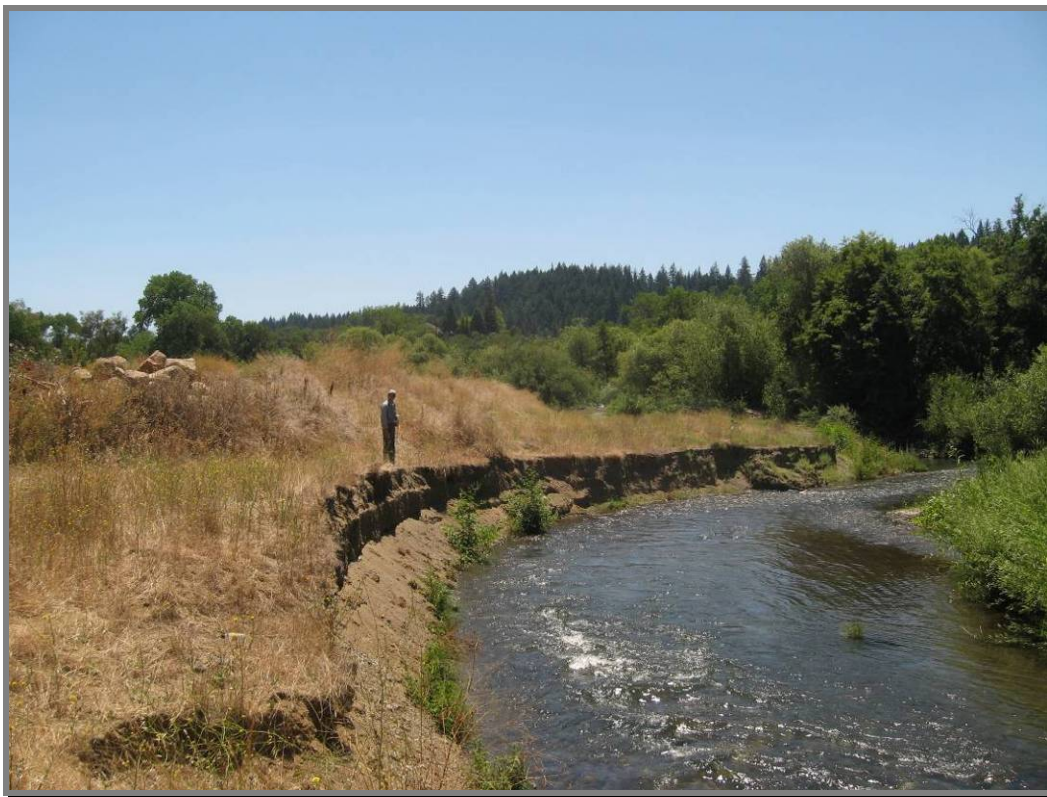
The stream section between Pena Creek and Westside Bridge (RM 11 to RM 2; Reaches 11 to 3) did not appear to be actively incising or aggrading, though there are areas of active channel adjustment (Photograph 6). In this section, a bedrock outcrop provides bed grade control at Lambert Bridge (RM 6.6; Photograph 7), and three grouted rock grade control sills (Photograph 8) located between RM 3.8 and 3.2 provide bed grade control for the stream. The stream section between Westside Bridge and the confluence (Reaches 2 to 1) appeared to be the most alluvial section, in which the channel position and shape are most readily shaped by fluvial forces (Photograph 9). Some signs of aggradation were observed in this section, with the influence of backwater from the Russian River during floods clearly visible from Mill Creek downstream to the confluence (Photograph 10).

Photograph 6: Active channel meandering into relic terrace deposit at RM 6.4.

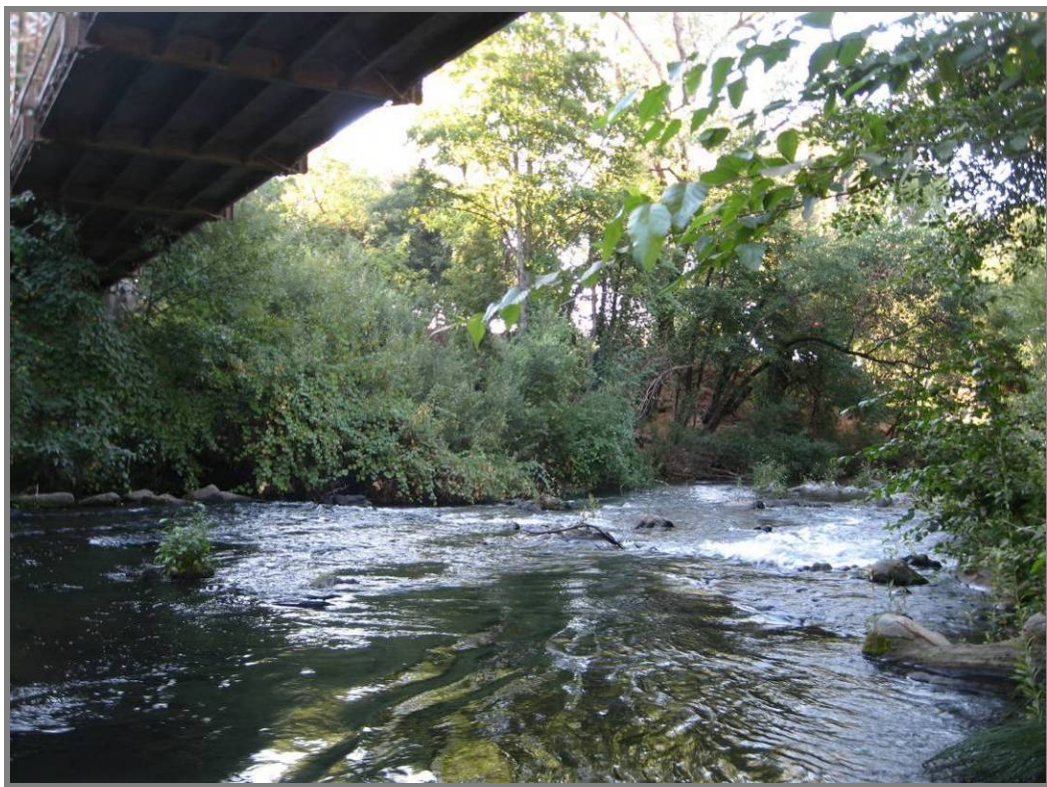
Photograph 7: Bedrock outcrop beneath Lambert Bridge, RM 6.6.

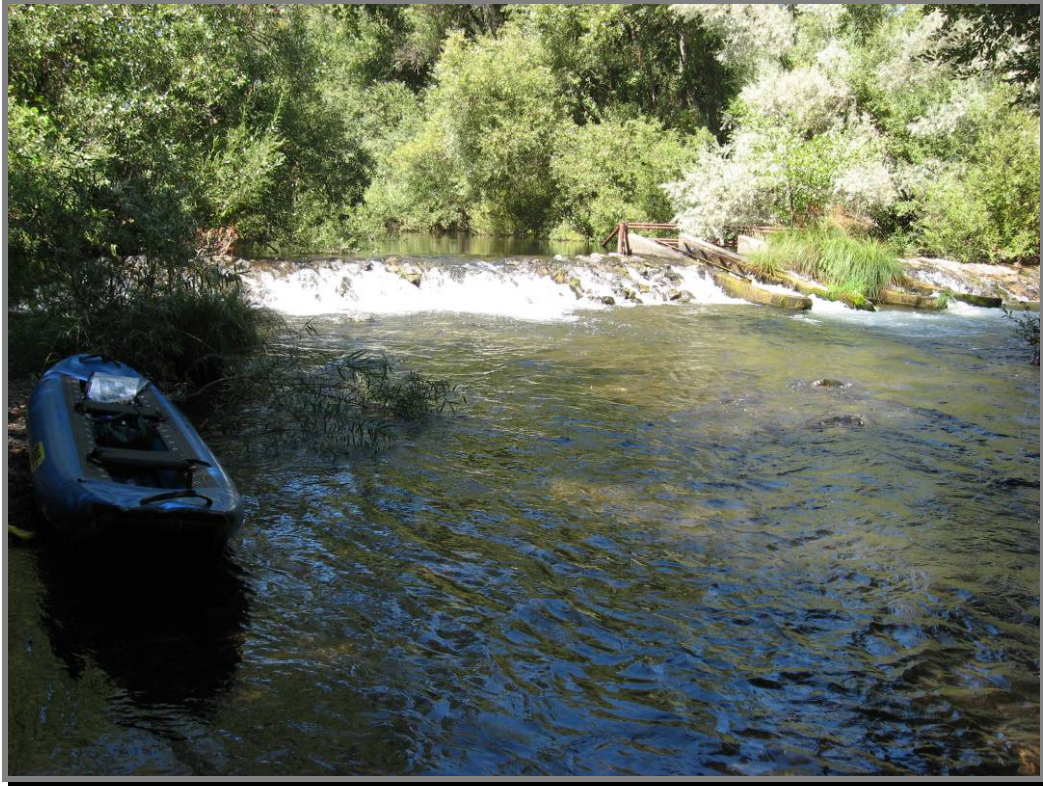
Photograph 8: Grade control sill, with fish ladder at top right, RM 3.2.

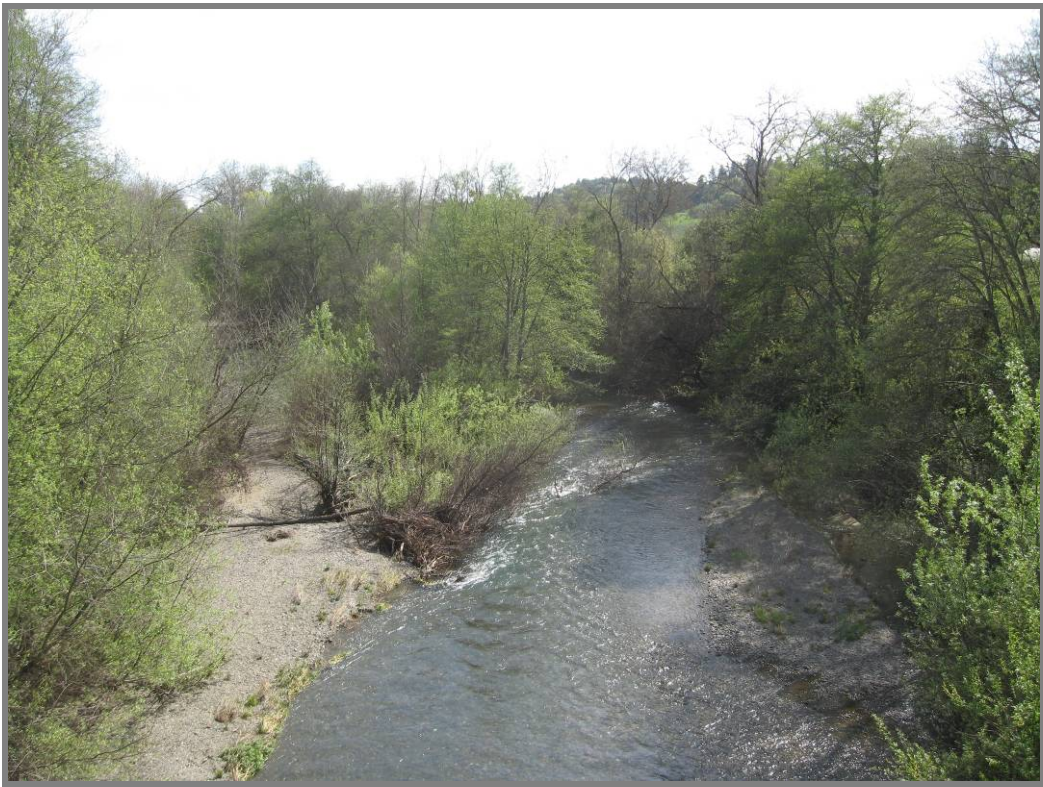
Photograph 9: View looking downstream from Westside Bridge, RM 2.

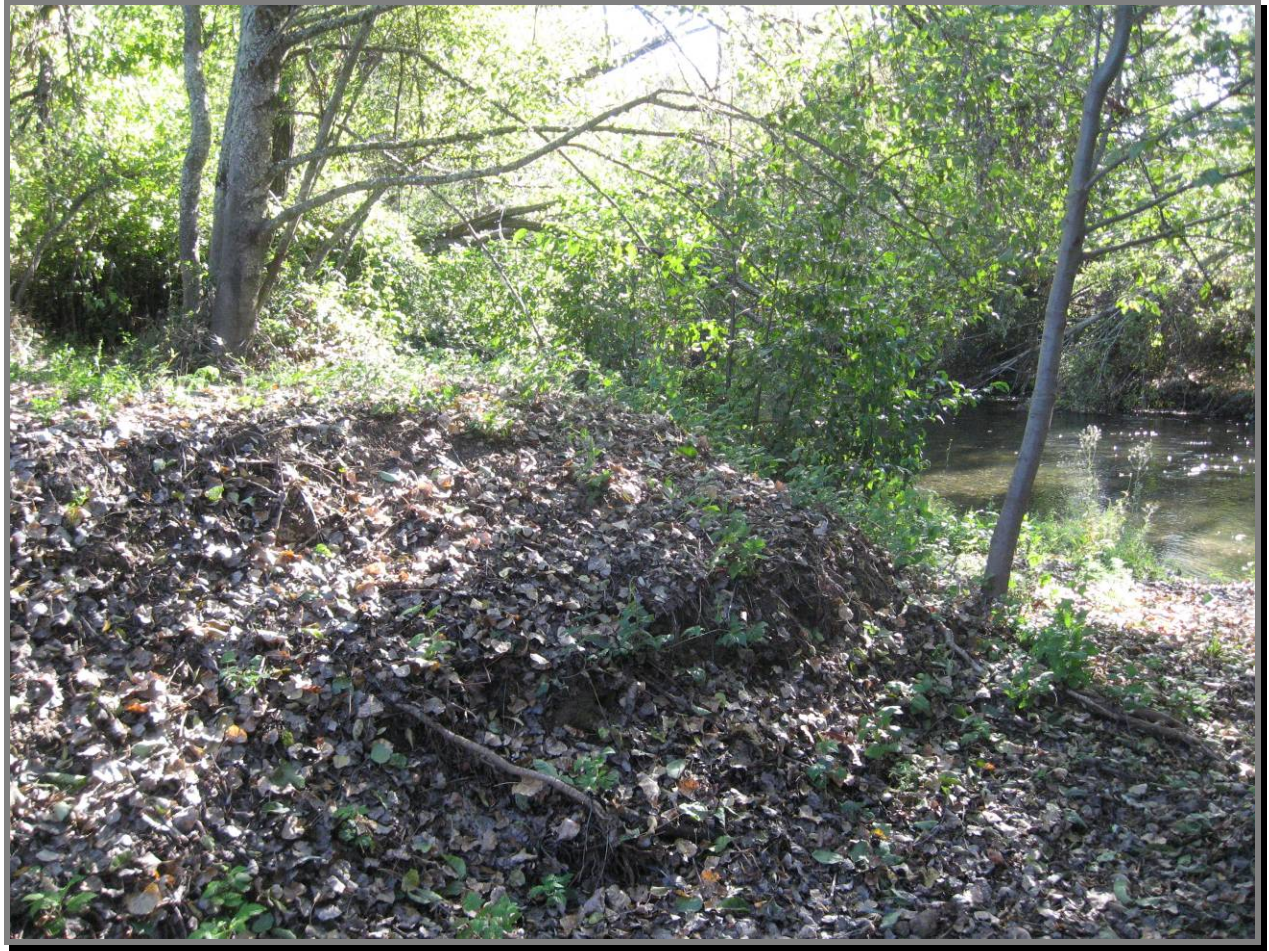
The hydrologic regime influences the geomorphology of lower Dry Creek. Regulation has resulted in elevated summer baseflow conditions that when combined with the Mediterranean climate produces near ideal conditions for growth of riparian trees and shrubs. Regulation has also resulted in severe curtailment of major floods, which limits disturbance and removal of newly recruited and established vegetation. The estimated highest maximum peak flow release from the dam (6000 cfs) is less than a 1-year flood for the unregulated period. In the reach, even-aged stands of alder trees dating to various eras (confirmed through selected tree coring) mark the elevations of terraces and bar surfaces that were abandoned or active at the time of dam closure (Photograph 11).

Photograph 11: Riparian trees date alluvial features at RM 10.3 near confluence of Canyon Road Creek. The larger tree at left on terrace dated to 1984-86. The smaller tree at right dated to 1995-97.

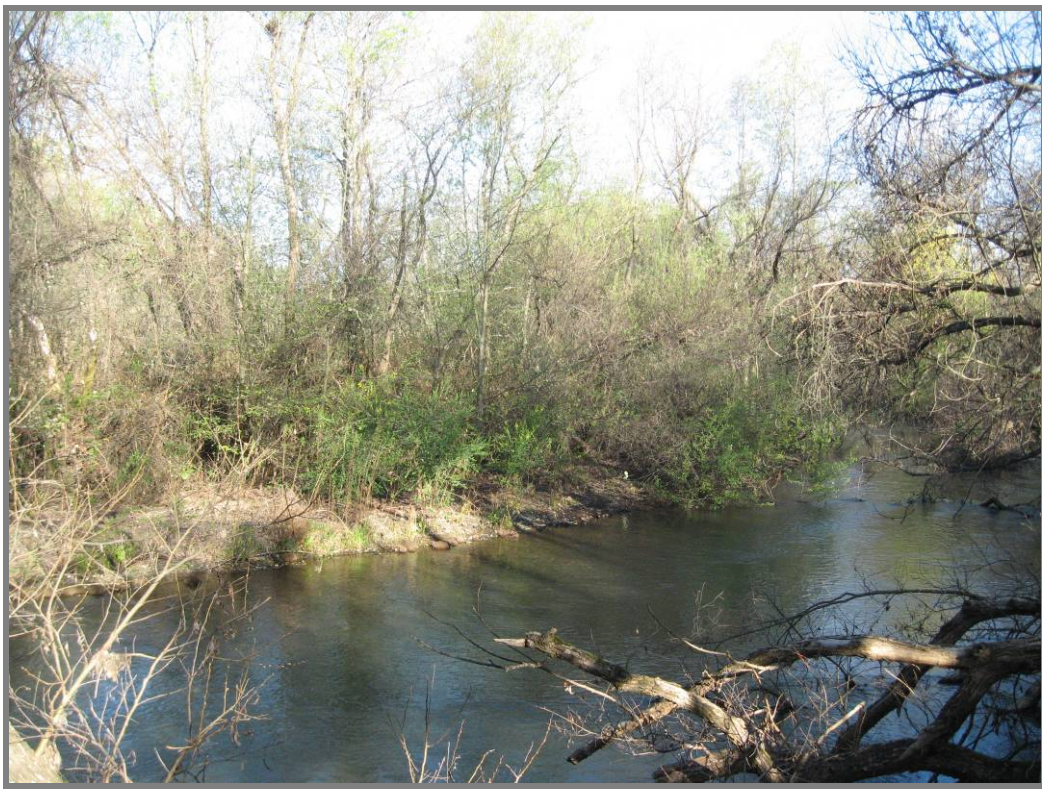
This combination of effects has resulted in extensive vegetative colonization of formerly active bar surfaces – elevated baseflow nurtures vegetative growth, while the lack of significant disturbance (flood) flows allows vegetation to flourish. Vegetative colonization of the bar surfaces has stabilized the formerly active morphologic features (Photograph 12), which serves to limit lateral migration of the active channel within the channel corridor, and has the effect of sequestering a reservoir of gravel within the system. The expansion of riparian vegetation within the system has also likely led to greater stabilization of channel corridor banks that were frequently destabilized during the period of adjustment to historic channel incision previously discussed. Areas of bank instability which are exceptions to this can be found in the reach and are consistent with what occurred historically before vegetation became a more dominant geomorphic influence (Photograph 13).

Photograph 12: Vegetative colonization of bar surface, RM 12.3

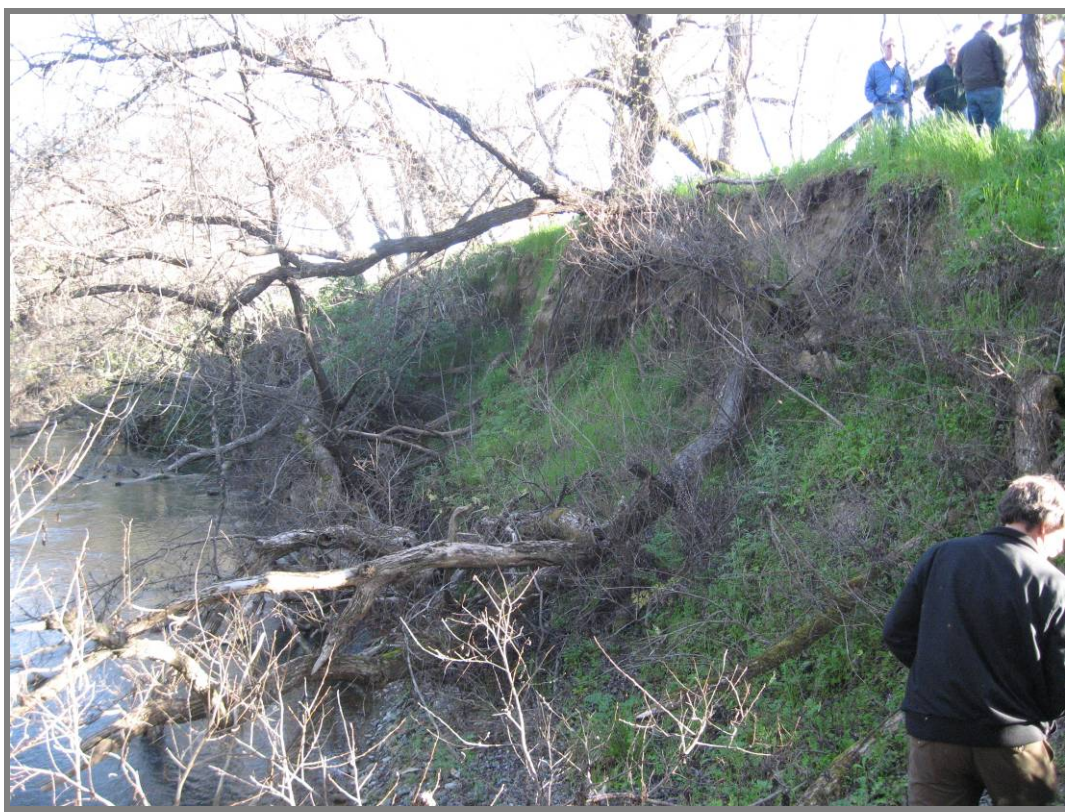
Photograph 13: Slumped high bank at RM 12.3.

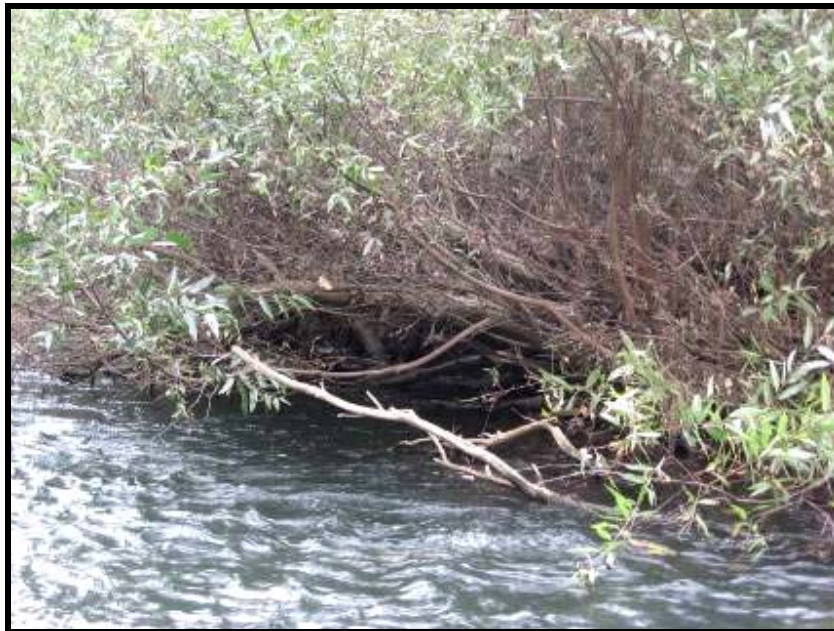
Photograph 14: Overhanging willows and other vegetation providing cover.

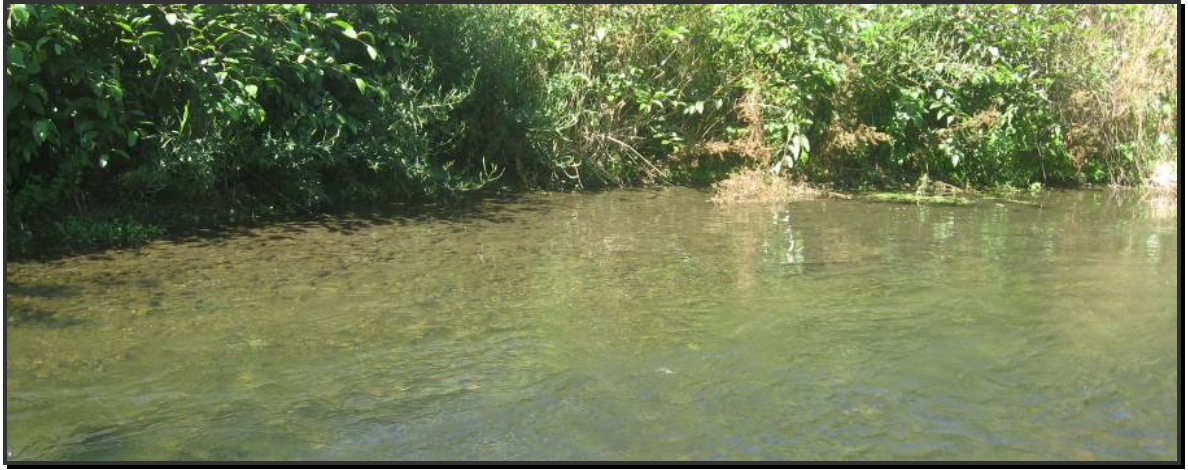
Photograph 15: Example of shallow “Edge” habitat in Reach 7.

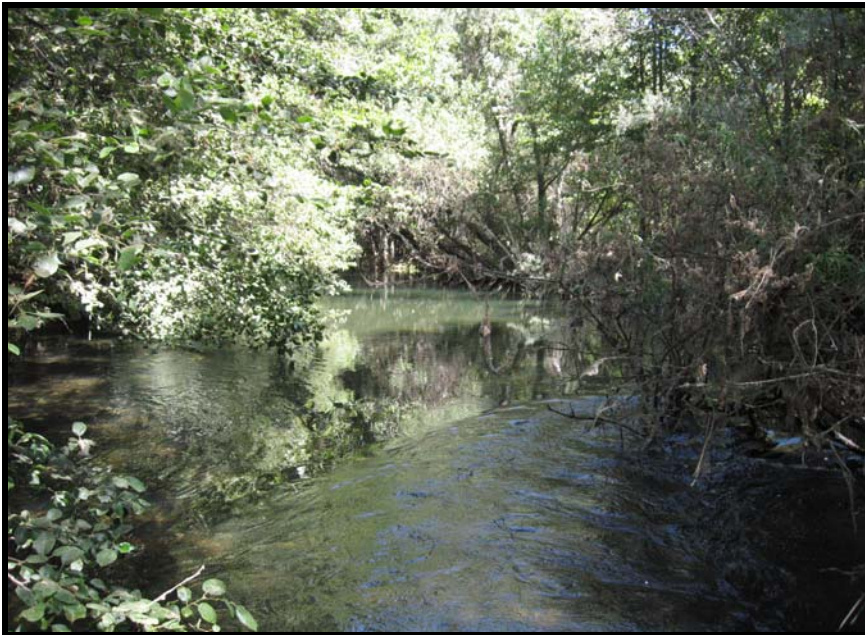
Photograph 17: Dry Creek's riparian forest.

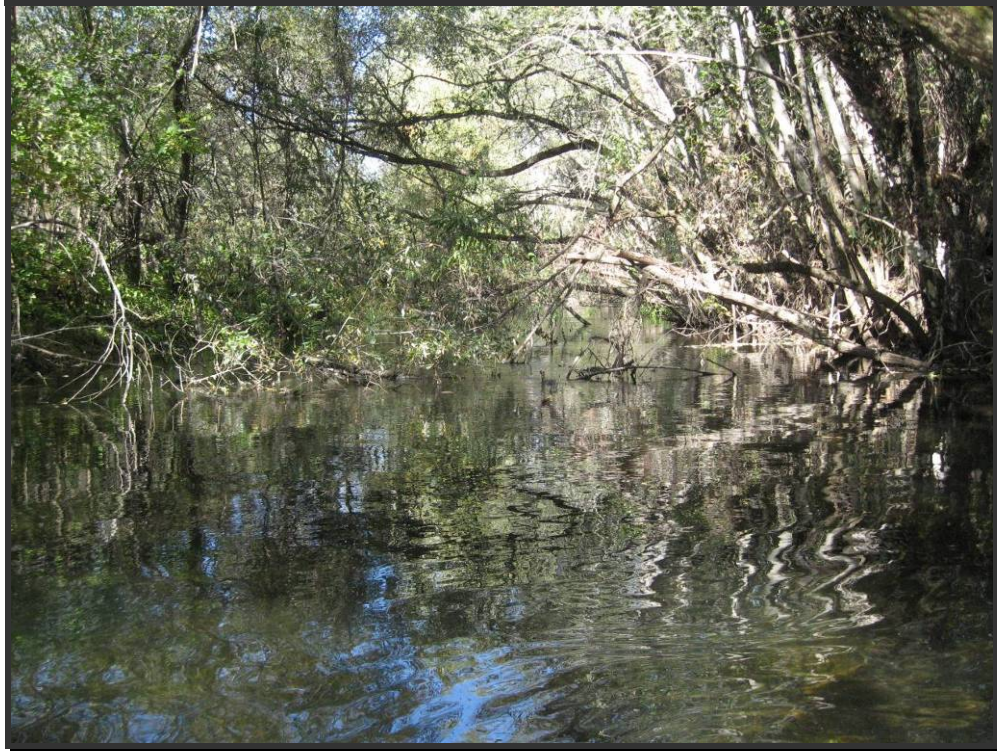
Photograph 19: Potential backwater channel / side channel analog site on Dry Creek upstream of Westside Bridge, RM 2.2. Additional large woody debris would be included in proposed designs of similar habitat.

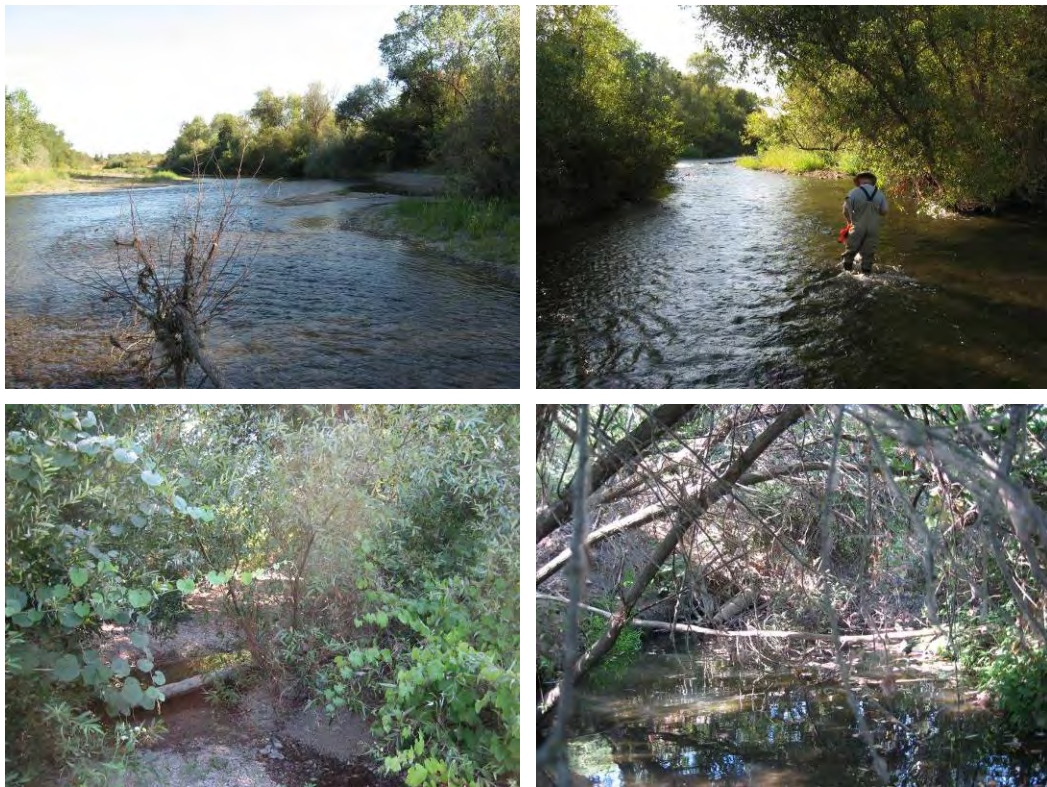
Figure 1: (upper left) looking down the Russian River at the Dry Creek confluence, (upper right) looking up the mouth of Dry Creek, (lower left) the mouth of Mill Creek, and (lower right) the mouth of the unnamed tributary.

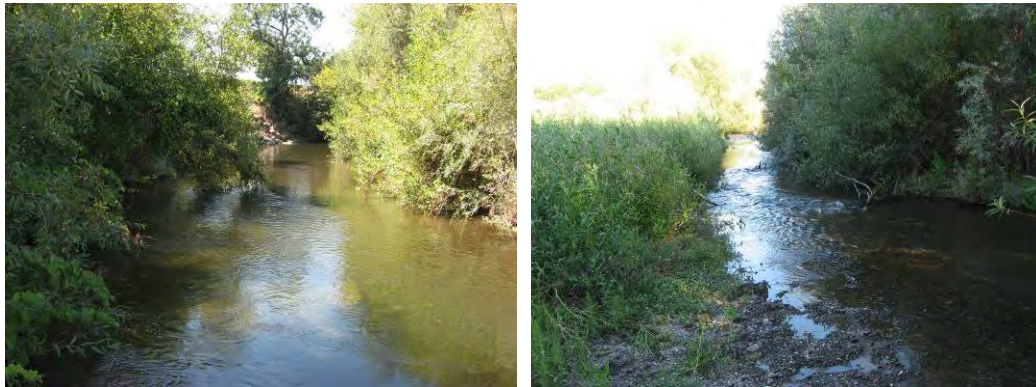
Figure 4: (left) A typical pool in Reach 1 with overhanging vegetation, (right) the 150', glide-dominated side-channel.

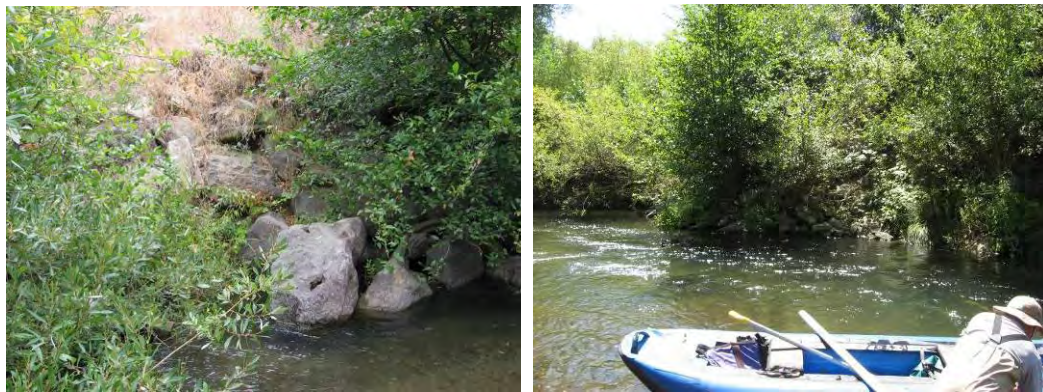
Figure 7: (left) Boulder riprap along streambanks, (right) a pool with riprap along the right bank.

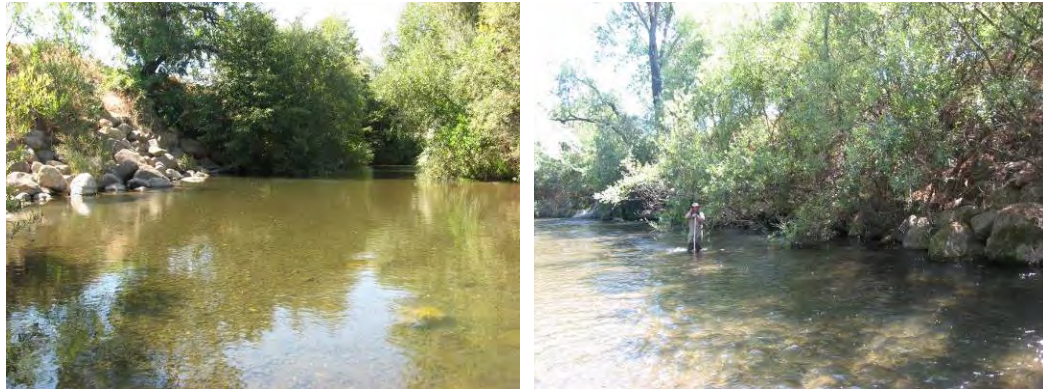
Figure 9: Glide habitat units in Reach 2, with riprap along the banks.

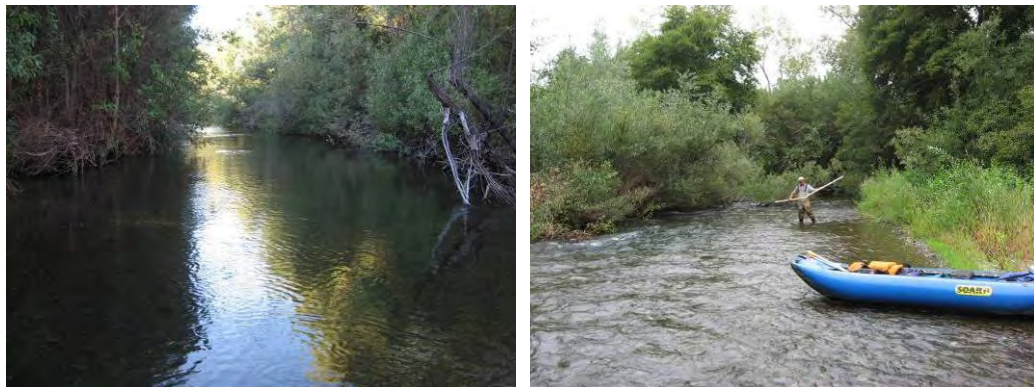
Degradation has likely not occurred in Reach 3 since the dam was built and there may be some aggradation. There are extensive gravel bar deposits and some alders were observed to be slightly buried or closer to the water surface. During flood flows, bedload may be transported and deposited in large volumes, leading to the higher degree of channel change and lateral instability in this reach.

Figure 13: (left) a typical pool in Reach 3, (right) one of the three riffles in Reach 3.

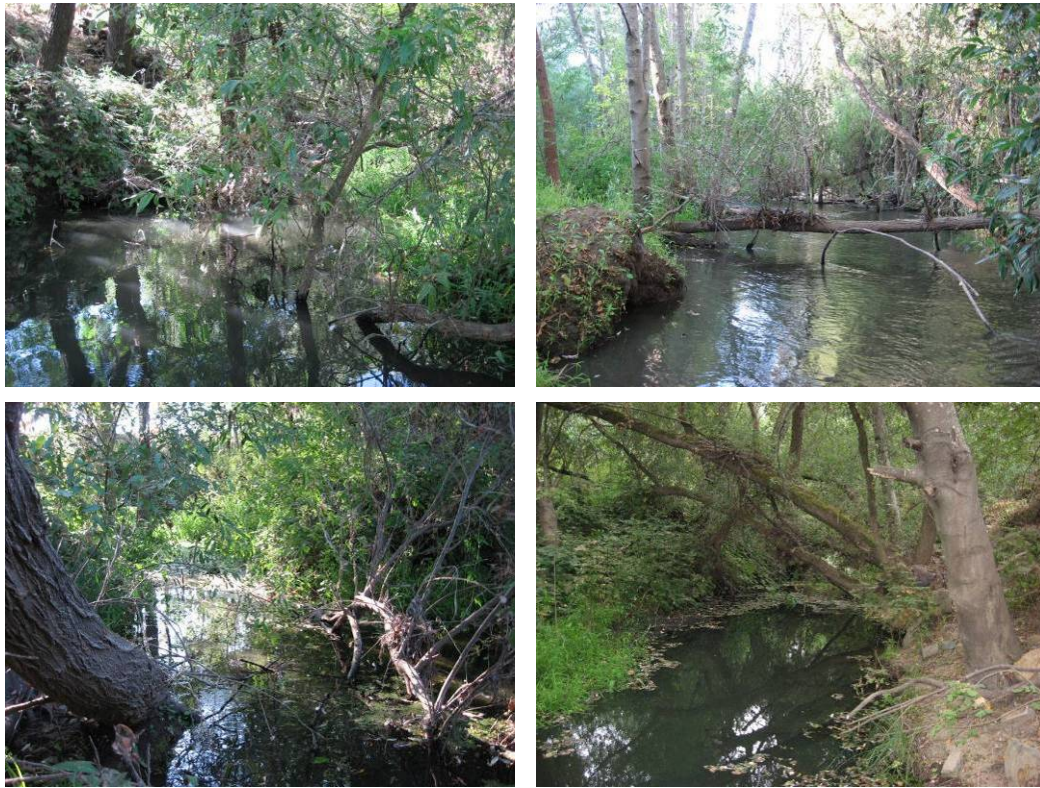
In the eight side channels, most of the substrate was fine sediment and sand, with some gravel. Seven out of the eight side channels were pool-dominated, with one flatwater-dominated. Maximum depths in pool-dominated side-channels averaged 2.9 feet, with only one over three feet deep. The flatwater-dominated side channel was 0.8 feet deep on average. There was one long side-channel on left side that extends for a few hundred feet with pools and flatwaters, woody debris and other cover. This side-channel is deep

(~3.5') and wide (~30') and abuts the terrace wall. A smaller side channel and alcove on the channel right side provides additional habitat.

Figure 17: (top row) side-channel habitat units, (bottom row) alcoves in Reach 3.

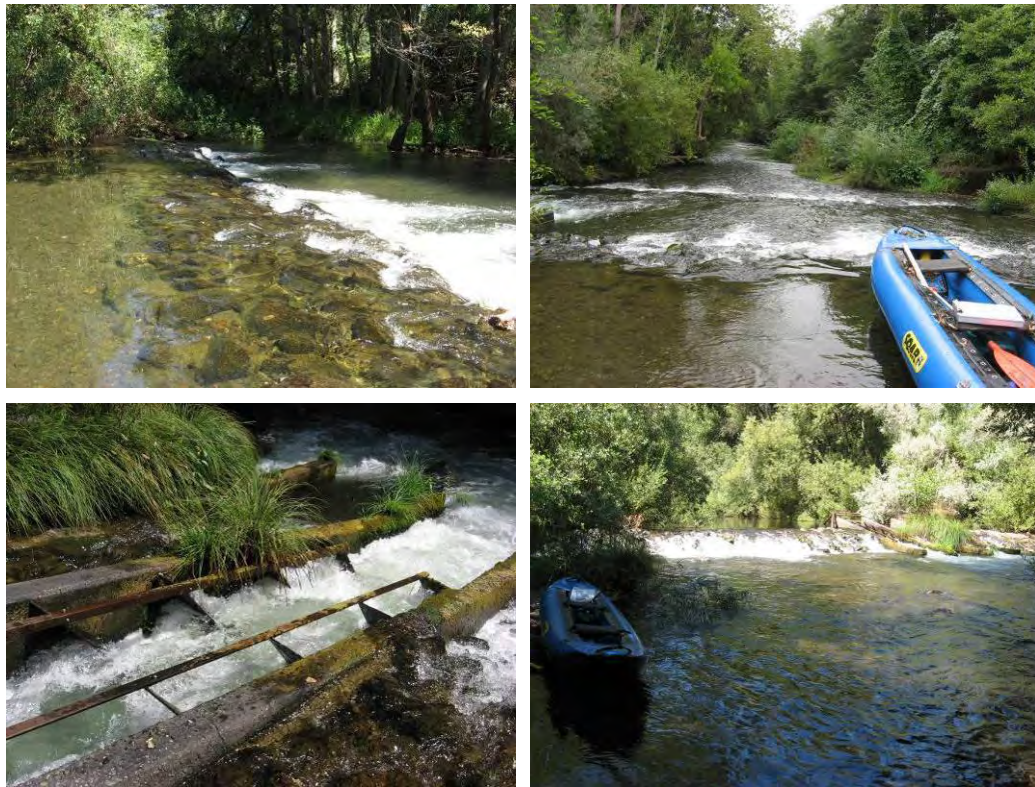
Three gradient sills were constructed in 1983 by the ACOE to slow migrating nick points and associated channel incision in lower Dry Creek. This reach is vertically stable due to the check dams. The backwatered pools created by each sill extended several hundred feet upstream, forming a pool-dominated reach. The upper sill (RM 3.8) consisted of a cascade down two sets of boulder falls, 2' and 1' in height. The middle sill (RM 3.5) was 200' long, 10' wide, and 3' in height. The lower sill (RM 3.3) was 100' long, 10' wide, and 1 foot tall. Each sill has a fish ladder to provide passage through the short cascades. Rock riprap covers the right bank between the upper and middle sill, and short sections of boulder riprap cover both banks upstream and downstream of each sill. An unnamed tributary enters Dry Creek just downstream of the lower sill at river mile 3.25.

Figure 18: (upper left) lower sill, (upper right) upper sill, (lower left) ladder on middle sill, (lower right) middle sill.

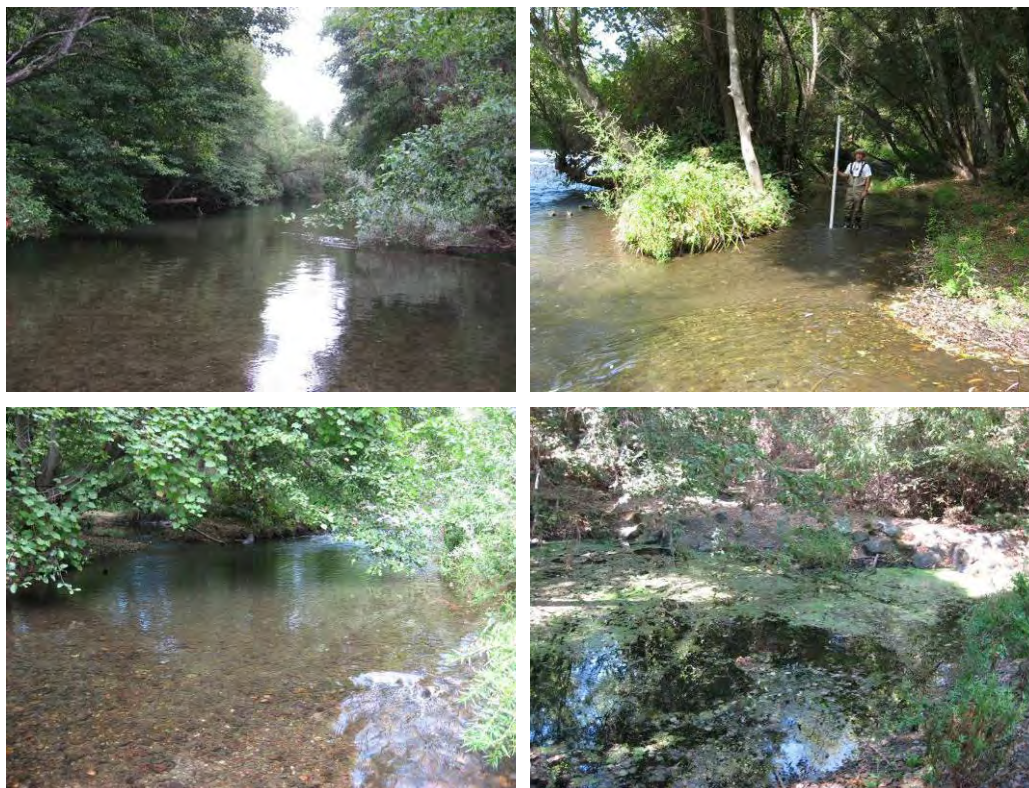
Figure 22: (upper left) long pool above upper sill, (upper right) alcove off upper sill, (lower left) side-channel habitat, (lower right) aquatic vegetation in alcove near middle sill.

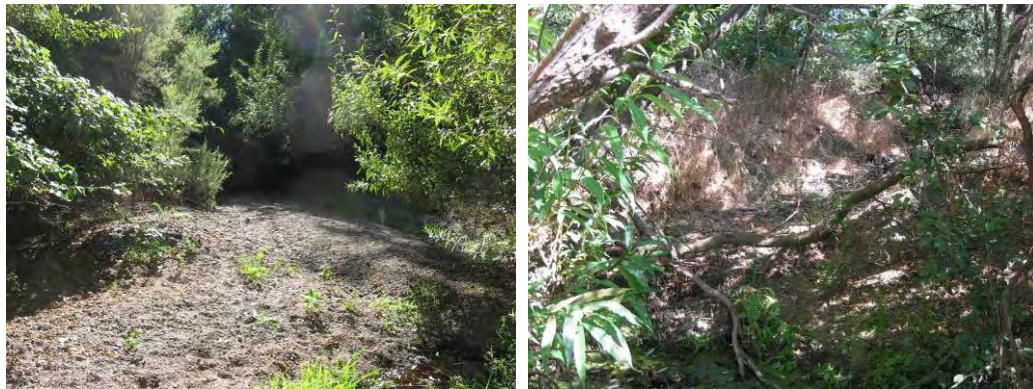
Figure 23: (left) mouth of Kelley Creek, (right) mouth of unnamed tributary.

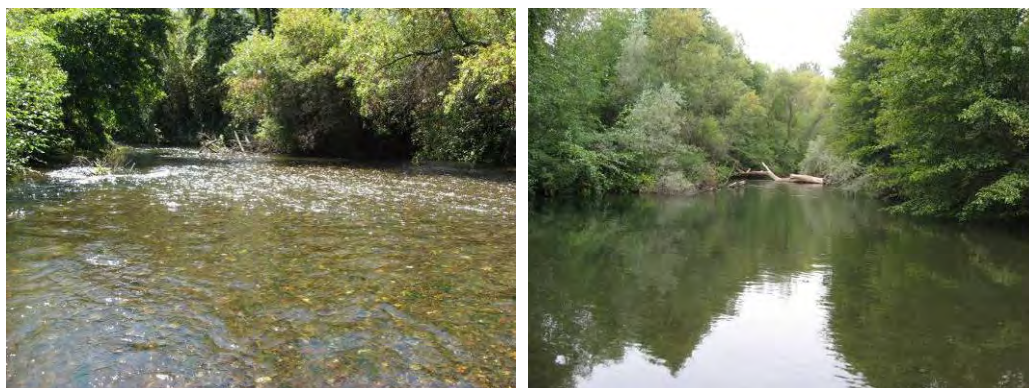
Figure 28: (left) riffle habitat unit, (right) long, deep pool with woody debris.

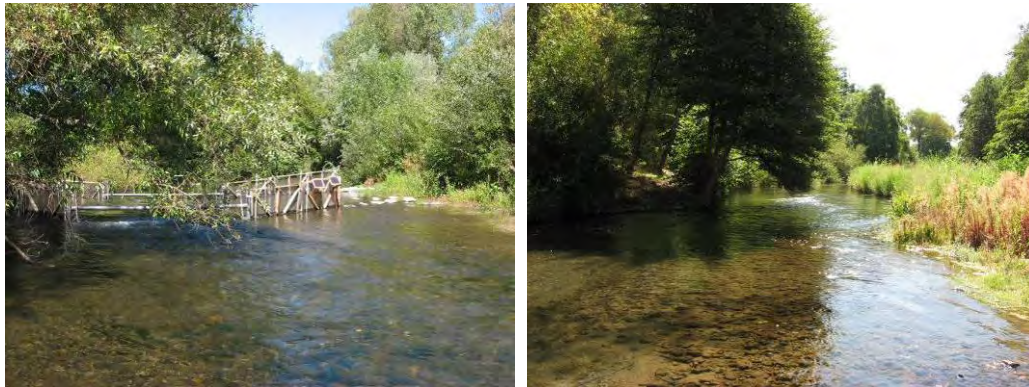
A PIT tag antenna was located in the middle of the reach at the time of the survey (Figure 29). Car bodies and riprap were observed for 500 feet along the streambanks at the downstream end of the reach. The upstream end of this reach terminates at the first visible expression of bedrock in the channel.

Figure 29: (left) adult fish monitoring station, (right) scour pool.

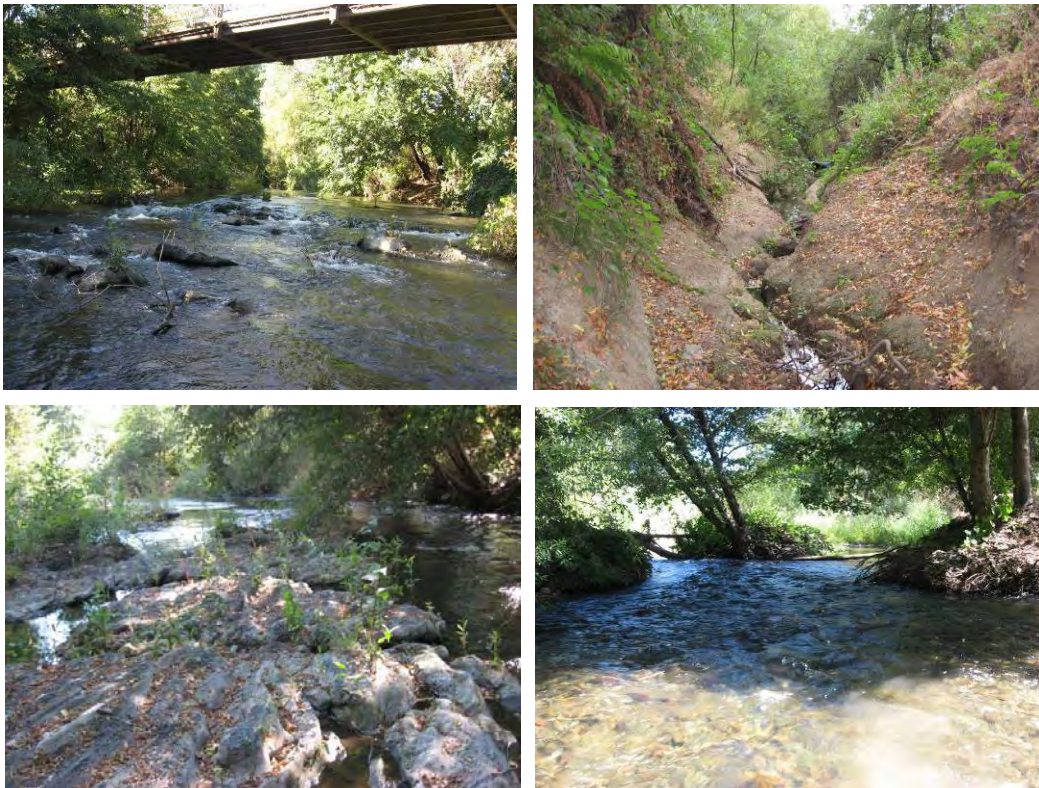
Figure 33: (upper left) cascade under Lambert Bridge, (upper right) mouth of Crane Creek, (lower left) bedrock outcrop, (lower right) riffle where Grape Creek enters Dry Creek.

Substantial incision has occurred through this reach, but the bedrock outcrops have limited further degradation. The most apparent bedrock outcrop is the bedrock cascade under the Lambert Bridge, but there are also outcrops at river mile 6.4 between the unnamed tributary and Crane Creek, at the mouth of Grape Creek and upstream of Grape Creek. These occasional bedrock extrusions provide cover for fish, influence pool formation, and control stream gradient. Despite the bedrock outcrops, the dominant substrate is gravel, followed by sand.

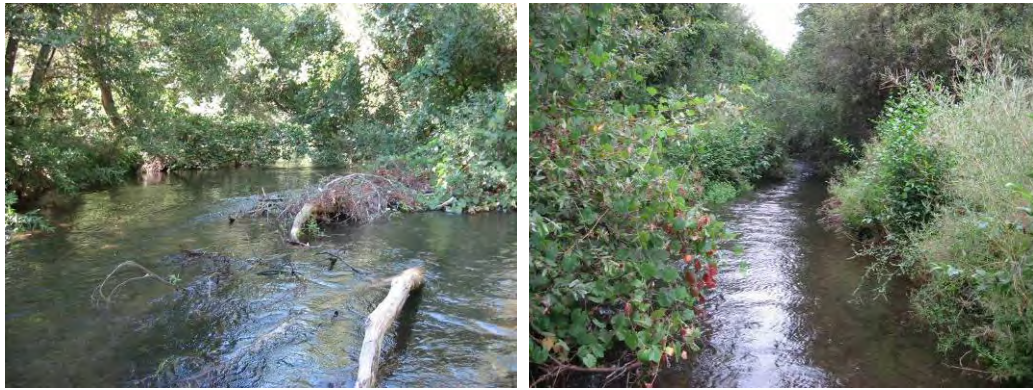
Figure 39: (left) wood associated with a scour pool, (right) side channel D183.

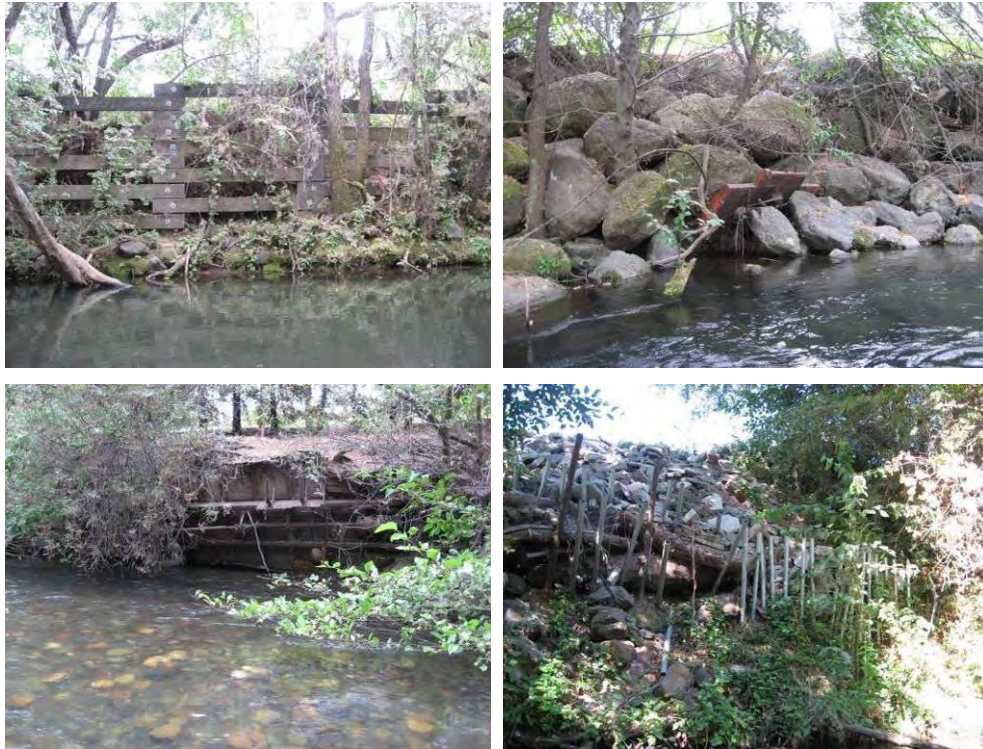
Nearly all of the various types of bank stabilization techniques applied in Dry Creek are present throughout Reach 8 (Figure 40). Approximately 2500 feet of banks are armored with large boulder riprap, some of it including car parts intermingled with the boulders and riprap. An old truckbed is used to stabilize one streambank at river mile 8.8, and a mix of metal pipes, logs, and rocks have been used to shore up another bank at river mile 7.9. Board fence lined 750 feet of the right<sup>5</sup> bank at river mile 8.5. A dry, unnamed tributary enters on the left bank at river mile 8.9.

Figure 40: Bank stabilization features. (upper left) Board Fence, (upper right) boulder riprap with car parts, (lower left) a truck bed, (lower right) metal poles with logs and rocks.
