## **Current Conditions Inventory Report**

### **Dry Creek: Warm Springs Dam to Russian River**

**Sonoma County, CA**

**December 2, 2010**

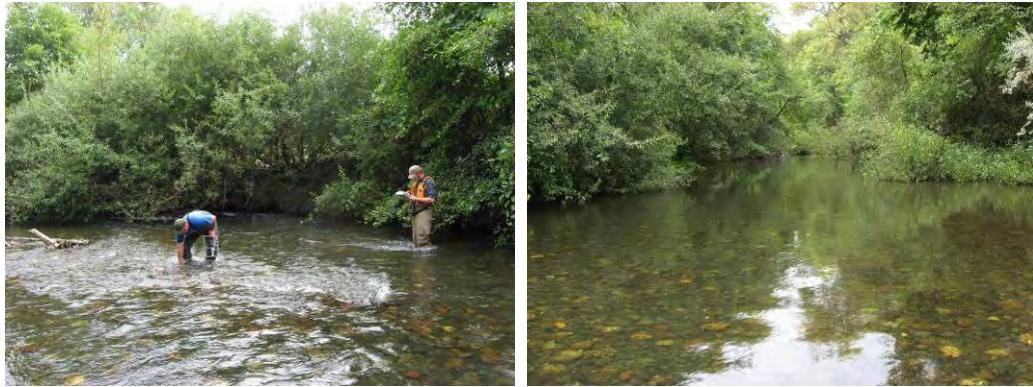
Figure 43: (left) conducting a pebble count in a riffle, (right) pool habitat in Reach 8.

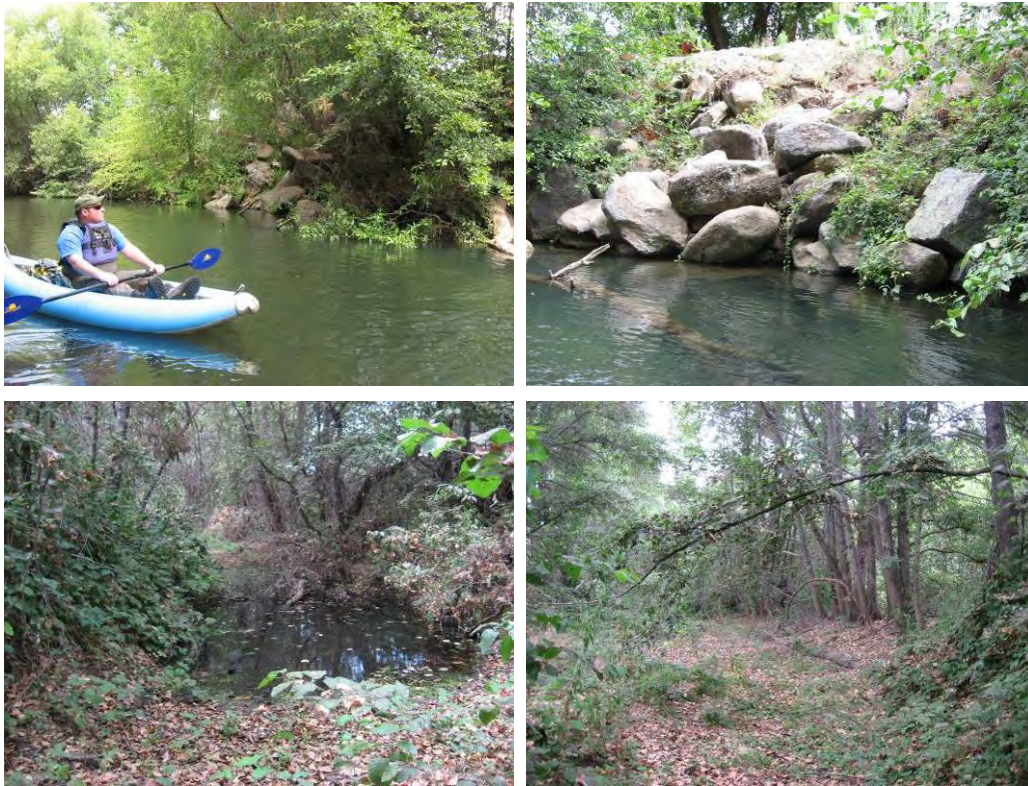
Reach 9 is a single-thread channel extending upstream to the lower extent of a long stretch of new rock riprap bank stabilization on the right<sup>6</sup> bank. The upper reach boundary is also about 800 feet downstream of where the west lineament diverges from the channel. The Dry Creek channel flows along, or close to, this lineament for about half of the length of Reach 9. There is little sinuosity in this reach and there has been little channel change since the 1940s, other than channel narrowing resulting from channel incision. In some areas, the older and wider channel bed provides opportunities for habitat enhancement. These older channel beds are elevated a few feet above the current channel bed and are often separated from the current channel by alder ‘fences’ (Figure 45), but habitat could be created with some excavation.

Figure 45: (upper row) pool habitat with riprap bank protection, (lower left) alcove habitat, (lower right) former channel along left bank, protected by a long, straight berm vegetated by even-aged alders.

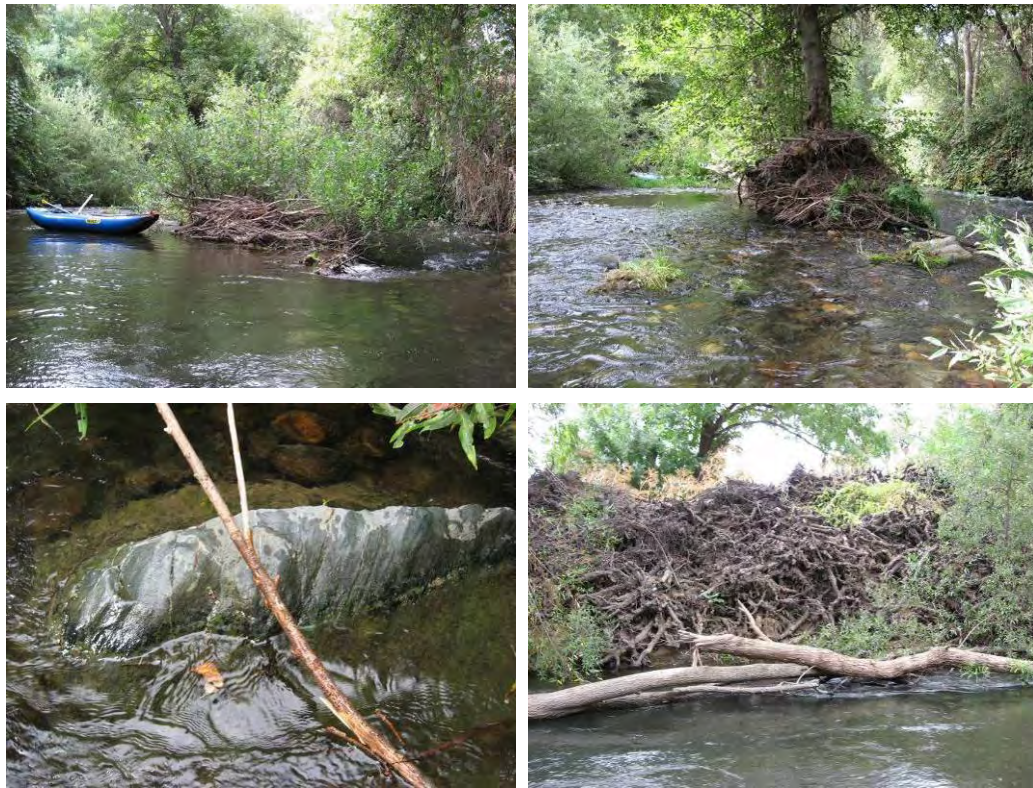
This reach contains significant length of stabilized streambank. From the start of Reach 10 at river mile 9.8, boulder riprap lines the right<sup>7</sup> bank for 0.3 miles upstream. At river mile 10.1, the tall, eroding left bank is covered with dead grapevines (Figure 49). The right bank at this site has a wide floodplain. Last, at river mile 10.3, I-beam and chainlink fence stabilization structures have been built along the left bank for 250 feet.

Figure 49: (upper row) vegetated islands in the middle of a riffle, recruiting small woody debris and creating a small scour pool, (lower left) native green boulder, (lower right) dead grapevine dump to stabilize the bank.

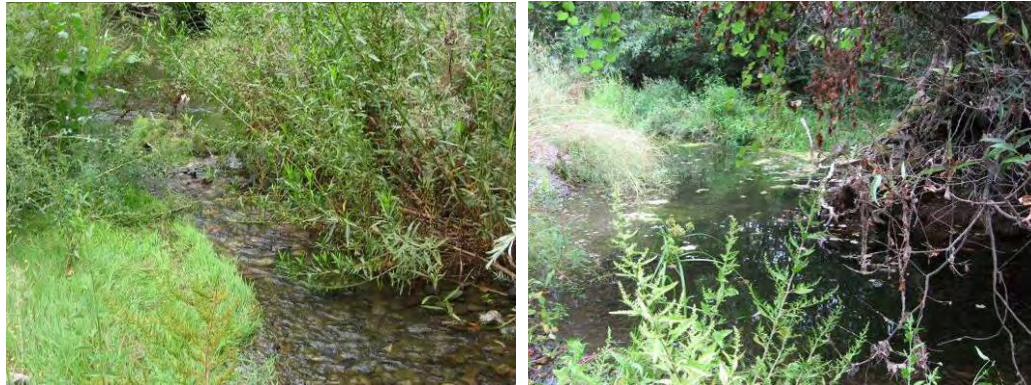
One riffle-dominated side channel in Reach 10 was measured, with a length of 70 feet, a width of 7 feet, and an average depth of 0.3 feet (Figure 53). Substrate was gravel, with small cobble.

Figure 53: (left) side channel, (right) alcove habitat.

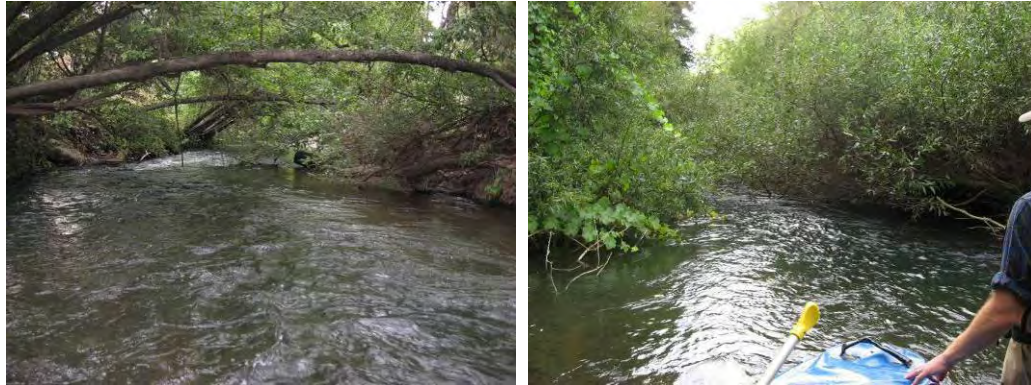
Figure 59: (left) glide habitat in Reach 11, (right) a deep pool with overhanging willows.

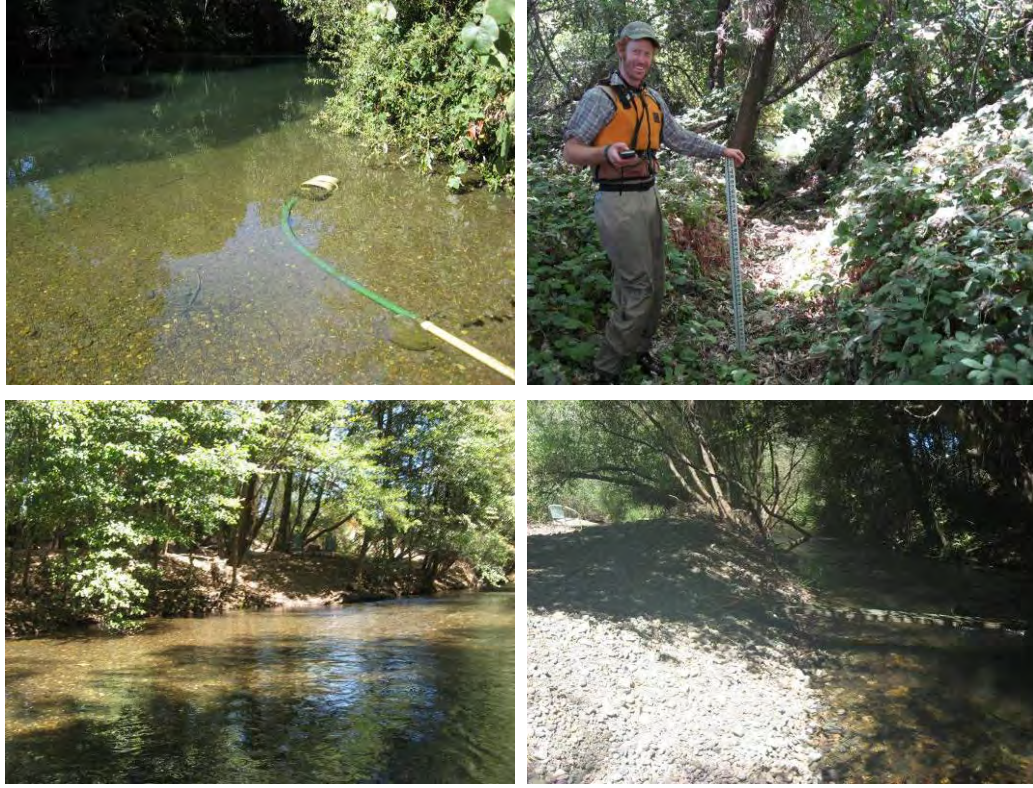
Figure 60: (upper left) pump in Dry Creek at river mile 11.75, (upper right) tributary at river mile 11.6, (lower left) straight bermed streambank along left bank, (lower right) gravel bar at river mile 11.75.

At river mile 11.65, a gravel bar forms along the left bank. Riprap bank stabilization covers the streambanks for about 800 feet throughout Reach 12. Riprap boulders have tumbled into the creek from these bank protection measures and provide some cover. A fault lineament runs along the left bank for the lower half of Reach 12.

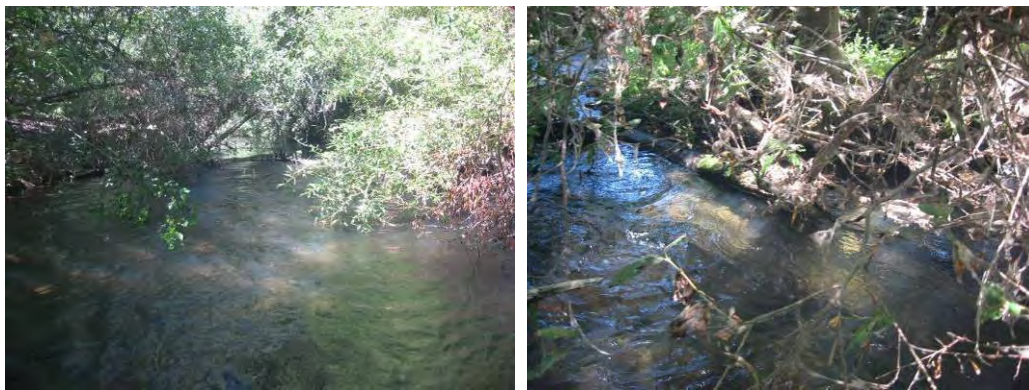
Figure 64: (left) green tunnel of riparian vegetation, (right) vegetation providing instream cover.

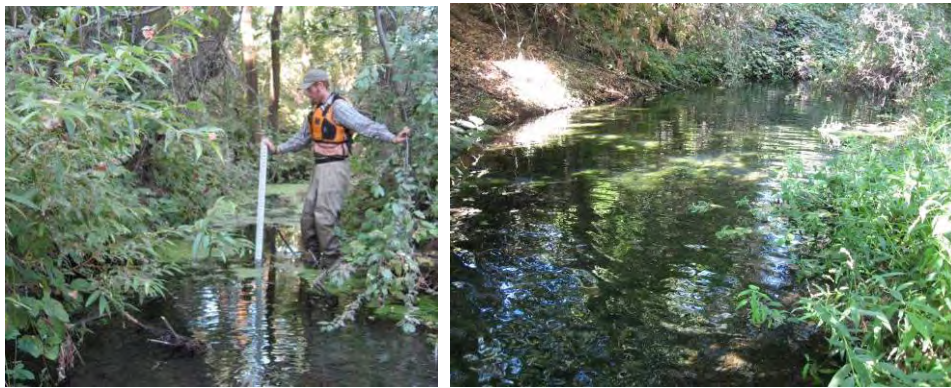
Figure 69: Alcoves in Reach 13 with abundant cover provided by aquatic vegetation.

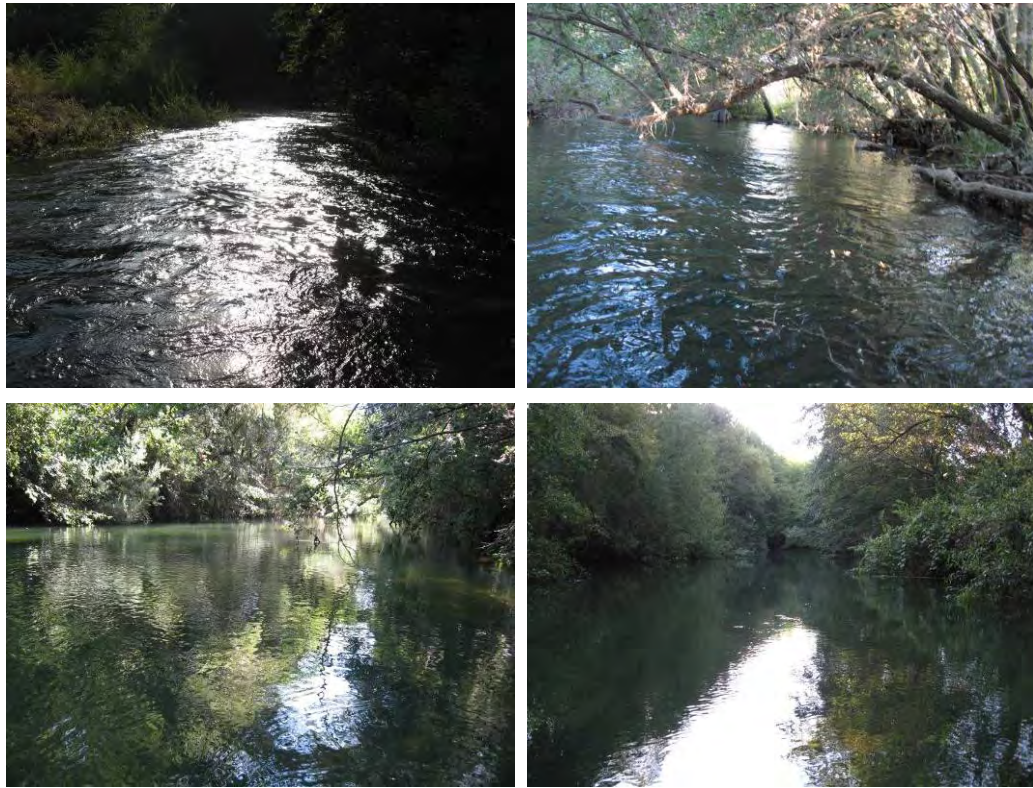
At the Bord Bridge, a boulder revetment associated with the bridge armors the right<sup>12</sup> bank. Higher on this bank, there is evidence of an older wood revetment. The high canopy cover in this reach is provided by California bay, willow, alder, and cottonwood. Himalayan blackberries and other exotics were present on both banks, but overstory vegetation dominates. An old board fence with metal mesh and cable covers part of the right bank along a pool unit. In general the banks were steeper on the right, and with a more gradual floodplain on the left bank.

Figure 74: (upper left) the riffle under Bord Bridge, (upper right) canopy cover, (lower left) deep, slow pool unit downstream, , (lower right) the long pool.

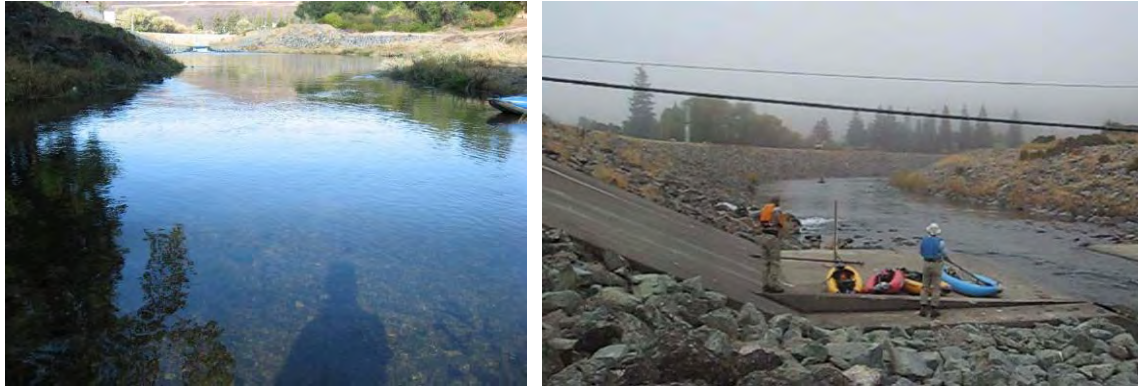
Reach 16 extends upstream from Bord Bridge to a flow measuring flume immediately below Warm Springs Dam. From the outlet of the dam, water flows through a constructed channel and over two drop structures before spilling into a deep pool (>12 feet deep) immediately upstream of the Bord bridge. Boulder revetments cover both banks within this constructed channel.

Figure 78: (left) looking upstream at the deep pool downstream of the measuring flume structure, (right) preparing to launch from the measuring flume structure.
