Herber Farm House

Building Review

July 27th, 2016

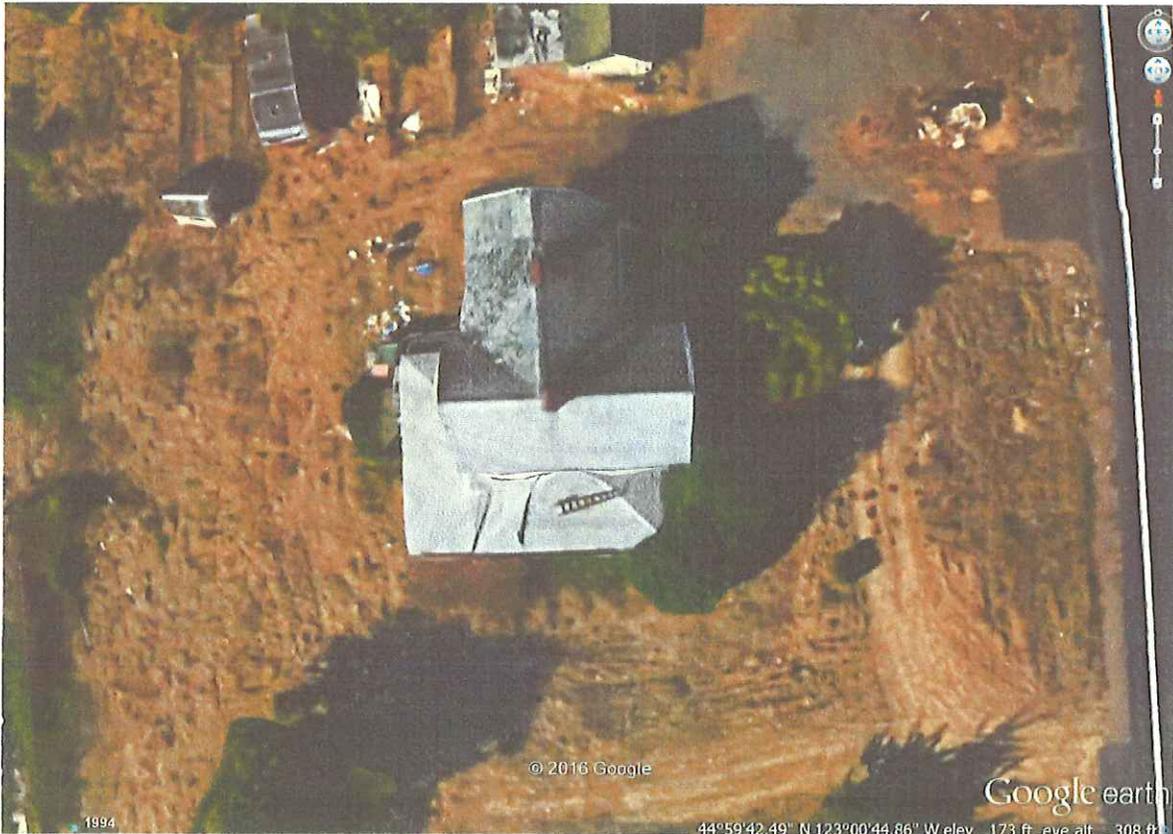
The original portion of the present house was constructed in the 1870's. Since that time, the house has had three exterior additions and several interior remodels.
