City of Dover, Delaware

Old Dover Public Library, Building Assessment Report

Date: July 2017

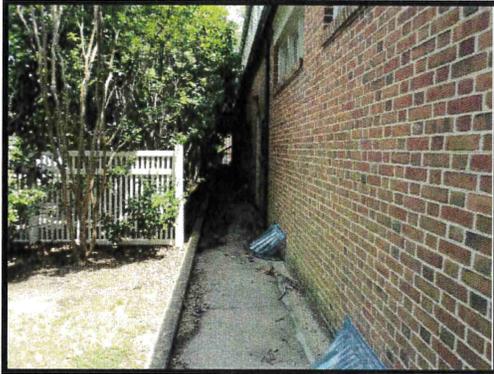
C-3
Exterior
North Elevation at Stairwell/Fire Escape Egress

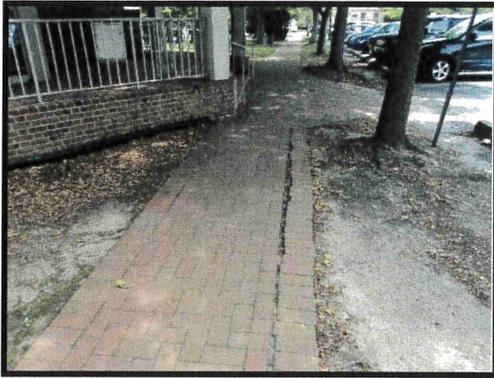
C-7
Exterior
Main Entrance, Uneven Brick Walkway

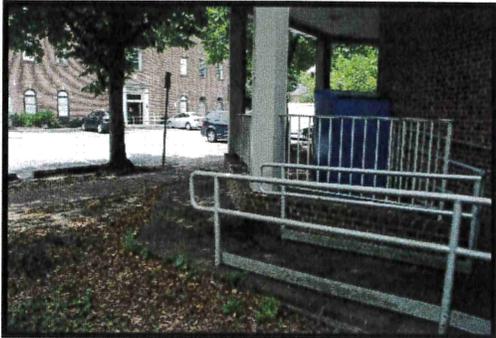
- Stair and ramps to the main entrance are in good condition. The brick stoop and stairs on the northeast side are in good condition.
- All woodwork, trim, wood windows, and doors are in fair condition and need to be prepped and painted.

D-26
Exterior
Southeast, Ramp and Stairs

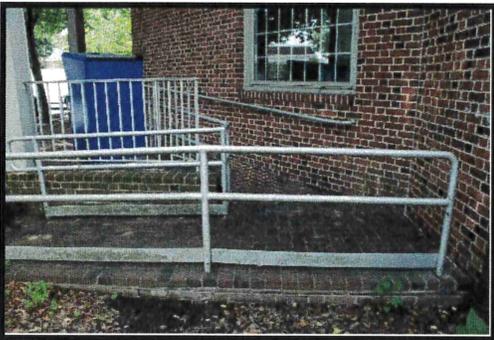
D-27
Exterior
Southeast, Ramp and Stairs

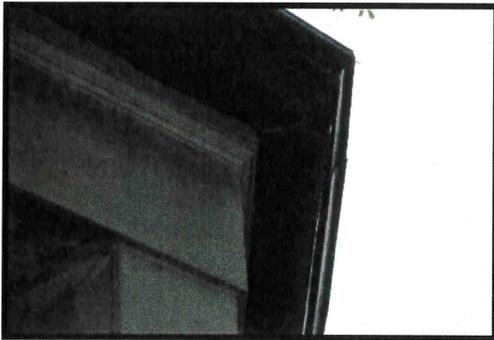
D-31
Exterior
Woodwork

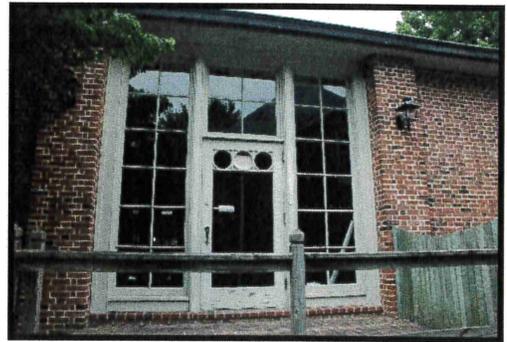
D-32
Exterior
Woodwork

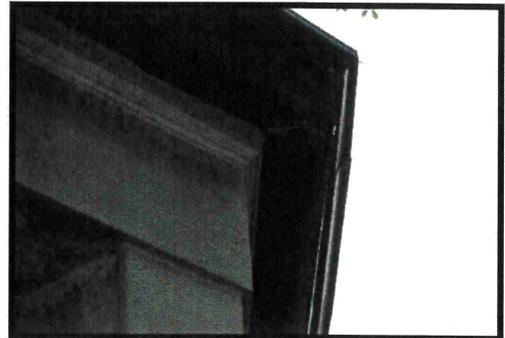
- Gutters and downspouts are copper and in need of repair. Dissimilar metal connections on the downspout system are deteriorating and causing leaking back into the building along with uncoupled connections.

D-38
Exterior
Gutter Downspout

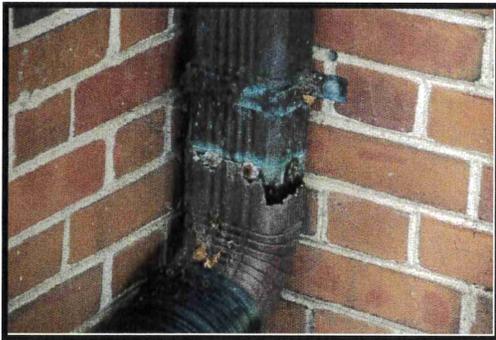
D-39
Exterior
Gutter Downspout

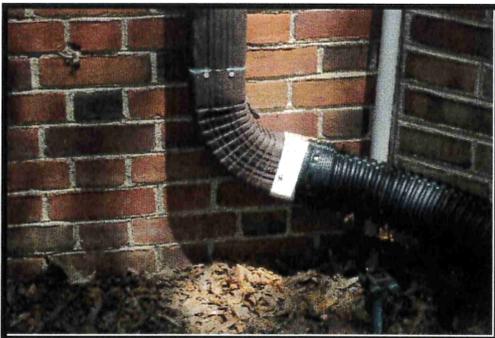
D-41
Exterior
Gutter Downspout

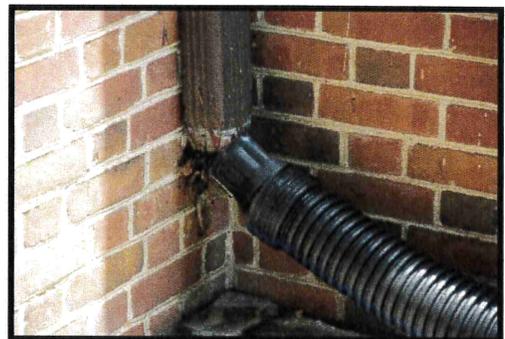
D-42
Exterior
Gutter Downspout

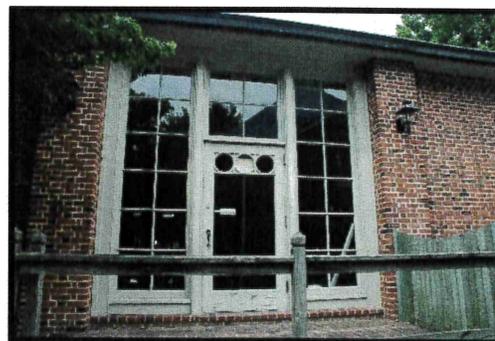
- The storefront doors (main entrance) are in good condition. However, the two doors on the northwest side of the building are in fair condition, and the fire escape exterior door on the second floor is in poor condition. The wood/glass door on the northeast side of Section 2 is in fair condition and needs to be prepped and painted.

D-48
Exterior
Northeast, Door

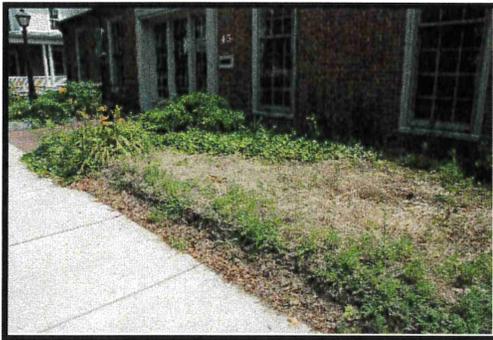
- The cupola above the main entrance (Section 2) seems to be in good shape but should be prepped and painted.
- Planters and retaining walls on the southwest side of the building are in poor condition and should be repaired.

D-51
Exterior
Southwest Planters

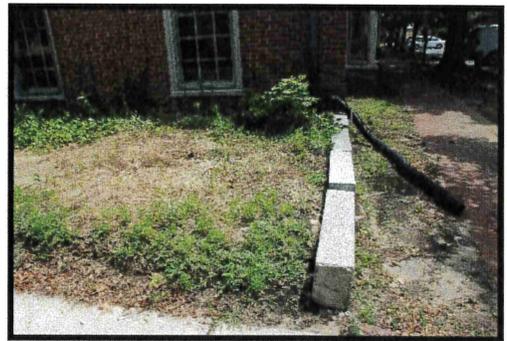
D-52
Exterior
Southwest Planters

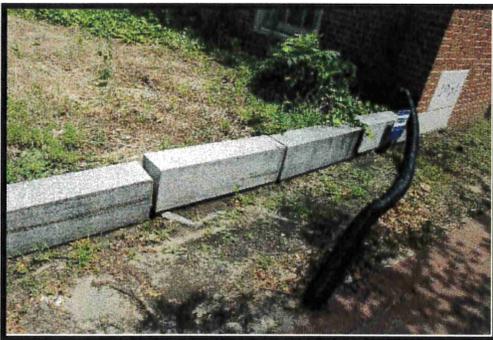
D-53
Exterior
Southwest Planters

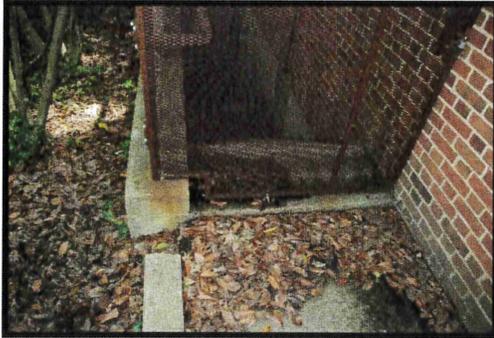
D-55
Exterior
Basement Stairwell

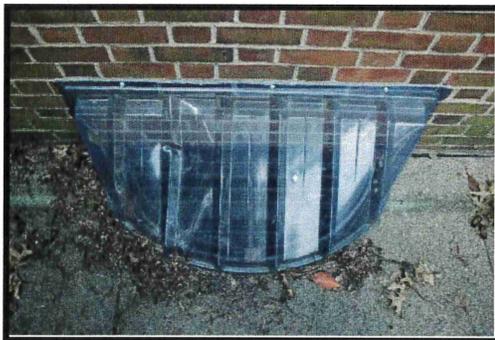
D-57
Exterior
Window Well

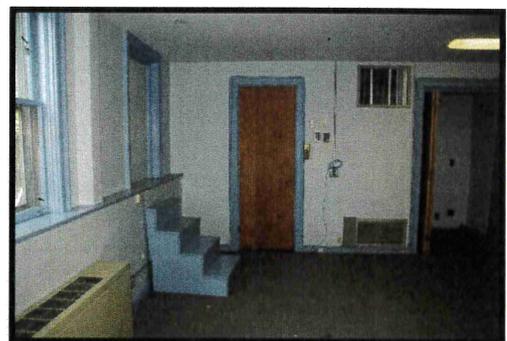
D-60
Interior
Book Elevator

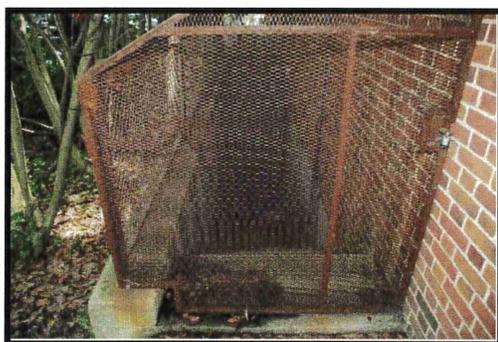
D-63
Exterior
Basement Stairwell Padlock

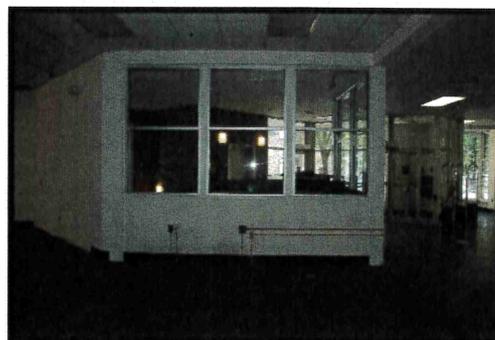
D-66
Interior
Wall Partitions

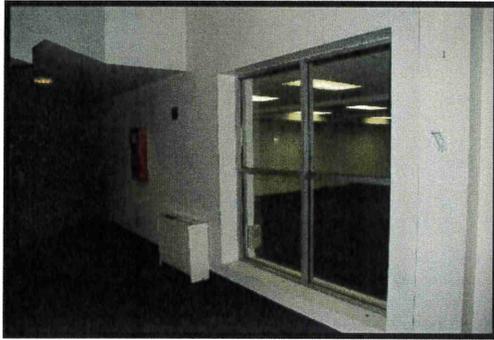
D-67
Interior
Basement, Wall Partitions

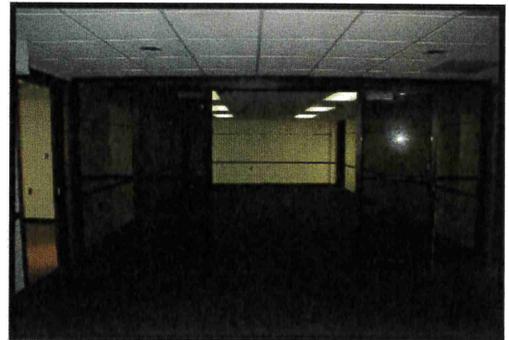
D-68
Interior
Basement, Wall Partitions

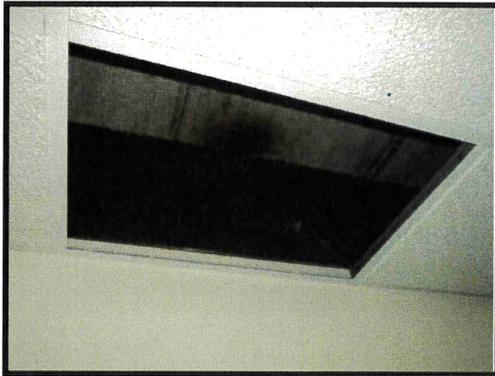
E-3
Basement Ceiling - East Addition with
Concrete Plank Floor Above

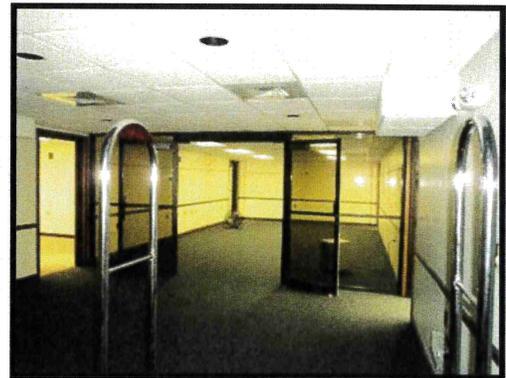
E-4
Basement
East Addition

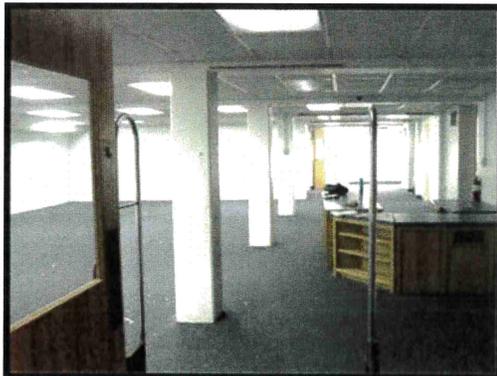
E-5
Basement
Original Construction

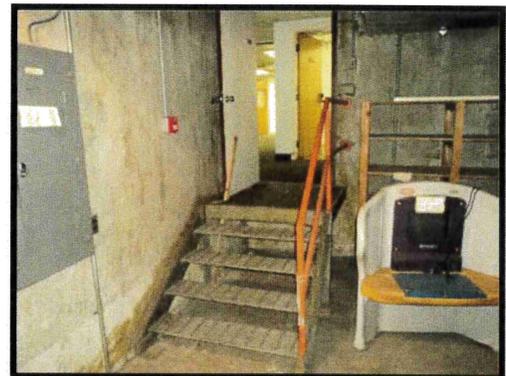
E-6
Basement
Mechanical Room and Stairs

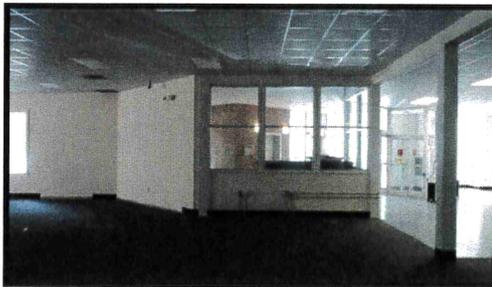
E-9
First Floor
Stair Well at Old and Addition Transition

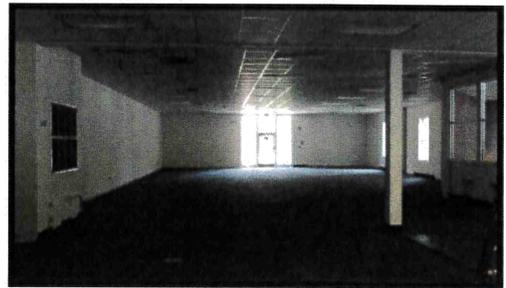
E-10
First Floor
Addition

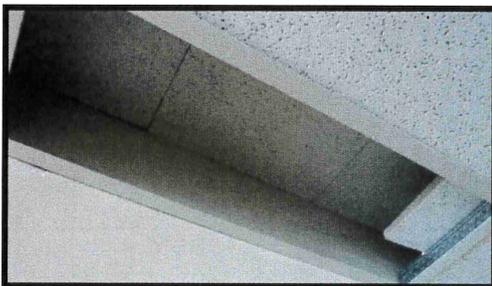
E-11
First Floor - Ceiling at Addition with Original
Ceiling Visible Above

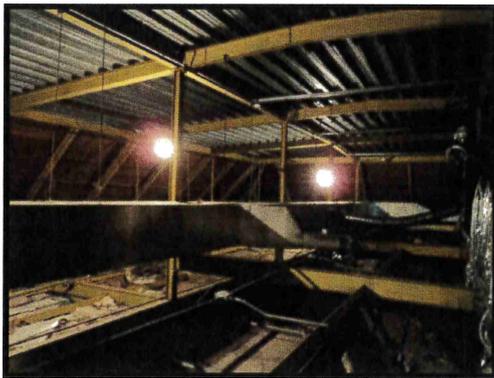
E-15
Second Floor - Attic Space with Steel Girders,
Metal Deck, and Timber Deck

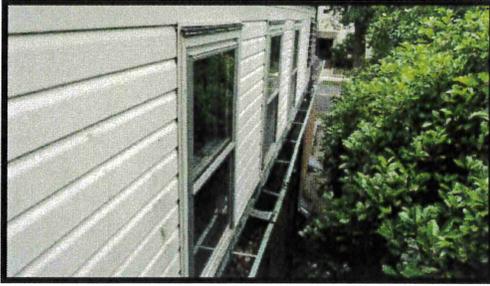
E-19
Exterior - North Elevation
Original Construction Lower Gutters

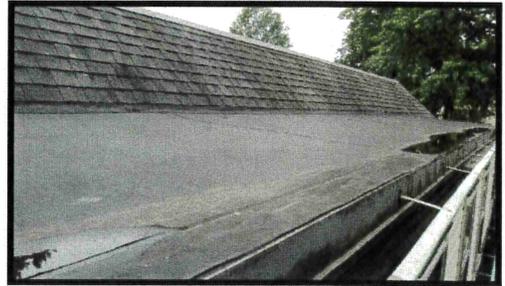
E-20
Exterior - North Elevation
Original Construction Upper Roof Gutters

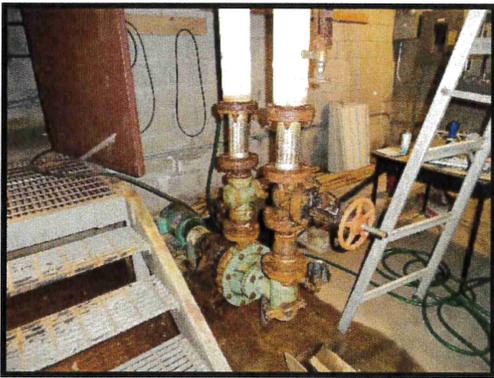
F-3
Chilled Water Pump.

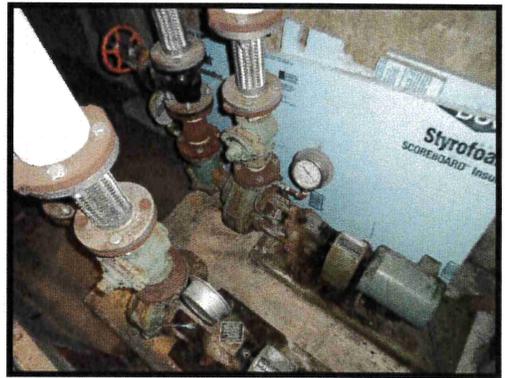
F-4
Hot Water Pumps.

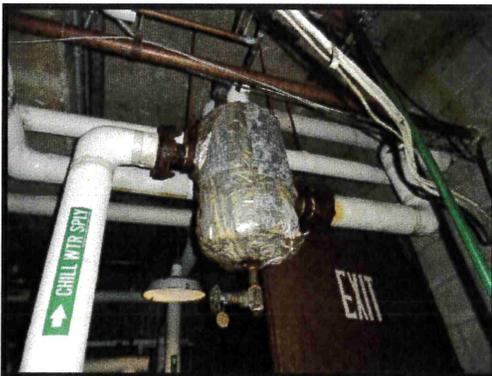
F-5
Chilled Water Air Separator.

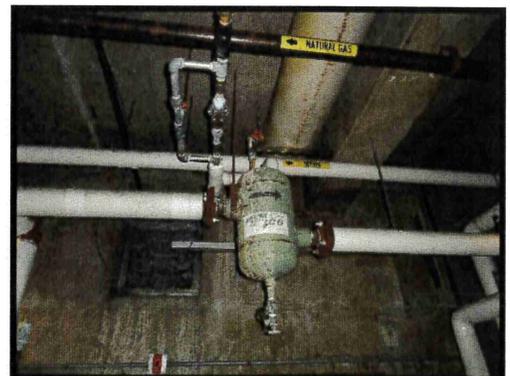
F-6
Hot Water Air Separator.

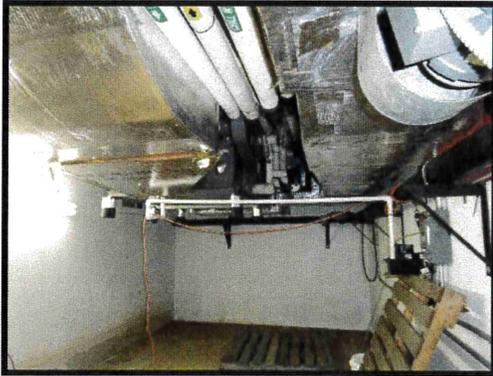
F-7
Air-Handling Unit (HC-1).

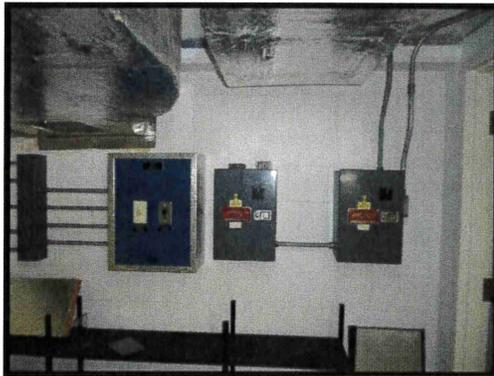
F-9
ATC Controls and Elec. Duct Heaters.

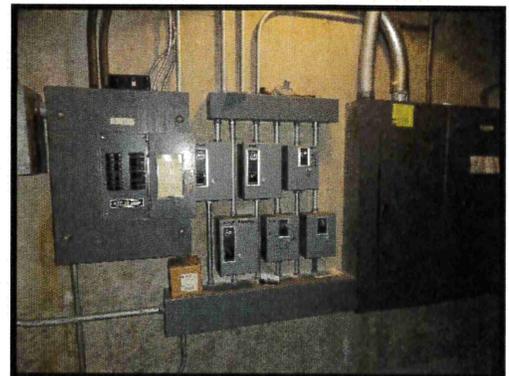
F-10
Starters.

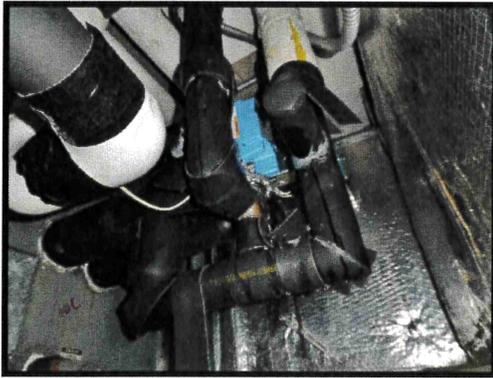
F-13
Pipe Insulation.

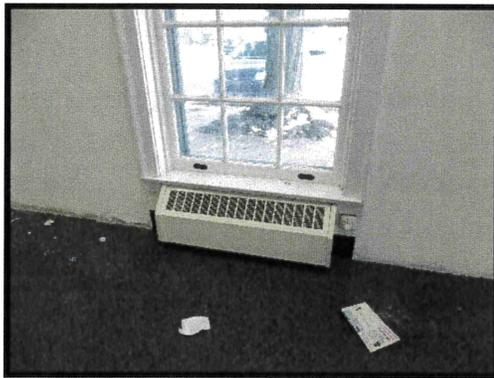
F-15
Perimeter Fintube.

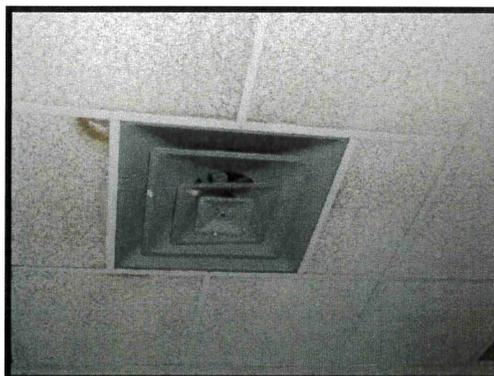
F-17
Ceiling Diffuser.

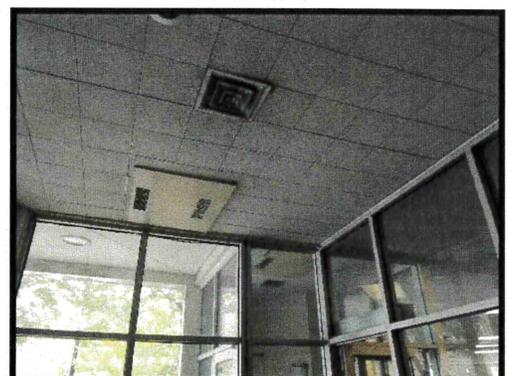
F-18
Electric Ceiling Heater.

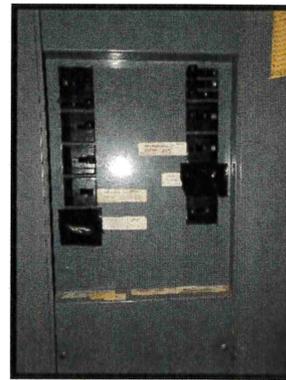
H-8
Basement - Older Panel MDP Section 2.
(No longer used as MDP)

- Existing panels inside the addition mechanical room have a remaining service life of approximately 10 years.
- Panels inside the original construction mechanical room and on second floor have reached the end of their service life and require replacement.
- All interior and exterior lighting fixtures, emergency lighting fixtures, exit signs and controls require replacement to meet current codes.
- Replace feeder and branch circuit wiring and conduits for panels, receptacles and lighting.
- Replace fire alarm control panel, initiation devices, notification appliances with UL Listed addressable system. Elevator recall should also be addressed.

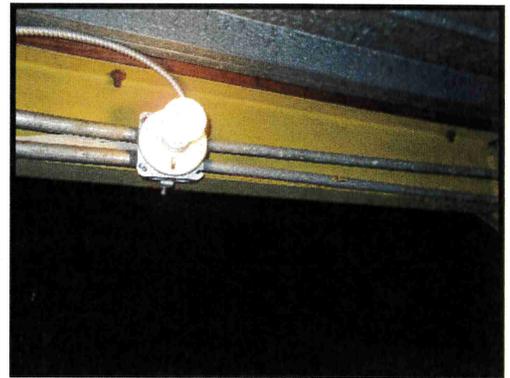
H-33
Second Floor - Incandescent Flushed Mounted
Lighting Fixture Fitted with CF Lamps.

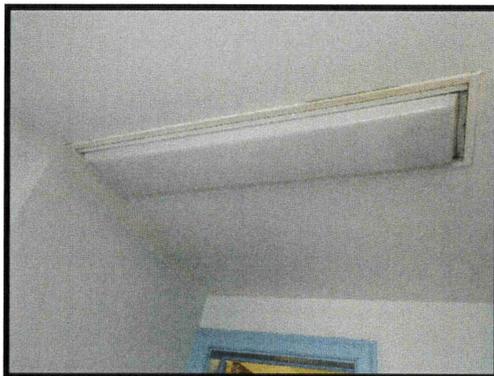
H-34
Attic - Incandescent Lighting Fixture.

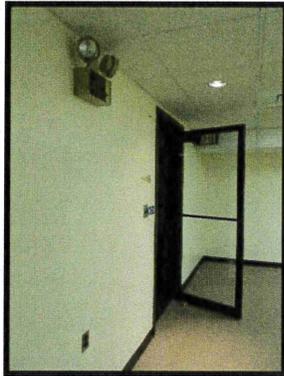
H-42
Basement - Tungsten Emergency Remote
Head, Fire Alarm Pull Station, Horn and
Strobe.

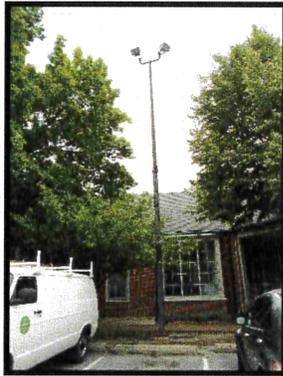
H-44
Damage Pole Base and Aged Foundation.

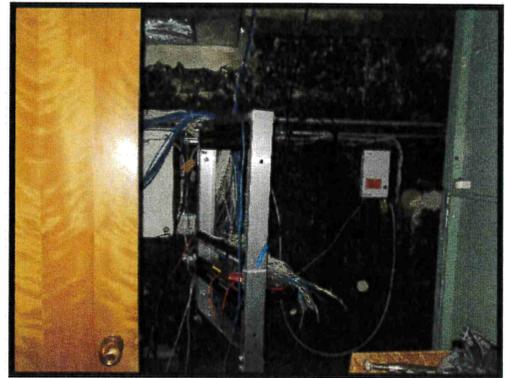
H-55
Basement - Main Telecom Punch Block.

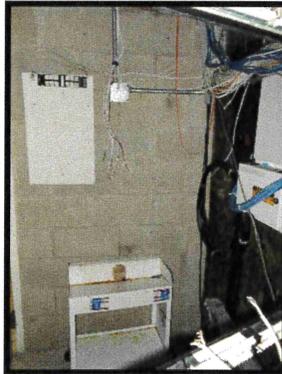
H-56
Basement - Disconnected Data Racks with
Equipment Removed.
